Profile/Photo Observation Report

Date:	09/24/2018	Weather:		Coding:	PACP 6.0
Pipe Length (ft):	274.1	Owner:	NA	Pre Clean:	Not Known
P.O.#:		Surveyor:	Selasie Honu	PSR:	P-303-024-023
Customer:		Clean Date:	01/01/1900	Shape:	C

Street:	KENWOOD ST	Flow Control:	Not Controlled
City:	Hobart, IN	Year Renewed:	
Location:	Light Highway	Tape/Media #:	
Purpose:	Routine Assessment	Dia/Height:	10"
Use:	Sanitary	Material:	VCP
Drain Area:	NA	Lining:	
Category:	NA		
Comment:

Location Details:		Direction of Survey:	Upstream
US MH:	M-303-023	DS MH:	M-303-024
		Total Length Surveyed (ft):	98.4

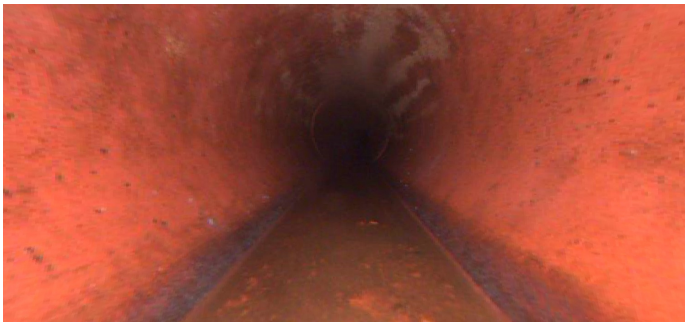
Code: **AMH**
Description: **Manhole**

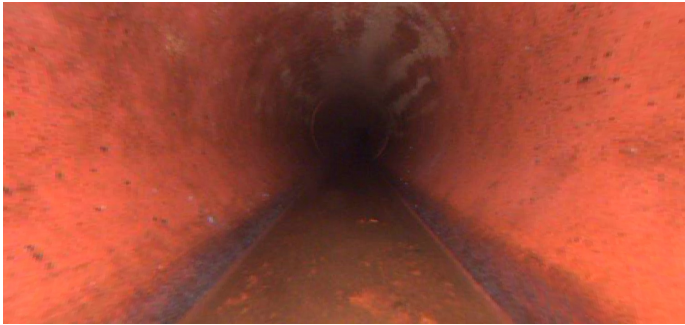
Code:	MWL
Description:	Water Level

Distance (ft):	.0
Structural Grade:	0
O&M Grade:	0
Clock Start/From:	
Clock To:	
1st Value:	
2nd Value:	
Value Percent:	5.000
Continuous Index:	
Within 8" of Joint:	NO
Remarks:

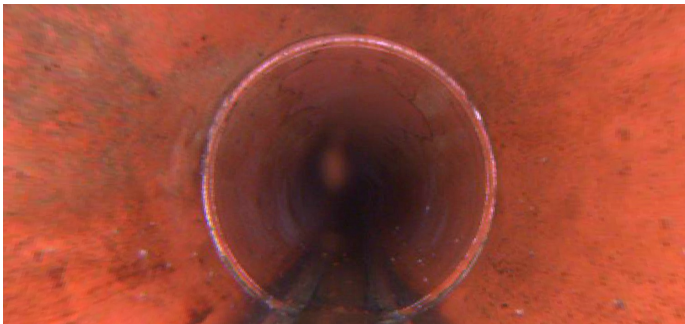
Code:	IS
Description:	Infil Stain

Distance (ft):	29.7
Structural Grade:	0
O&M Grade:	0
Clock Start/From:	7
Clock To:	5
1st Value:	
2nd Value:	
Value Percent:	
Continuous Index:	
Within 8" of Joint:	NO
Remarks:

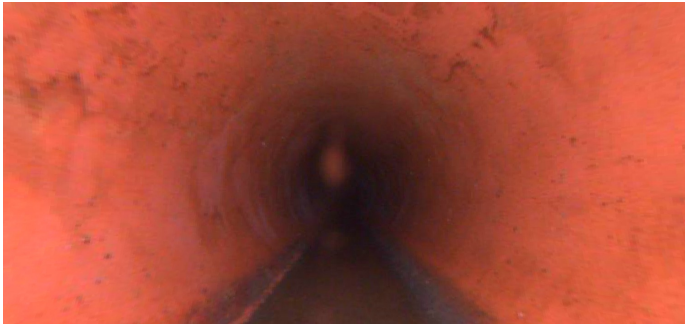
Code: **IS**
Description: **Infil Stain**

Distance (ft): **41.5**
Structural Grade: **0**
O&M Grade: **0**
Clock Start/From: **7**
Clock To: **5**
1st Value:
2nd Value:
Value Percent:
Continuous Index:
Within 8" of Joint: **NO**
Remarks:

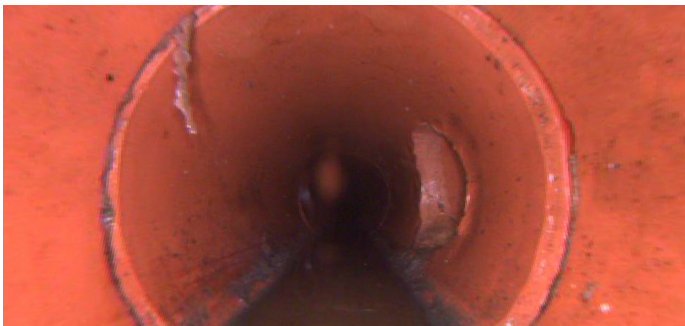
Code: **RFJ**
Description: **Roots Fine Joint**

Distance (ft): **49.9**
Structural Grade: **0**
O&M Grade: **1**
Clock Start/From: **11**
Clock To:
1st Value:
2nd Value:
Value Percent:
Continuous Index:
Within 8" of Joint: **YES**
Remarks:

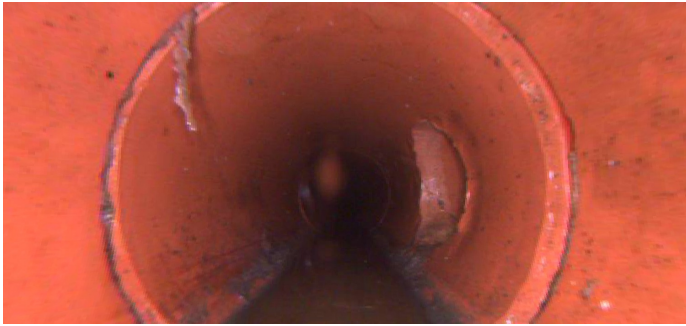
Code: **TF**
Description: **Tap Factory**

Distance (ft): **49.9**
Structural Grade: **0**
O&M Grade: **0**
Clock Start/From: **3**
Clock To:
1st Value: **4.000**
2nd Value:
Value Percent:
Continuous Index:
Within 8" of Joint:
Remarks:

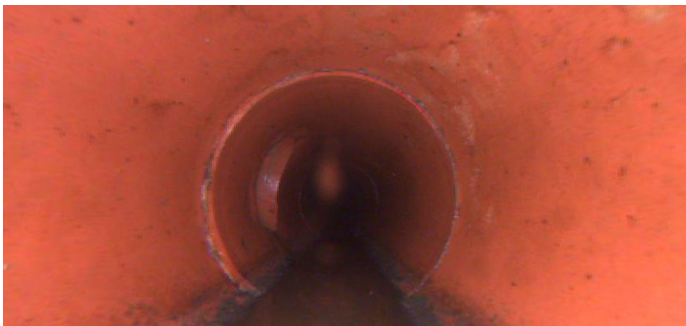
Code: **TF**
Description: **Tap Factory**

Distance (ft): **51.5**
Structural Grade: **0**
O&M Grade: **0**
Clock Start/From: **9**
Clock To:
1st Value: **4.000**
2nd Value:
Value Percent:
Continuous Index:
Within 8" of Joint:
Remarks:

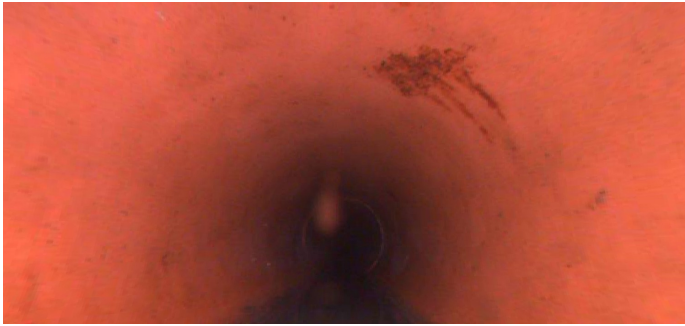
Code: **IS**
Description: **Infil Stain**

Distance (ft): **76.5**
Structural Grade: **0**
O&M Grade: **0**
Clock Start/From: **1**
Clock To: **2**
1st Value:
2nd Value:
Value Percent:
Continuous Index:
Within 8" of Joint:
Remarks:

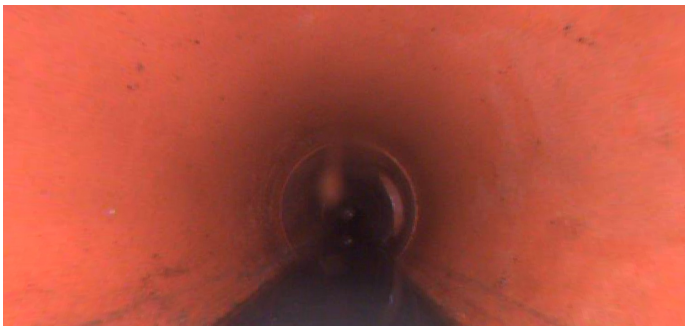
Code: **TF**
Description: **Tap Factory**

Distance (ft): **92.8**
Structural Grade: **0**
O&M Grade: **0**
Clock Start/From: **3**
Clock To:
1st Value: **4.000**
2nd Value:
Value Percent:
Continuous Index:
Within 8" of Joint:
Remarks:

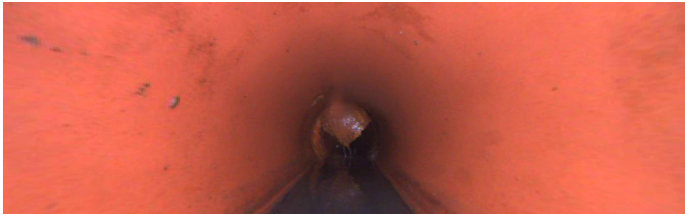
Code: **TBI**
Description: **Tap Break-in Intruding**

Distance (ft): **96.0**
Structural Grade: **0**
O&M Grade: **2**
Clock Start/From: **10**
Clock To:
1st Value: **6.000**
2nd Value: **4.000**
Value Percent:
Continuous Index:
Within 8" of Joint:
Remarks:

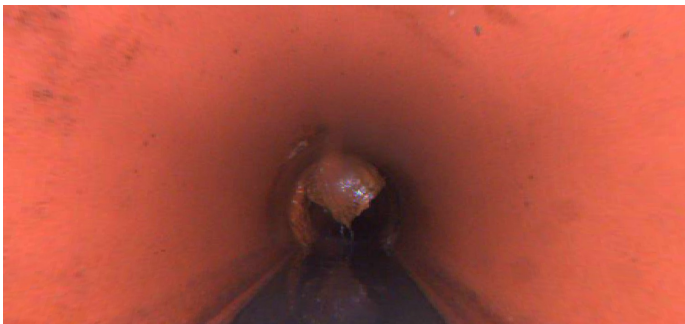
Code: **DAE**
Description: **Deposits Attached Encrustation**

Distance (ft): **96.2**
Structural Grade: **0**
O&M Grade: **2**
Clock Start/From: **7**
Clock To: **12**
1st Value:
2nd Value:
Value Percent: **5.000**
Continuous Index:
Within 8" of Joint: **NO**
Remarks:

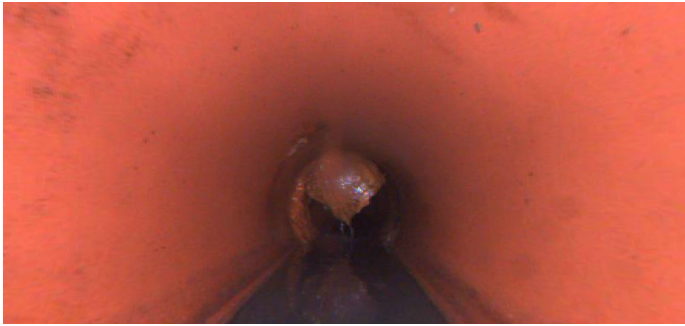
Code: **IS**
Description: **Infil Stain**

Distance (ft): **96.2**
Structural Grade: **0**
O&M Grade: **0**
Clock Start/From: **8**
Clock To: **11**
1st Value:
2nd Value:
Value Percent:
Continuous Index:
Within 8" of Joint:
Remarks:

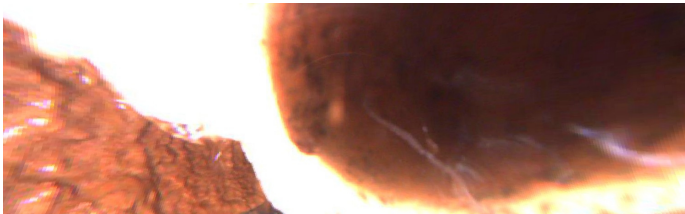
Code: **MSA**
Description: **Abandoned Survey**

Distance (ft): **98.4**
Structural Grade: **0**
O&M Grade: **0**
Clock Start/From:
Clock To:
1st Value:
2nd Value:
Value Percent:
Continuous Index:
Within 8" of Joint: **NO**
Remarks: **tap break in blocking camera passage**
