## Profile/Photo Observation Report

Street:	<b>Kenwood St</b>	Flow Control:	<b>Not Controlled</b>
City:	<b>Hobart, IN</b>	Year Renewed:	
Location:	<b>Light Highway</b>	Tape/Media #:	
Purpose:	<b>Routine Assessment</b>	Dia/Height:	<b>10"</b>
Use:	<b>Sanitary</b>	Material:	<b>VCP</b>
Drain Area:	<b>NA</b>	Lining:	
Category:	<b>NA</b>		
Comment:

Location Details:		Direction of Survey:	<b>Upstream</b>
US MH:	<b>M-303-023</b>	DS MH:	<b>M-303-024</b>
		Total Length Surveyed (ft):	<b>98.4</b>

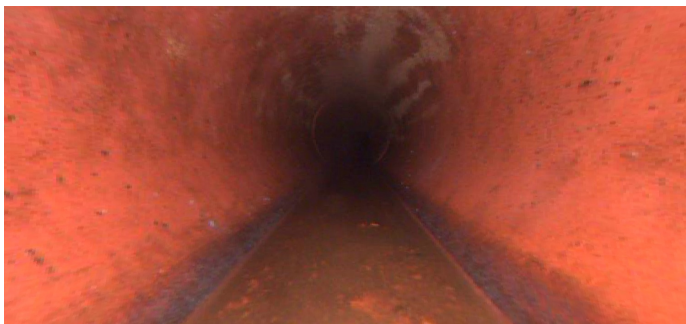
Code: **AMH**  
Description: **Manhole**

Distance (ft): **.0**  
Structural Grade: **0**  
O&M Grade: **0**  
Clock Start/From:  
Clock To:  
1st Value:  
2nd Value:  
Value Percent:  
Continuous Index:  
Within 8" of Joint: **NO**  
Remarks: **M-303-024**

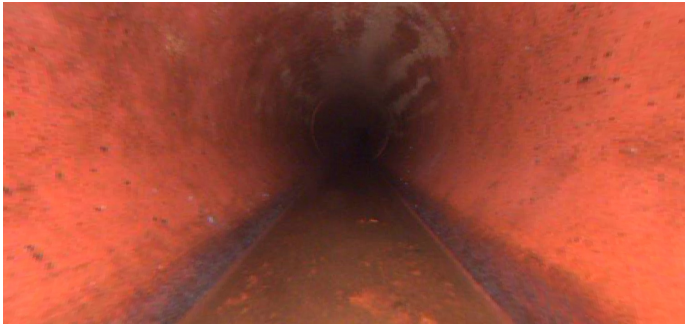
Code:	<b>MWL</b>
Description:	<b>Water Level</b>

Distance (ft):	<b>.0</b>
Structural Grade:	<b>0</b>
O&M Grade:	<b>0</b>
Clock Start/From:	
Clock To:	
1st Value:	
2nd Value:	
Value Percent:	<b>5.000</b>
Continuous Index:	
Within 8" of Joint:	<b>NO</b>
Remarks:

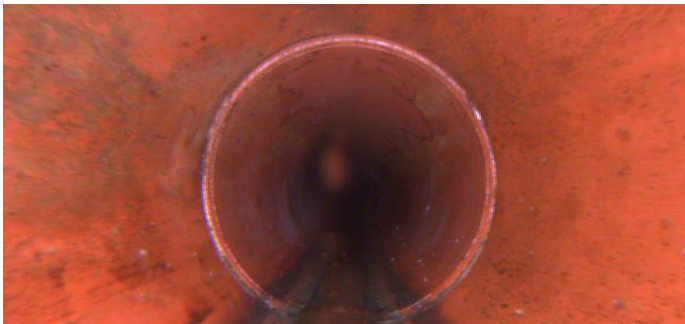
Code:	<b>IS</b>
Description:	<b>Infil Stain</b>

Distance (ft):	<b>29.7</b>
Structural Grade:	<b>0</b>
O&M Grade:	<b>0</b>
Clock Start/From:	<b>7</b>
Clock To:	<b>5</b>
1st Value:	
2nd Value:	
Value Percent:	
Continuous Index:	
Within 8" of Joint:	<b>NO</b>
Remarks:

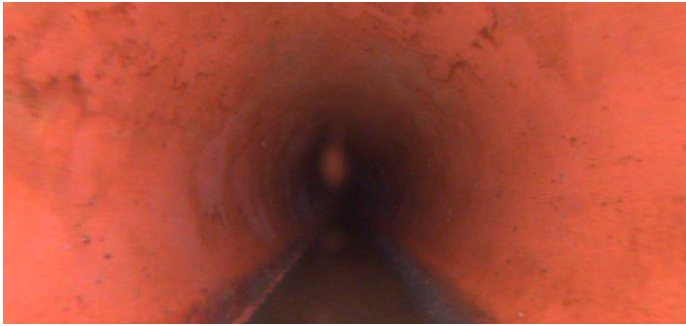
Code: **IS**  
Description: **Infil Stain**

Distance (ft): **41.5**  
Structural Grade: **0**  
O&M Grade: **0**  
Clock Start/From: **7**  
Clock To: **5**  
1st Value:  
2nd Value:  
Value Percent:  
Continuous Index:  
Within 8" of Joint: **NO**  
Remarks:

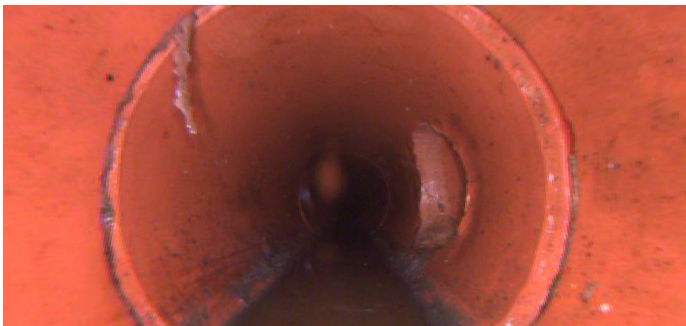
Code: **RFJ**  
Description: **Roots Fine Joint**

Distance (ft): **49.9**  
Structural Grade: **0**  
O&M Grade: **1**  
Clock Start/From: **11**  
Clock To:  
1st Value:  
2nd Value:  
Value Percent:  
Continuous Index:  
Within 8" of Joint: **YES**  
Remarks:

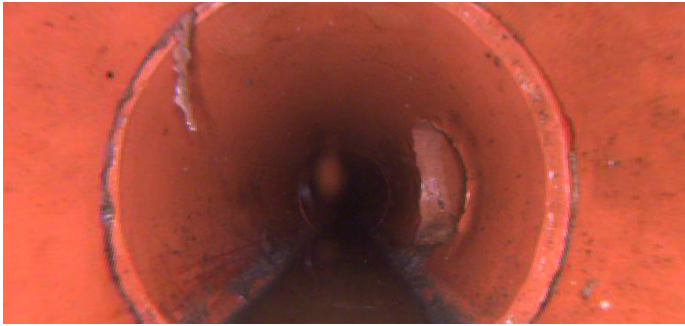
Code: **TF**  
Description: **Tap Factory**

Distance (ft): **49.9**  
Structural Grade: **0**  
O&M Grade: **0**  
Clock Start/From: **3**  
Clock To:  
1st Value: **4.000**  
2nd Value:  
Value Percent:  
Continuous Index:  
Within 8" of Joint:  
Remarks:

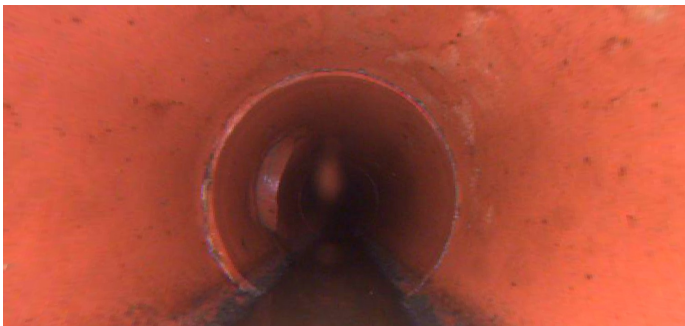
Code: **TF**  
Description: **Tap Factory**

Distance (ft): **51.5**  
Structural Grade: **0**  
O&M Grade: **0**  
Clock Start/From: **9**  
Clock To:  
1st Value: **4.000**  
2nd Value:  
Value Percent:  
Continuous Index:  
Within 8" of Joint:  
Remarks:

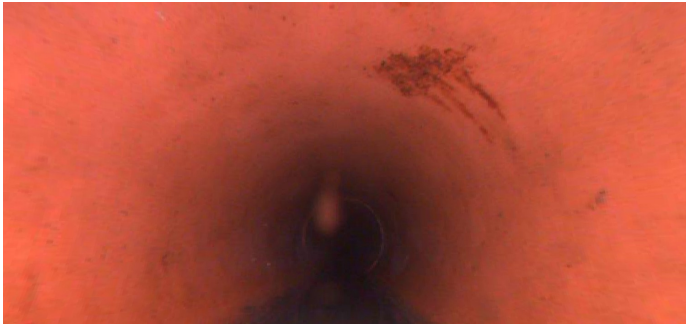
Code: **IS**  
Description: **Infil Stain**

Distance (ft): **76.5**  
Structural Grade: **0**  
O&M Grade: **0**  
Clock Start/From: **1**  
Clock To: **2**  
1st Value:  
2nd Value:  
Value Percent:  
Continuous Index:  
Within 8" of Joint:  
Remarks:

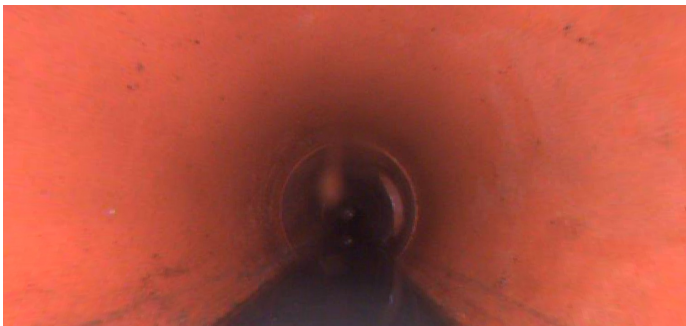
Code: **TF**  
Description: **Tap Factory**

Distance (ft): **92.8**  
Structural Grade: **0**  
O&M Grade: **0**  
Clock Start/From: **3**  
Clock To:  
1st Value: **4.000**  
2nd Value:  
Value Percent:  
Continuous Index:  
Within 8" of Joint:  
Remarks:

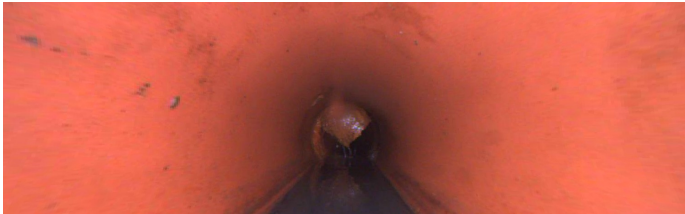
Code: **TBI**  
Description: **Tap Break-in Intruding**

Distance (ft): **96.0**  
Structural Grade: **0**  
O&M Grade: **2**  
Clock Start/From: **10**  
Clock To:  
1st Value: **6.000**  
2nd Value: **4.000**  
Value Percent:  
Continuous Index:  
Within 8" of Joint:  
Remarks:

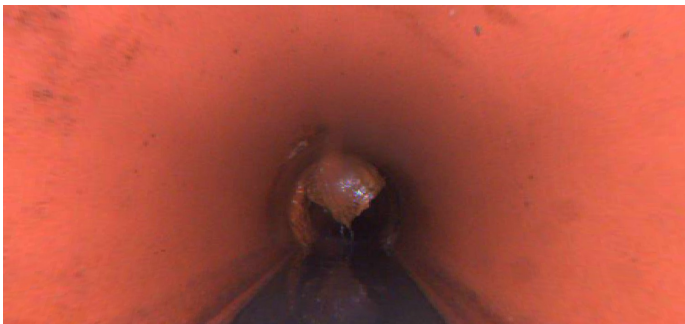
Code: **DAE**  
Description: **Deposits Attached Encrustation**

Distance (ft): **96.2**  
Structural Grade: **0**  
O&M Grade: **2**  
Clock Start/From: **7**  
Clock To: **12**  
1st Value:  
2nd Value:  
Value Percent: **5.000**  
Continuous Index:  
Within 8" of Joint: **NO**  
Remarks:

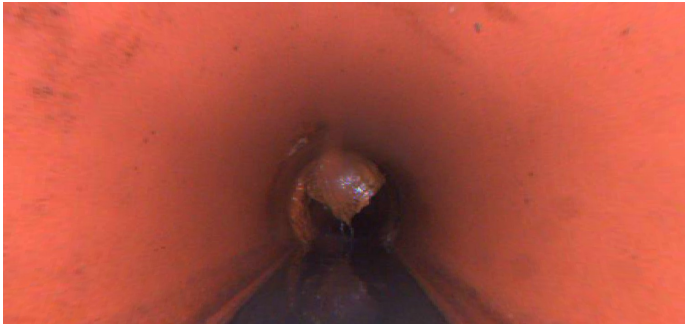
Code: **IS**  
Description: **Infil Stain**

Distance (ft): **96.2**  
Structural Grade: **0**  
O&M Grade: **0**  
Clock Start/From: **8**  
Clock To: **11**  
1st Value:  
2nd Value:  
Value Percent:  
Continuous Index:  
Within 8" of Joint:  
Remarks:

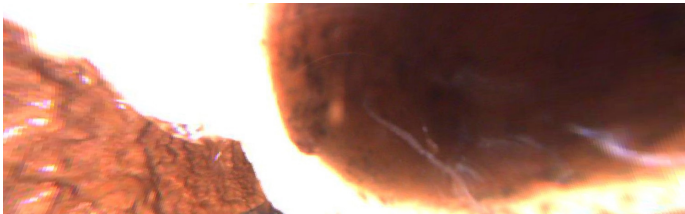
Code: **MSA**  
Description: **Abandoned Survey**

Distance (ft): **98.4**  
Structural Grade: **0**  
O&M Grade: **0**  
Clock Start/From:  
Clock To:  
1st Value:  
2nd Value:  
Value Percent:  
Continuous Index:  
Within 8" of Joint: **NO**  
Remarks: **tap break in blocking camera passage**
