Profile/Photo Observation Report

Street:	KENWOOD ST	Flow Control:	Not Controlled
City:	Hobart, IN	Year Renewed:	
Location:	Light Highway	Tape/Media #:	
Purpose:	Routine Assessment	Dia/Height:	10"
Use:	Sanitary	Material:	VCP
Drain Area:	NA	Lining:	
Category:	NA		
Comment:

Location Details:		Direction of Survey:	Downstream
US MH:	M-303-023	DS MH:	M-303-024
		Total Length Surveyed (ft):	178.2

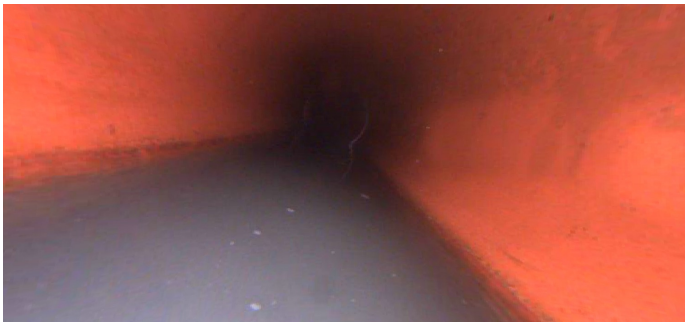
Code: **AMH**
Description: **Manhole**

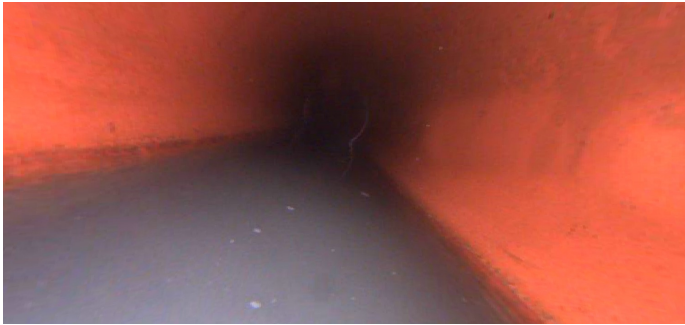
Code:	MWL
Description:	Water Level

Distance (ft):	.0
Structural Grade:	0
O&M Grade:	0
Clock Start/From:	
Clock To:	
1st Value:	
2nd Value:	
Value Percent:	5.000
Continuous Index:	
Within 8" of Joint:	NO
Remarks:

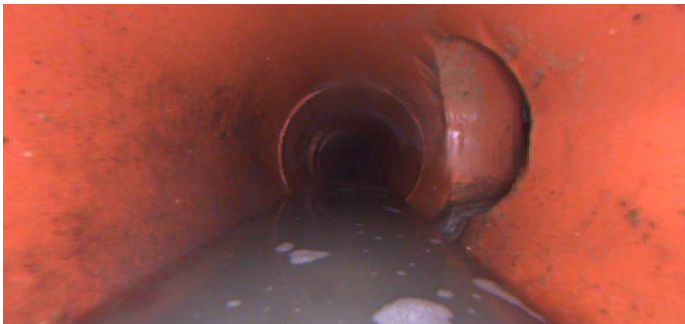
Code:	TF
Description:	Tap Factory

Distance (ft):	54.5
Structural Grade:	0
O&M Grade:	0
Clock Start/From:	3
Clock To:	
1st Value:	4.000
2nd Value:	
Value Percent:	
Continuous Index:	
Within 8" of Joint:	
Remarks:

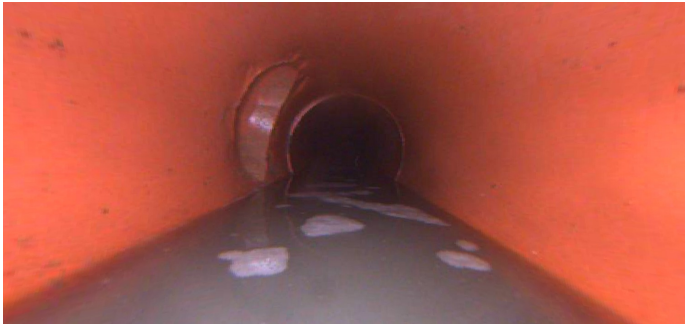
Code: **TF**
Description: **Tap Factory**

Distance (ft): **56.1**
Structural Grade: **0**
O&M Grade: **0**
Clock Start/From: **9**
Clock To:
1st Value: **4.000**
2nd Value:
Value Percent:
Continuous Index:
Within 8" of Joint:
Remarks:

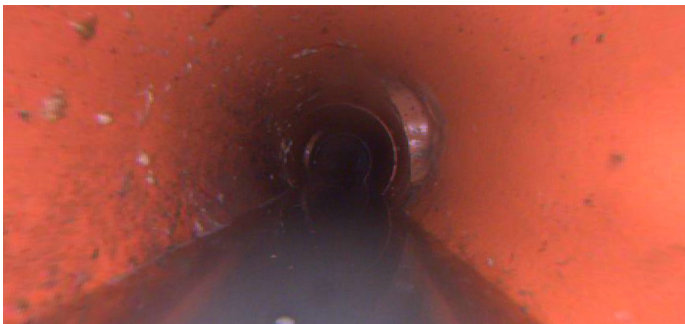
Code: **TF**
Description: **Tap Factory**

Distance (ft): **107.7**
Structural Grade: **0**
O&M Grade: **0**
Clock Start/From: **3**
Clock To:
1st Value: **4.000**
2nd Value:
Value Percent:
Continuous Index:
Within 8" of Joint:
Remarks:

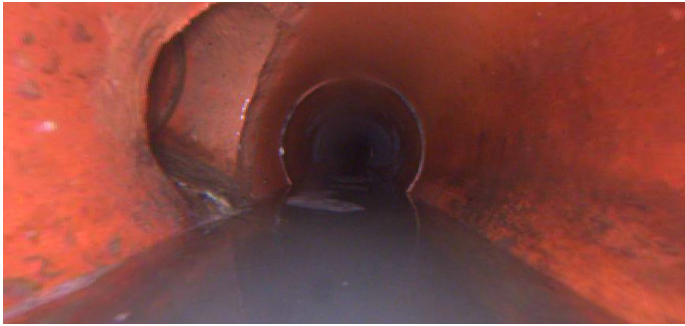
Code: **TF**
Description: **Tap Factory**

Distance (ft): **110.2**
Structural Grade: **0**
O&M Grade: **0**
Clock Start/From: **9**
Clock To:
1st Value: **4.000**
2nd Value:
Value Percent:
Continuous Index:
Within 8" of Joint:
Remarks:

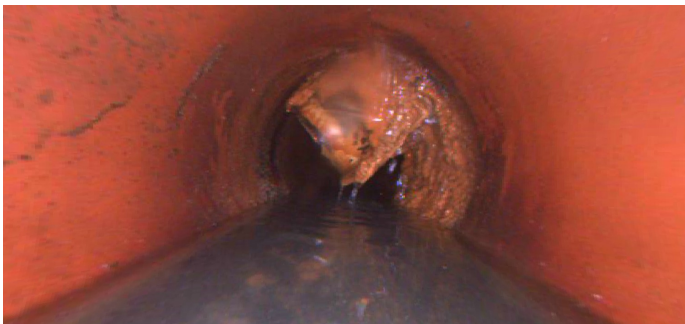
Code: **DAE**
Description: **Deposits Attached Encrustation**

Distance (ft): **176.3**
Structural Grade: **0**
O&M Grade: **5**
Clock Start/From: **12**
Clock To: **4**
1st Value:
2nd Value:
Value Percent: **40.000**
Continuous Index:
Within 8" of Joint: **NO**
Remarks:

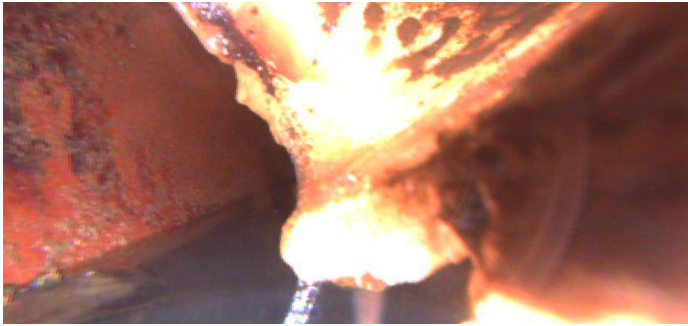
Code: **MSA**
Description: **Abandoned Survey**

Distance (ft): **178.2**

Remarks: **tap break in intruding blocking
camera passage**
