Profile/Photo Observation Report

Street:	Kenwood St	Flow Control:	Not Controlled
City:	Hobart, IN	Year Renewed:	
Location:	Light Highway	Tape/Media #:	
Purpose:	Routine Assessment	Dia/Height:	10"
Use:	Sanitary	Material:	VCP
Drain Area:	NA	Lining:	
Category:	NA		
Comment:

Location Details:		Direction of Survey:	Downstream
US MH:	M-303-023	DS MH:	M-303-024
		Total Length Surveyed (ft):	178.2

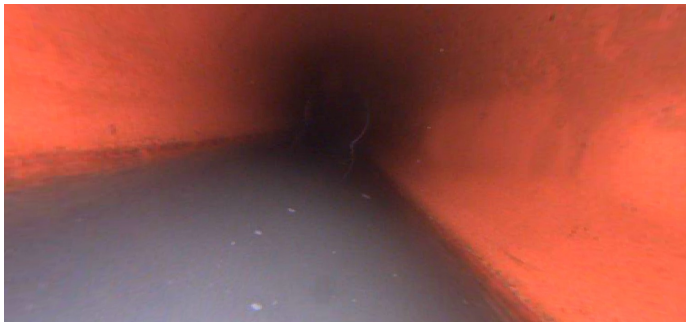
Code: **AMH**
Description: **Manhole**

Distance (ft): **.0**
Structural Grade: **0**
O&M Grade: **0**
Clock Start/From:
Clock To:
1st Value:
2nd Value:
Value Percent:
Continuous Index:
Within 8" of Joint: **NO**
Remarks: **M-303-023**

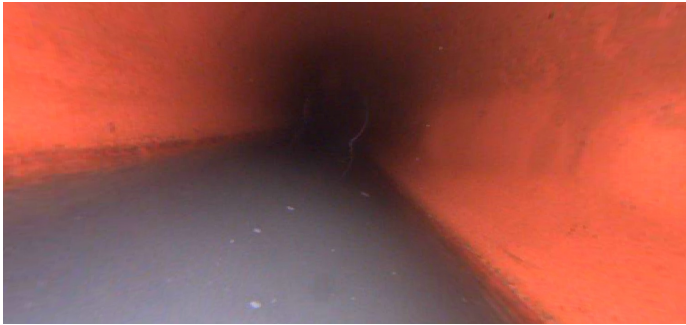
Code:	MWL
Description:	Water Level

Distance (ft):	.0
Structural Grade:	0
O&M Grade:	0
Clock Start/From:	
Clock To:	
1st Value:	
2nd Value:	
Value Percent:	5.000
Continuous Index:	
Within 8" of Joint:	NO
Remarks:

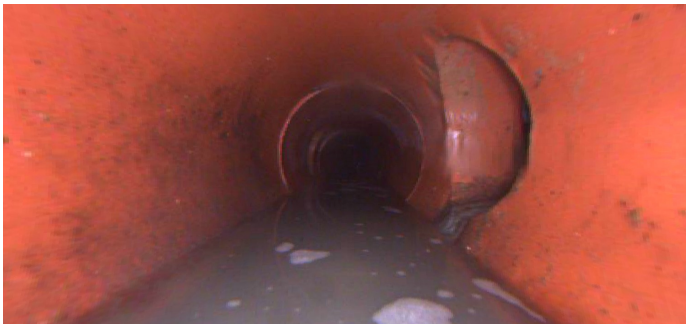
Code:	TF
Description:	Tap Factory

Distance (ft):	54.5
Structural Grade:	0
O&M Grade:	0
Clock Start/From:	3
Clock To:	
1st Value:	4.000
2nd Value:	
Value Percent:	
Continuous Index:	
Within 8" of Joint:	
Remarks:

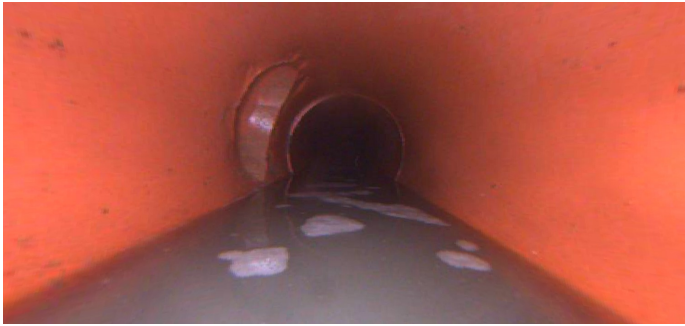
Code: **TF**
Description: **Tap Factory**

Distance (ft): **56.1**
Structural Grade: **0**
O&M Grade: **0**
Clock Start/From: **9**
Clock To:
1st Value: **4.000**
2nd Value:
Value Percent:
Continuous Index:
Within 8" of Joint:
Remarks:

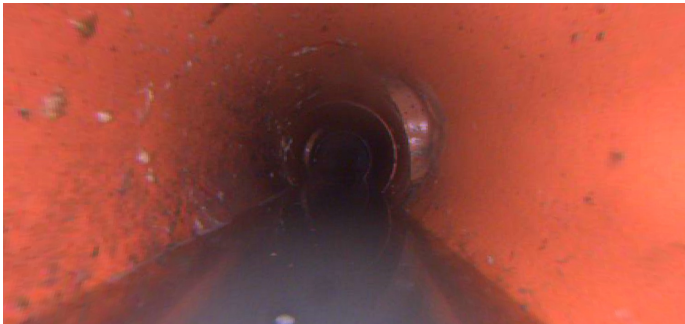
Code: **TF**
Description: **Tap Factory**

Distance (ft): **107.7**
Structural Grade: **0**
O&M Grade: **0**
Clock Start/From: **3**
Clock To:
1st Value: **4.000**
2nd Value:
Value Percent:
Continuous Index:
Within 8" of Joint:
Remarks:

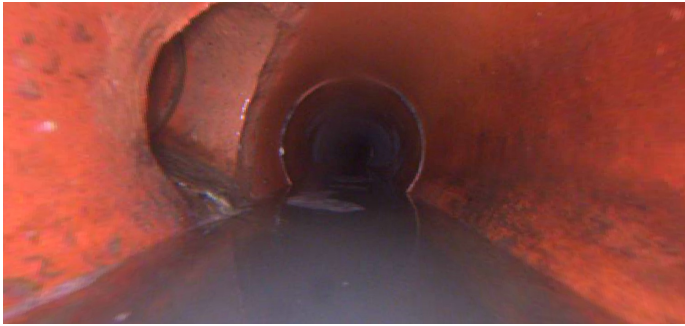
Code: **TF**
Description: **Tap Factory**

Distance (ft): **110.2**
Structural Grade: **0**
O&M Grade: **0**
Clock Start/From: **9**
Clock To:
1st Value: **4.000**
2nd Value:
Value Percent:
Continuous Index:
Within 8" of Joint:
Remarks:

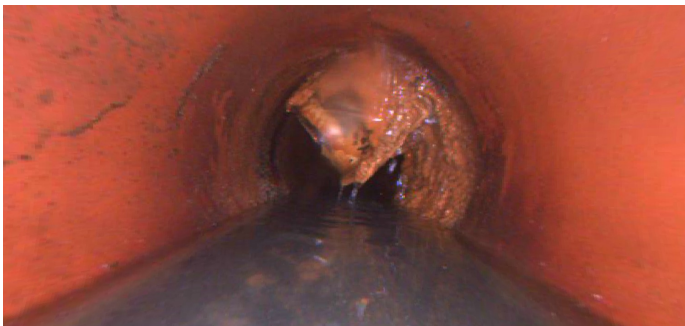
Code: **DAE**
Description: **Deposits Attached Encrustation**

Distance (ft): **176.3**
Structural Grade: **0**
O&M Grade: **5**
Clock Start/From: **12**
Clock To: **4**
1st Value:
2nd Value:
Value Percent: **40.000**
Continuous Index:
Within 8" of Joint: **NO**
Remarks:

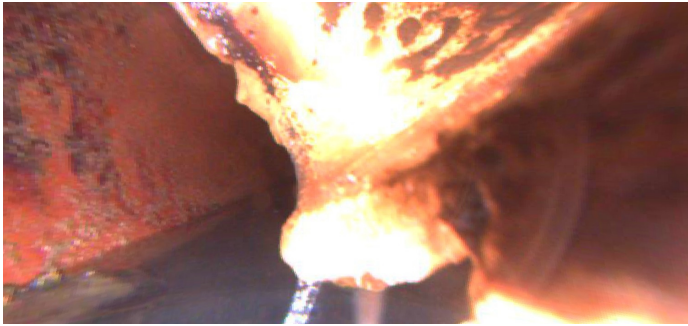
Code: **MSA**
Description: **Abandoned Survey**

Distance (ft): **178.2**
Structural Grade: **0**
O&M Grade: **0**
Clock Start/From:
Clock To:
1st Value:
2nd Value:
Value Percent:
Continuous Index:
Within 8" of Joint: **NO**
Remarks: **tap break in intruding blocking camera passage**
