Profile/Photo Observation Report

Street:	ALLEY BETWEEN W 39TH AVE & W 3	Flow Control:	Not Controlled
City:	Hobart, IN	Year Renewed:	
Location:	Light Highway	Tape/Media #:	
Purpose:	Routine Assessment	Dia/Height:	10"
Use:	Sanitary	Material:	VCP
Drain Area:	NA	Lining:	
Category:	NA		
Comment:

Location Details:		Direction of Survey:	Downstream
US MH:	M-303-024	DS MH:	M-303-025
		Total Length Surveyed (ft):	165.0

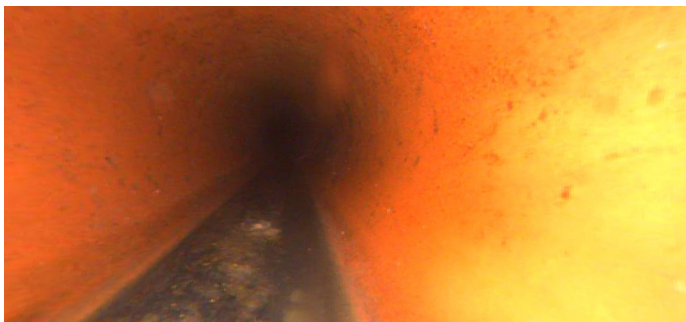
Code: **AMH**
Description: **Manhole**

Distance (ft): **.0**
Structural Grade: **0**
O&M Grade: **0**
Clock Start/From:
Clock To:
1st Value:
2nd Value:
Value Percent:
Continuous Index:
Within 8" of Joint: **NO**
Remarks: **M-303-024**

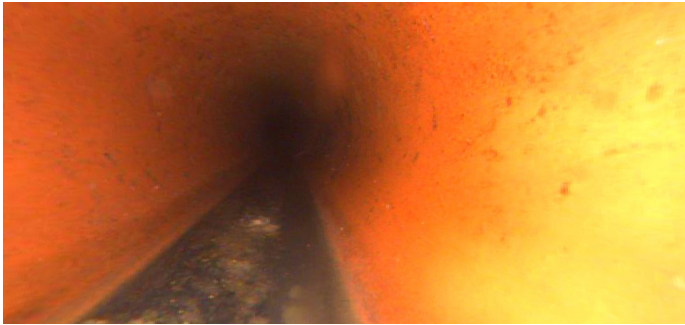
Code:	MWL
Description:	Water Level

Distance (ft):	.0
Structural Grade:	0
O&M Grade:	0
Clock Start/From:	
Clock To:	
1st Value:	
2nd Value:	
Value Percent:	5.000
Continuous Index:	
Within 8" of Joint:	NO
Remarks:

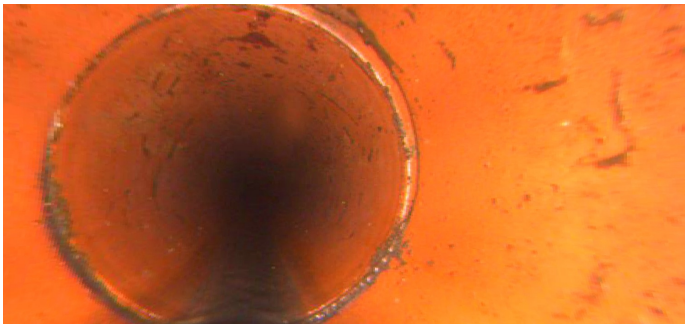
Code:	RFJ
Description:	Roots Fine Joint

Distance (ft):	4.2
Structural Grade:	0
O&M Grade:	1
Clock Start/From:	7
Clock To:	5
1st Value:	
2nd Value:	
Value Percent:	
Continuous Index:	
Within 8" of Joint:	YES
Remarks:

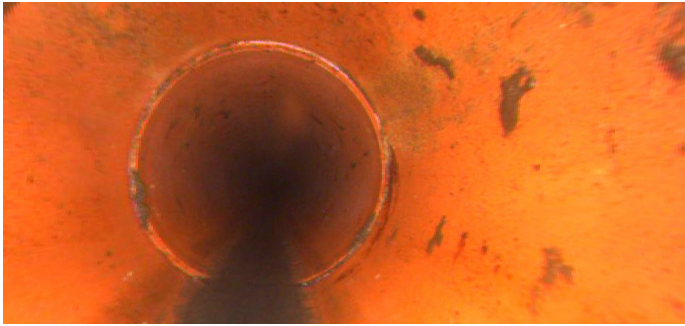
Code: **RFJ**
Description: **Roots Fine Joint**

Distance (ft): **9.0**
Structural Grade: **0**
O&M Grade: **1**
Clock Start/From: **8**
Clock To: **5**
1st Value:
2nd Value:
Value Percent:
Continuous Index:
Within 8" of Joint: **YES**
Remarks:

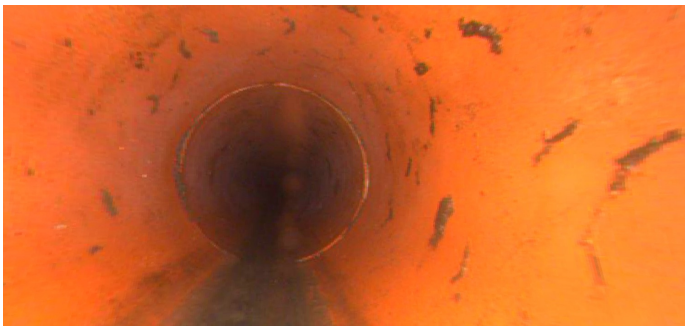
Code: **RFJ**
Description: **Roots Fine Joint**

Distance (ft): **23.5**
Structural Grade: **0**
O&M Grade: **1**
Clock Start/From: **8**
Clock To: **4**
1st Value:
2nd Value:
Value Percent:
Continuous Index:
Within 8" of Joint: **YES**
Remarks:

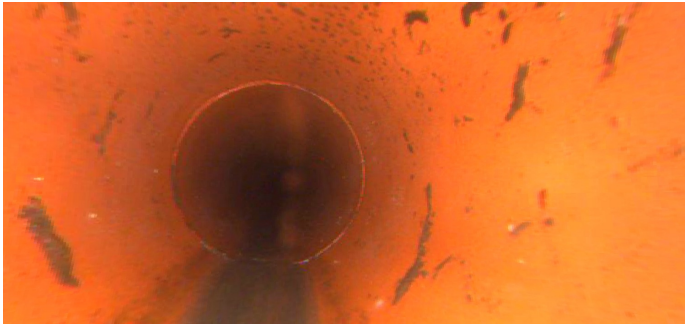
Code: **RFJ**
Description: **Roots Fine Joint**

Distance (ft): **28.4**
Structural Grade: **0**
O&M Grade: **1**
Clock Start/From: **7**
Clock To: **5**
1st Value:
2nd Value:
Value Percent:
Continuous Index:
Within 8" of Joint: **YES**
Remarks:

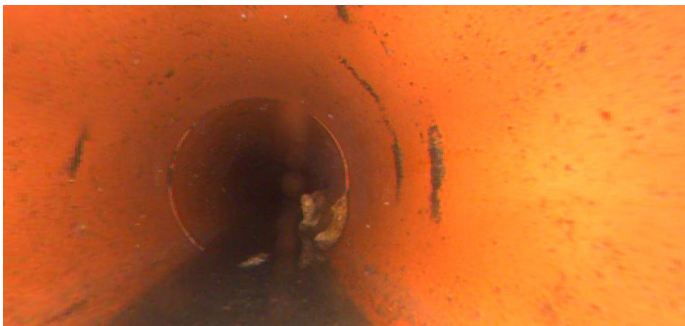
Code: **DAE**
Description: **Deposits Attached Encrustation**

Distance (ft): **38.4**
Structural Grade: **0**
O&M Grade: **3**
Clock Start/From: **3**
Clock To: **5**
1st Value:
2nd Value:
Value Percent: **15.000**
Continuous Index:
Within 8" of Joint: **YES**
Remarks:

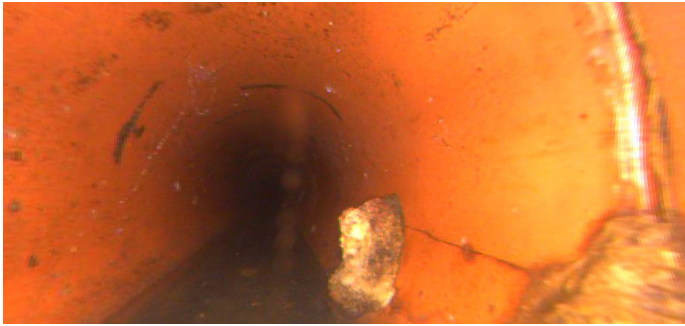
Code: **FL**
Description: **Fracture Longitudinal**

Distance (ft): **39.5**
Structural Grade: **3**
O&M Grade: **0**
Clock Start/From: **4**
Clock To:
1st Value:
2nd Value:
Value Percent:
Continuous Index:
Within 8" of Joint:
Remarks:

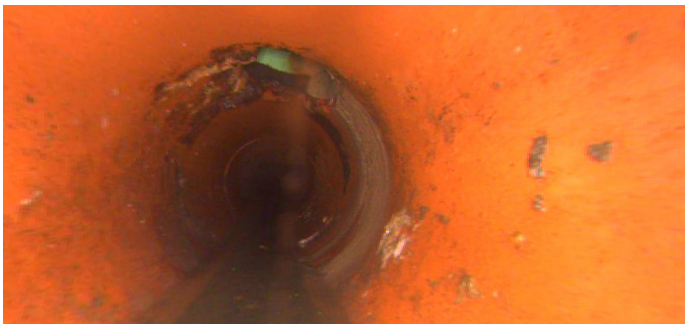
Code: **TF**
Description: **Tap Factory**

Distance (ft): **42.1**
Structural Grade: **0**
O&M Grade: **0**
Clock Start/From: **12**
Clock To:
1st Value: **4.000**
2nd Value:
Value Percent:
Continuous Index:
Within 8" of Joint:
Remarks:

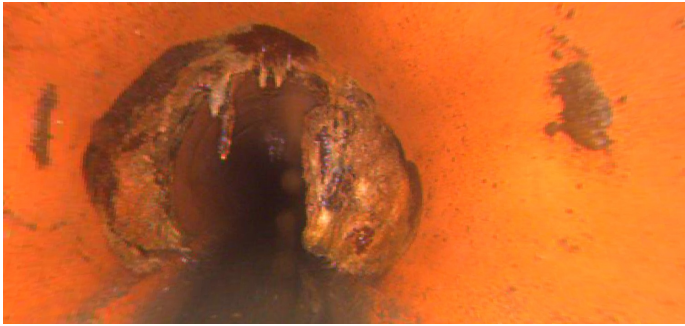
Code: **DAE**
Description: **Deposits Attached Encrustation**

Distance (ft): **63.7**
Structural Grade: **0**
O&M Grade: **4**
Clock Start/From: **8**
Clock To: **4**
1st Value:
2nd Value:
Value Percent: **30.000**
Continuous Index:
Within 8" of Joint: **NO**
Remarks:

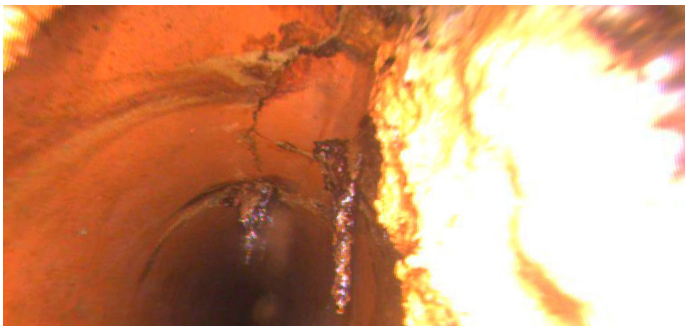
Code: **FL**
Description: **Fracture Longitudinal**

Distance (ft): **64.7**
Structural Grade: **3**
O&M Grade: **0**
Clock Start/From: **12**
Clock To:
1st Value:
2nd Value:
Value Percent:
Continuous Index:
Within 8" of Joint:
Remarks:

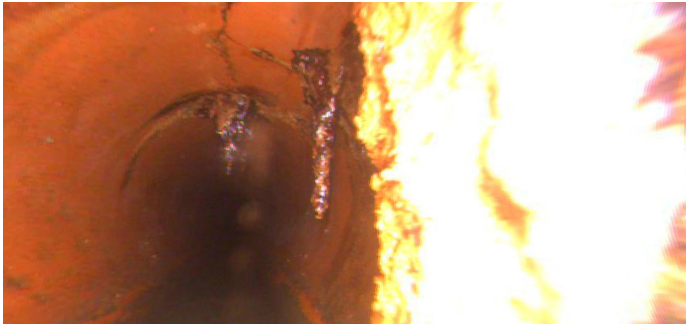
Code: **FC**
Description: **Fracture Circumferential**

Distance (ft): **64.7**
Structural Grade: **2**
O&M Grade: **0**
Clock Start/From: **12**
Clock To: **3**
1st Value:
2nd Value:
Value Percent:
Continuous Index:
Within 8" of Joint:
Remarks:

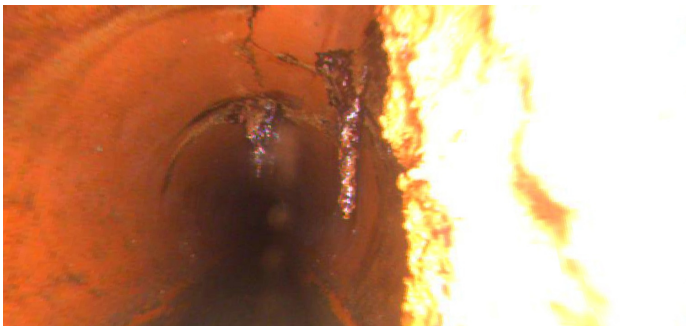
Code: **DAE**
Description: **Deposits Attached Encrustation**

Distance (ft): **64.7**
Structural Grade: **0**
O&M Grade: **2**
Clock Start/From: **9**
Clock To: **4**
1st Value:
2nd Value:
Value Percent: **10.000**
Continuous Index:
Within 8" of Joint: **NO**
Remarks:

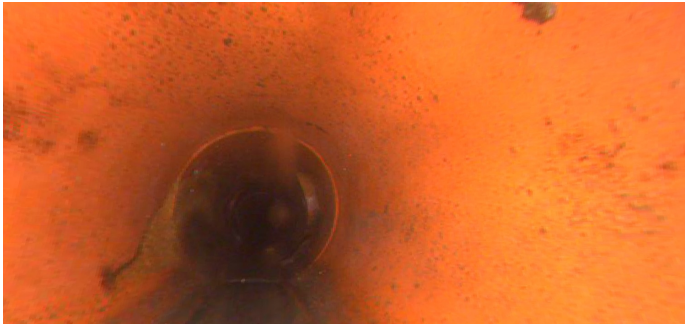
Code: **FC**
Description: **Fracture Circumferential**

Distance (ft): **68.3**
Structural Grade: **2**
O&M Grade: **0**
Clock Start/From: **9**
Clock To: **10**
1st Value:
2nd Value:
Value Percent:
Continuous Index:
Within 8" of Joint: **YES**
Remarks:

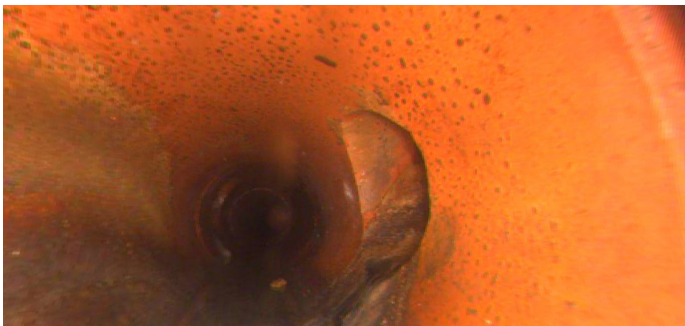
Code: **TF**
Description: **Tap Factory**

Distance (ft): **69.6**
Structural Grade: **0**
O&M Grade: **0**
Clock Start/From: **10**
Clock To:
1st Value: **4.000**
2nd Value:
Value Percent:
Continuous Index:
Within 8" of Joint:
Remarks:

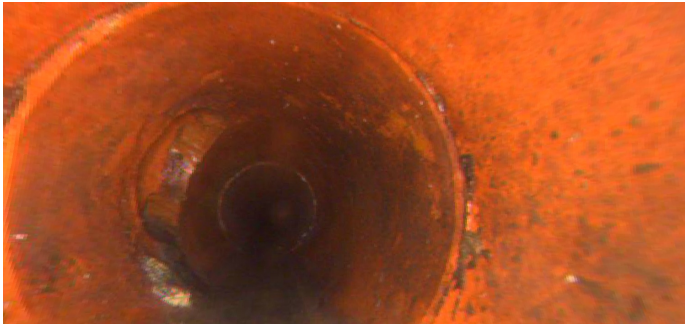
Code: **TF**
Description: **Tap Factory**

Distance (ft): **71.2**
Structural Grade: **0**
O&M Grade: **0**
Clock Start/From: **10**
Clock To:
1st Value: **4.000**
2nd Value:
Value Percent:
Continuous Index:
Within 8" of Joint:
Remarks:

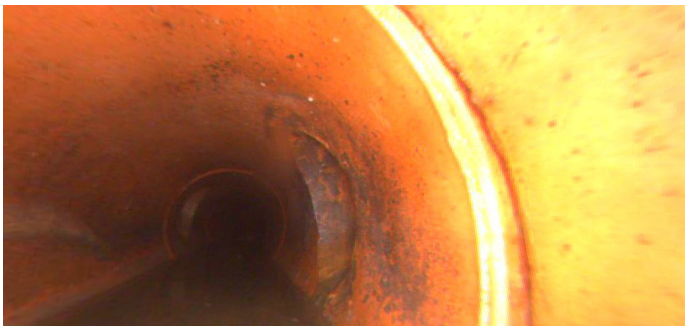
Code: **TF**
Description: **Tap Factory**

Distance (ft): **148.7**
Structural Grade: **0**
O&M Grade: **0**
Clock Start/From: **3**
Clock To:
1st Value: **4.000**
2nd Value:
Value Percent:
Continuous Index:
Within 8" of Joint:
Remarks:

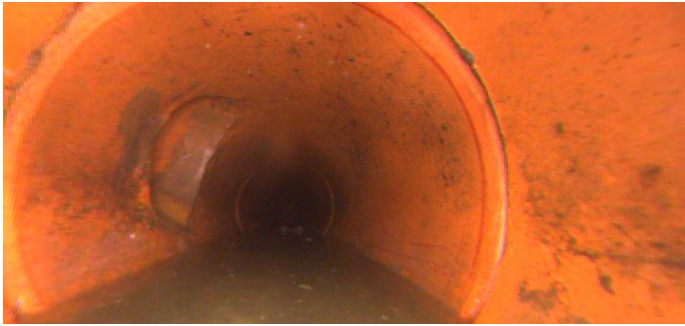
Code: **TF**
Description: **Tap Factory**

Distance (ft): **150.5**
Structural Grade: **0**
O&M Grade: **0**
Clock Start/From: **9**
Clock To:
1st Value: **4.000**
2nd Value:
Value Percent:
Continuous Index:
Within 8" of Joint:
Remarks:

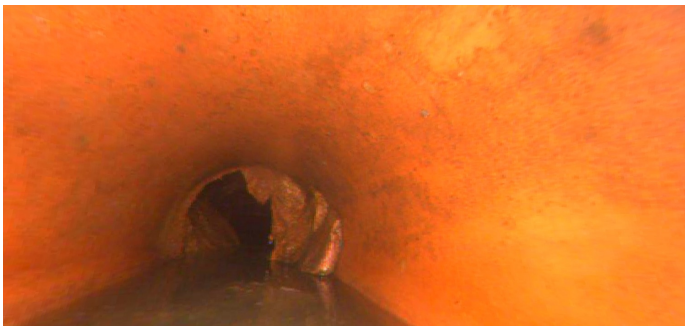
Code: **DAE**
Description: **Deposits Attached Encrustation**

Distance (ft): **161.3**
Structural Grade: **0**
O&M Grade: **4**
Clock Start/From: **9**
Clock To: **3**
1st Value:
2nd Value:
Value Percent: **30.000**
Continuous Index:
Within 8" of Joint: **YES**
Remarks:

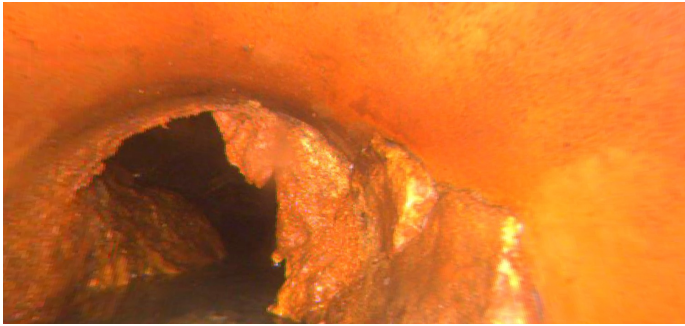
Code: **FC**
Description: **Fracture Circumferential**

Distance (ft): **162.2**
Structural Grade: **2**
O&M Grade: **0**
Clock Start/From: **1**
Clock To: **3**
1st Value:
2nd Value:
Value Percent:
Continuous Index:
Within 8" of Joint: **YES**
Remarks:

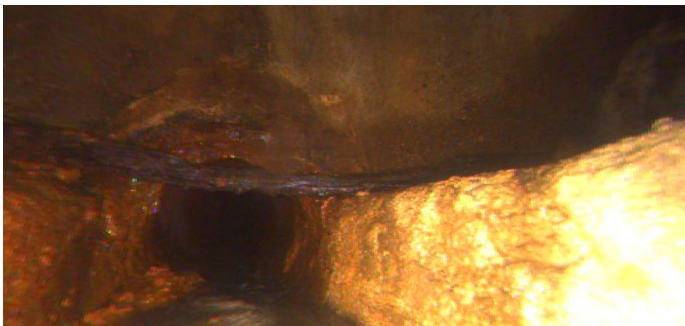
Code: **AMH**
Description: **Manhole**

Distance (ft): **165.0**
Structural Grade: **0**
O&M Grade: **0**
Clock Start/From:
Clock To:
1st Value:
2nd Value:
Value Percent:
Continuous Index:
Within 8" of Joint: **NO**
Remarks: **M-303-025**
