## Profile/Photo Observation Report

Date:	<b>09/25/2018</b>	Weather:		Coding:	<b>PACP 6.0</b>
Pipe Length (ft):	<b>184.8</b>	Owner:	<b>NA</b>	Pre Clean:	<b>Not Known</b>
P.O.#:		Surveyor:	<b>Selasie Honu</b>	PSR:	<b>P-303-025-024</b>
Customer:		Clean Date:	<b>01/01/1900</b>	Shape:	<b>C</b>

Street:	<b>Maxwell St</b>	Flow Control:	<b>Not Controlled</b>
City:	<b>Hobart, IN</b>	Year Renewed:	
Location:	<b>Light Highway</b>	Tape/Media #:	
Purpose:	<b>Routine Assessment</b>	Dia/Height:	<b>10"</b>
Use:	<b>Sanitary</b>	Material:	<b>VCP</b>
Drain Area:	<b>NA</b>	Lining:	
Category:	<b>NA</b>		
Comment:

Location Details:		Direction of Survey:	<b>Downstream</b>
US MH:	<b>M-303-024</b>	DS MH:	<b>M-303-025</b>
		Total Length Surveyed (ft):	<b>165.0</b>

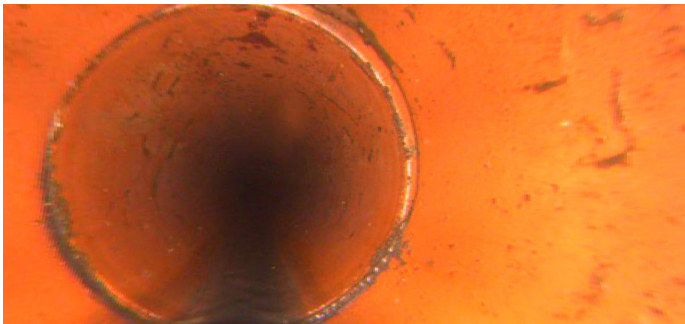
Code:	<b>RFJ</b>
Description:	<b>Roots Fine Joint</b>

Distance (ft):	<b>4.2</b>
Structural Grade:	<b>0</b>
O&M Grade:	<b>1</b>
Clock Start/From:	<b>7</b>
Clock To:	<b>5</b>
1st Value:	
2nd Value:	
Value Percent:	
Continuous Index:	
Within 8" of Joint:	<b>YES</b>
Remarks:

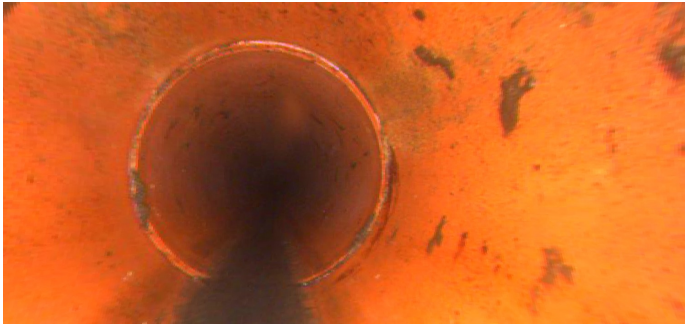
Code: **RFJ**  
Description: **Roots Fine Joint**

Distance (ft): **9.0**  
Structural Grade: **0**  
O&M Grade: **1**  
Clock Start/From: **8**  
Clock To: **5**  
1st Value:  
2nd Value:  
Value Percent:  
Continuous Index:  
Within 8" of Joint: **YES**  
Remarks:

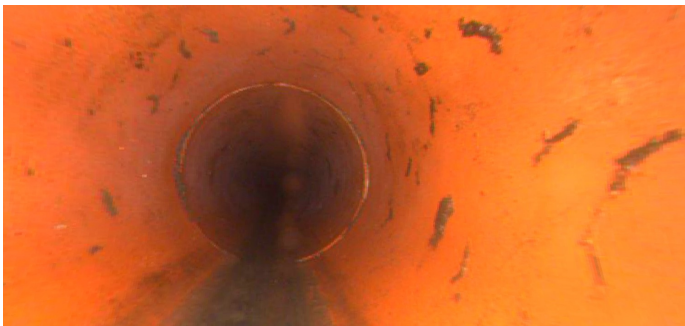
Code: **RFJ**  
Description: **Roots Fine Joint**

Distance (ft): **23.5**  
Structural Grade: **0**  
O&M Grade: **1**  
Clock Start/From: **8**  
Clock To: **4**  
1st Value:  
2nd Value:  
Value Percent:  
Continuous Index:  
Within 8" of Joint: **YES**  
Remarks:

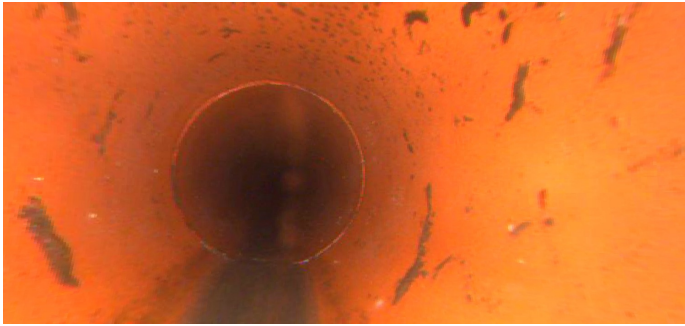
Code: **RFJ**  
Description: **Roots Fine Joint**

Distance (ft): **28.4**  
Structural Grade: **0**  
O&M Grade: **1**  
Clock Start/From: **7**  
Clock To: **5**  
1st Value:  
2nd Value:  
Value Percent:  
Continuous Index:  
Within 8" of Joint: **YES**  
Remarks:

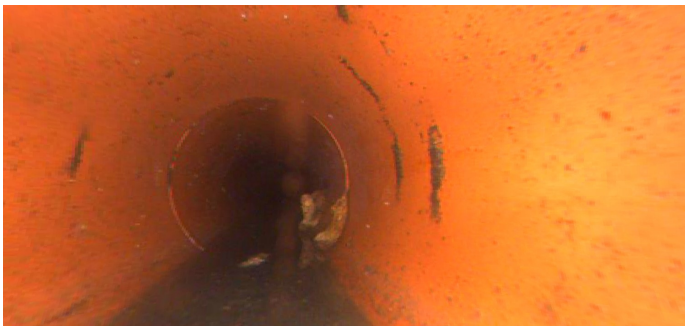
Code: **DAE**  
Description: **Deposits Attached Encrustation**

Distance (ft): **38.4**  
Structural Grade: **0**  
O&M Grade: **3**  
Clock Start/From: **3**  
Clock To: **5**  
1st Value:  
2nd Value:  
Value Percent: **15.000**  
Continuous Index:  
Within 8" of Joint: **YES**  
Remarks:

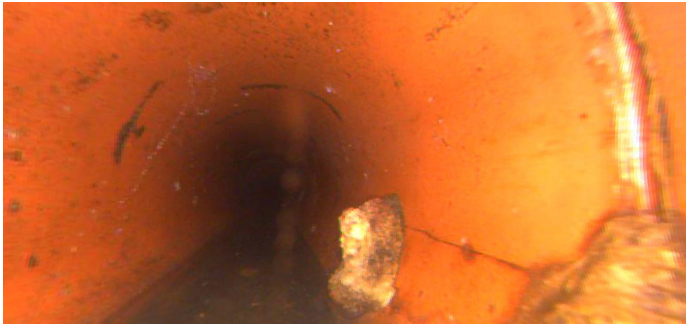
Code: **FL**  
Description: **Fracture Longitudinal**

Distance (ft): **39.5**  
Structural Grade: **3**  
O&M Grade: **0**  
Clock Start/From: **4**  
Clock To:  
1st Value:  
2nd Value:  
Value Percent:  
Continuous Index:  
Within 8" of Joint:  
Remarks:

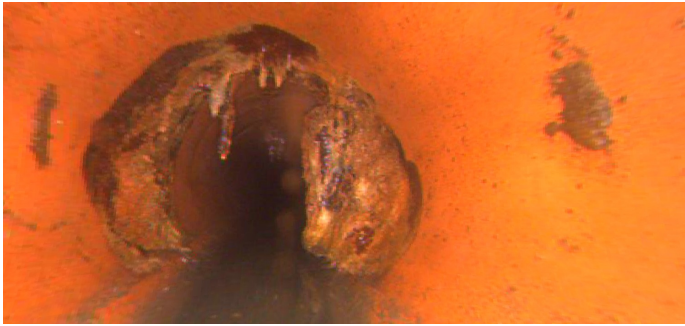
Code: **DAE**  
Description: **Deposits Attached Encrustation**

Distance (ft): **63.7**  
Structural Grade: **0**  
O&M Grade: **4**  
Clock Start/From: **8**  
Clock To: **4**  
1st Value:  
2nd Value:  
Value Percent: **30.000**  
Continuous Index:  
Within 8" of Joint: **NO**  
Remarks:

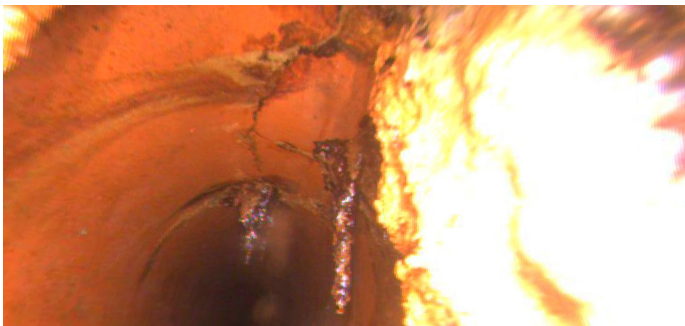
Code: **FL**  
Description: **Fracture Longitudinal**

Distance (ft): **64.7**  
Structural Grade: **3**  
O&M Grade: **0**  
Clock Start/From: **12**  
Clock To:  
1st Value:  
2nd Value:  
Value Percent:  
Continuous Index:  
Within 8" of Joint:  
Remarks:

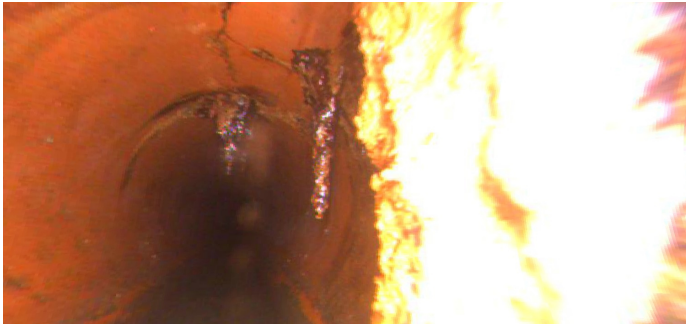
Code: **FC**  
Description: **Fracture Circumferential**

Distance (ft): **64.7**  
Structural Grade: **2**  
O&M Grade: **0**  
Clock Start/From: **12**  
Clock To: **3**  
1st Value:  
2nd Value:  
Value Percent:  
Continuous Index:  
Within 8" of Joint:  
Remarks:

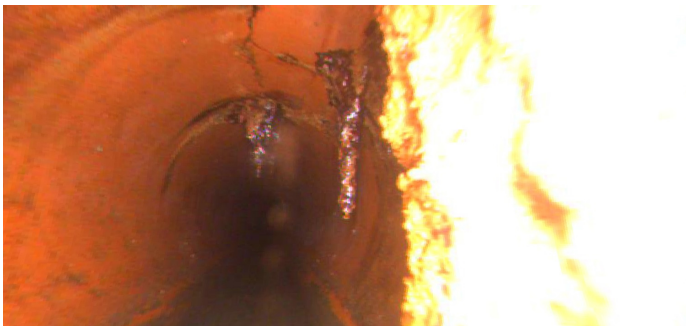
Code: **DAE**  
Description: **Deposits Attached Encrustation**

Distance (ft): **64.7**  
Structural Grade: **0**  
O&M Grade: **2**  
Clock Start/From: **9**  
Clock To: **4**  
1st Value:  
2nd Value:  
Value Percent: **10.000**  
Continuous Index:  
Within 8" of Joint: **NO**  
Remarks:

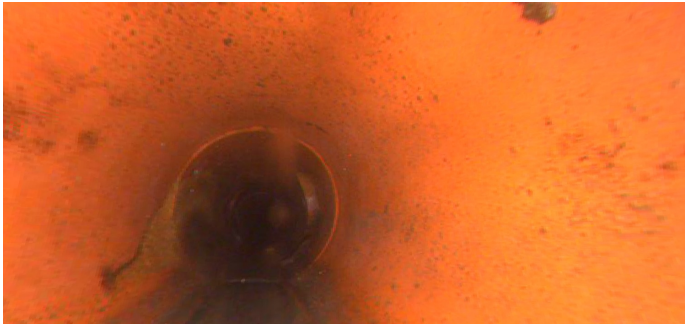
Code: **FC**  
Description: **Fracture Circumferential**

Distance (ft): **68.3**  
Structural Grade: **2**  
O&M Grade: **0**  
Clock Start/From: **9**  
Clock To: **10**  
1st Value:  
2nd Value:  
Value Percent:  
Continuous Index:  
Within 8" of Joint: **YES**  
Remarks:

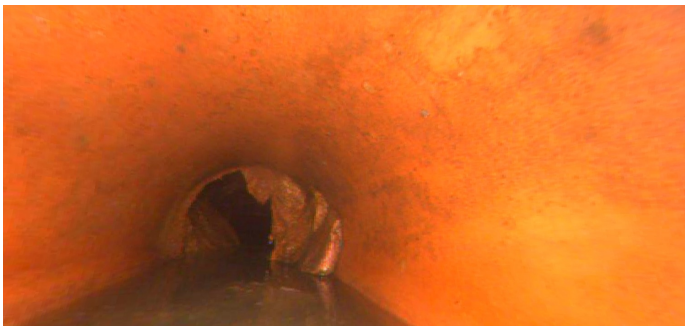
Code: **DAE**  
Description: **Deposits Attached Encrustation**

Distance (ft): **161.3**  
Structural Grade: **0**  
O&M Grade: **4**  
Clock Start/From: **9**  
Clock To: **3**  
1st Value:  
2nd Value:  
Value Percent: **30.000**  
Continuous Index:  
Within 8" of Joint: **YES**  
Remarks:

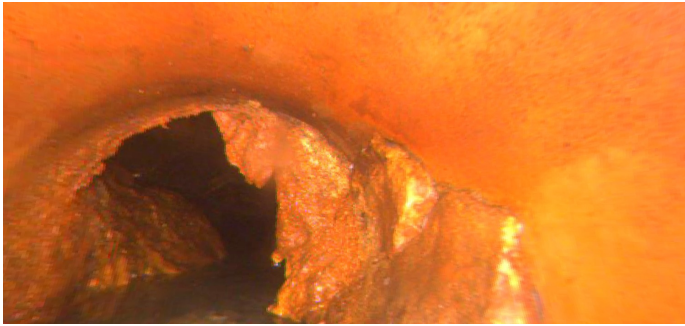
Code: **FC**  
Description: **Fracture Circumferential**

Distance (ft): **162.2**  
Structural Grade: **2**  
O&M Grade: **0**  
Clock Start/From: **1**  
Clock To: **3**  
1st Value:  
2nd Value:  
Value Percent:  
Continuous Index:  
Within 8" of Joint: **YES**  
Remarks:
