Profile/Photo Observation Report

Street:	ALLEY BETWEEN W 39TH AVE & W 3	Flow Control:	Not Controlled
City:	Hobart, IN	Year Renewed:	
Location:	Light Highway	Tape/Media #:	
Purpose:	Routine Assessment	Dia/Height:	8"
Use:	Sanitary	Material:	VCP
Drain Area:	NA	Lining:	
Category:	NA		
Comment:

Location Details:		Direction of Survey:	Downstream
US MH:	M-303-025	DS MH:	M-303-026
		Total Length Surveyed (ft):	35.7

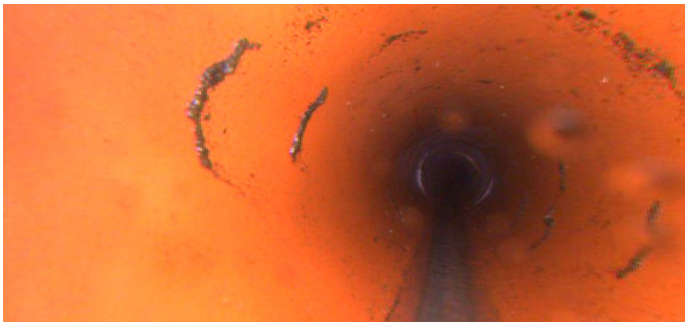
Code: **AMH**
Description: **Manhole**

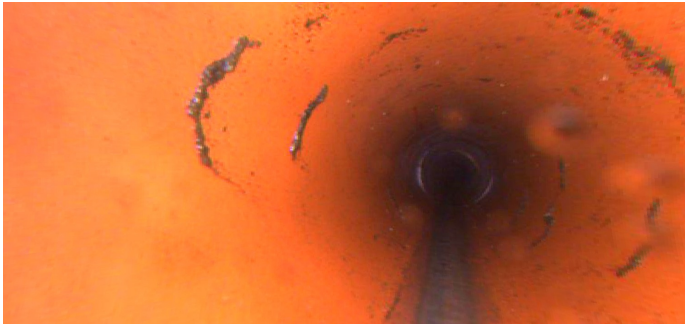
Code:	MWL
Description:	Water Level

Distance (ft):	.0
Structural Grade:	0
O&M Grade:	0
Clock Start/From:	
Clock To:	
1st Value:	
2nd Value:	
Value Percent:	5.000
Continuous Index:	
Within 8" of Joint:	NO
Remarks:

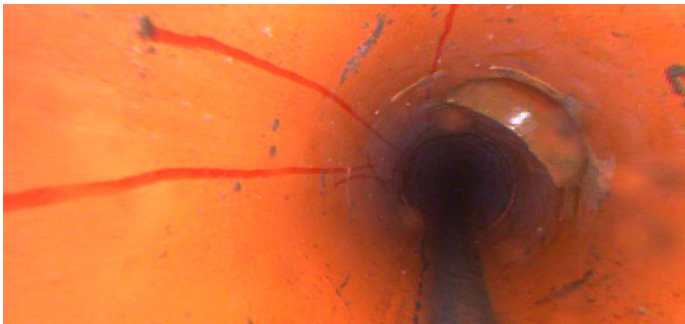
Code:	TF
Description:	Tap Factory

Distance (ft):	4.1
Structural Grade:	0
O&M Grade:	0
Clock Start/From:	1
Clock To:	
1st Value:	4.000
2nd Value:	
Value Percent:	
Continuous Index:	
Within 8" of Joint:	
Remarks:

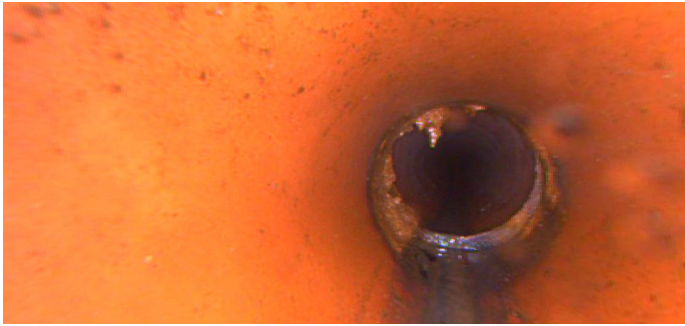
Code: **DAE**
Description: **Deposits Attached Encrustation**

Distance (ft): **14.4**
Structural Grade: **0**
O&M Grade: **3**
Clock Start/From: **6**
Clock To: **6**
1st Value:
2nd Value:
Value Percent: **20.000**
Continuous Index:
Within 8" of Joint: **YES**
Remarks:

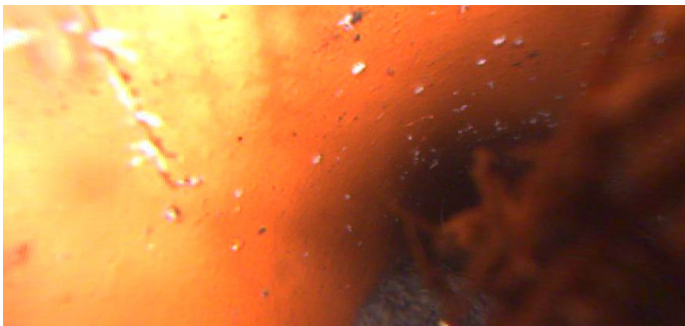
Code: **MSA**
Description: **Abandoned Survey**

Distance (ft): **35.7**
Structural Grade: **0**
O&M Grade: **0**
Clock Start/From:
Clock To:
1st Value:
2nd Value:
Value Percent:
Continuous Index:
Within 8" of Joint: **NO**
Remarks: **root infiltration**
