Profile/Photo Observation Report

Date:	09/25/2018	Weather:		Coding:	PACP 6.0
Pipe Length (ft):	136.6	Owner:	NA	Pre Clean:	Not Known
P.O.#:		Surveyor:	Selasie Honu	PSR:	P-303-026-025
Customer:		Clean Date:	01/01/1900	Shape:	C

Street:	Maxwell St	Flow Control:	Not Controlled
City:	Hobart, IN	Year Renewed:	
Location:	Light Highway	Tape/Media #:	
Purpose:	Routine Assessment	Dia/Height:	8"
Use:	Sanitary	Material:	VCP
Drain Area:	NA	Lining:	
Category:	NA		
Comment:

Location Details:		Direction of Survey:	Downstream
US MH:	M-303-025	DS MH:	M-303-026
		Total Length Surveyed (ft):	35.7

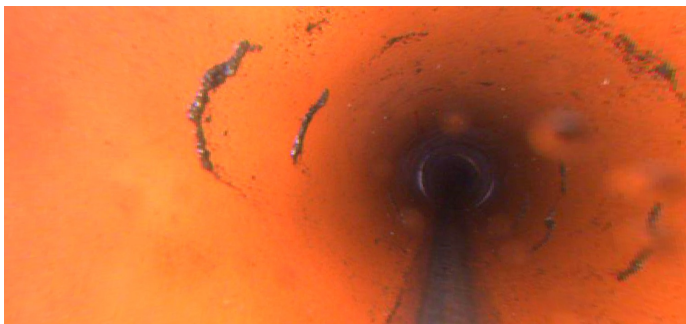
Code: **AMH**
Description: **Manhole**

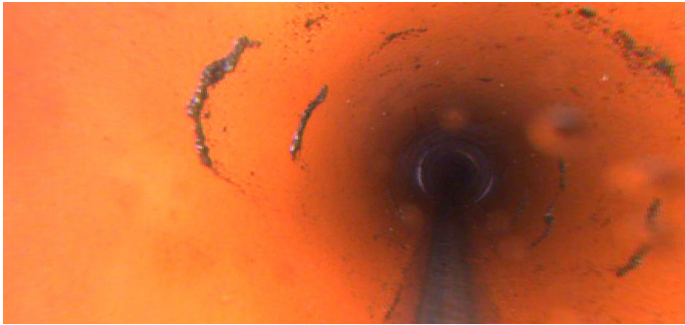
Code:	MWL
Description:	Water Level

Distance (ft):	.0
Structural Grade:	0
O&M Grade:	0
Clock Start/From:	
Clock To:	
1st Value:	
2nd Value:	
Value Percent:	5.000
Continuous Index:	
Within 8" of Joint:	NO
Remarks:

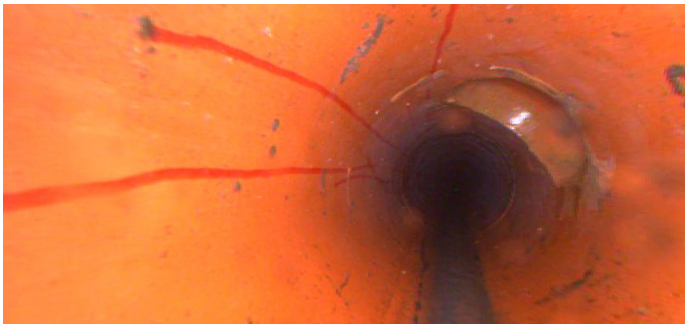
Code:	TF
Description:	Tap Factory

Distance (ft):	4.1
Structural Grade:	0
O&M Grade:	0
Clock Start/From:	1
Clock To:	
1st Value:	4.000
2nd Value:	
Value Percent:	
Continuous Index:	
Within 8" of Joint:	
Remarks:

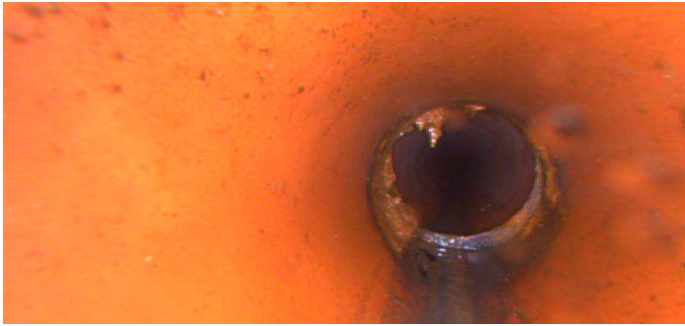
Code: **DAE**
Description: **Deposits Attached Encrustation**

Distance (ft): **14.4**
Structural Grade: **0**
O&M Grade: **3**
Clock Start/From: **6**
Clock To: **6**
1st Value:
2nd Value:
Value Percent: **20.000**
Continuous Index:
Within 8" of Joint: **YES**
Remarks:

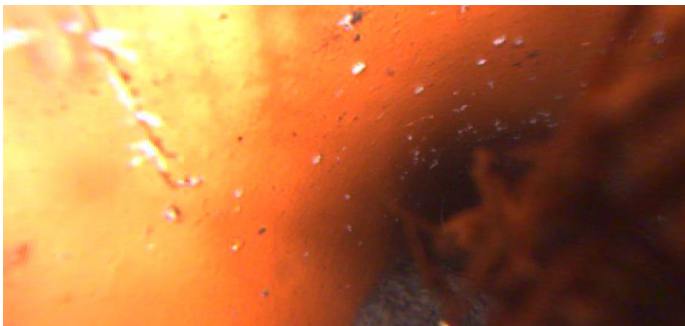
Code: **MSA**
Description: **Abandoned Survey**

Distance (ft): **35.7**
Structural Grade: **0**
O&M Grade: **0**
Clock Start/From:
Clock To:
1st Value:
2nd Value:
Value Percent:
Continuous Index:
Within 8" of Joint: **NO**
Remarks: **root infiltration**
