Profile/Photo Observation Report

Street:	Ridgelawn Drive	Flow Control:	
City:	Hobart, IN	Year Renewed:	
Location:	Light Highway	Tape/Media #:	805
Purpose:	Routine Assessment	Dia/Height:	10"
Use:	Sanitary	Material:	VCP
Drain Area:		Lining:	
Category:	NA		
Comment:

Location Details:		Direction of Survey:	Upstream
US MH:	M-303-27	DS MH:	M-303-28
		Total Length Surveyed (ft):	9.6

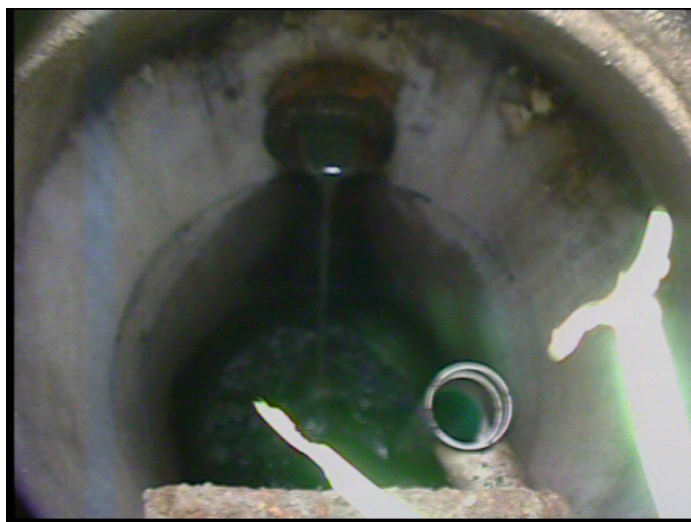
Code: **AMH**
Description: **Manhole**

Distance (ft): **.0**
Structural Grade: **0**
O&M Grade: **0**
Clock Start/From:
Clock To:
1st Value:
2nd Value:
Value Percent:
Continuous Index:
Within 8" of Joint: **NO**
Remarks: **M-303-28**

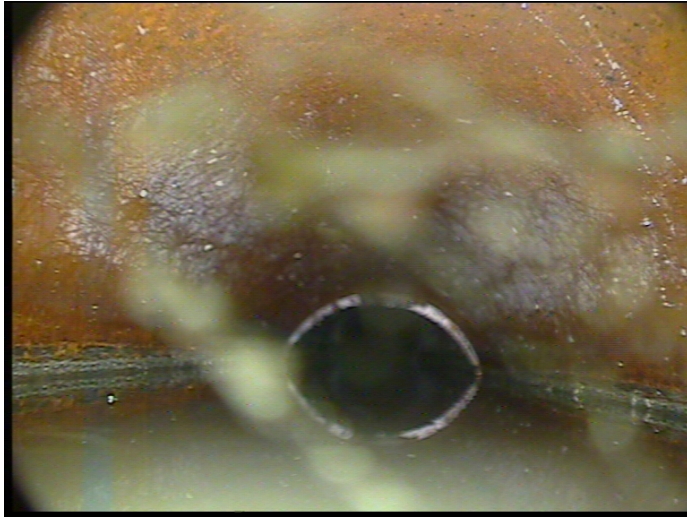
Code: **MWL**
Description: **Water Level**

Distance (ft): **.0**
Structural Grade: **0**
O&M Grade: **0**
Clock Start/From:
Clock To:
1st Value:
2nd Value:
Value Percent: **50.000**
Continuous Index:
Within 8" of Joint: **NO**
Remarks:

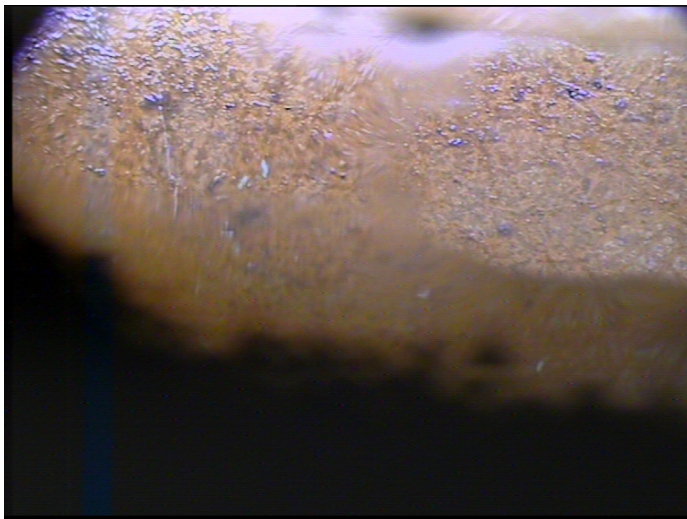
Code: **DSF**
Description: **Deposits Settled Fine**

Distance (ft): **9.6**
Structural Grade: **0**
O&M Grade: **3**
Clock Start/From: **4**
Clock To: **8**
1st Value:
2nd Value:
Value Percent: **20.000**
Continuous Index:
Within 8" of Joint: **NO**
Remarks:
