Profile/Photo Observation Report

Date:	10/18/2021	Weather:		Coding:	PACP 6.0
Pipe Length (ft):		Owner:	Hobart, IN	Pre Clean:	Not Known
P.O.#:	876_1	Surveyor:	M. Pielacha	PSR:	P-303-028-027
Customer:	Hobart, IN	Clean Date:		Shape:	C

Street:	Off Ridgelawn Drive	Flow Control:	
City:	Hobart, IN	Year Renewed:	
Location:	Easement/Right of Way	Tape/Media #:	876
Purpose:	Routine Assessment	Dia/Height:	10"
Use:	Sanitary	Material:	VCP
Drain Area:		Lining:

US MH: **M-303-27** DS MH: **M-303-28** Total Length Surveyed (ft): **34.7**

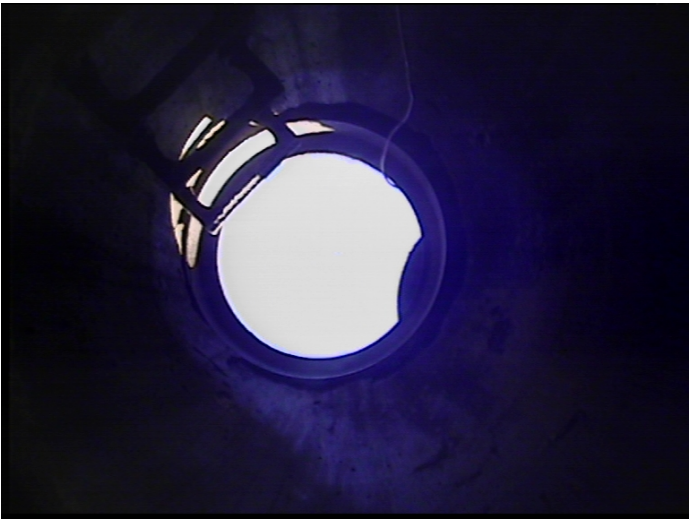
AMH

Manhole

M-303-27

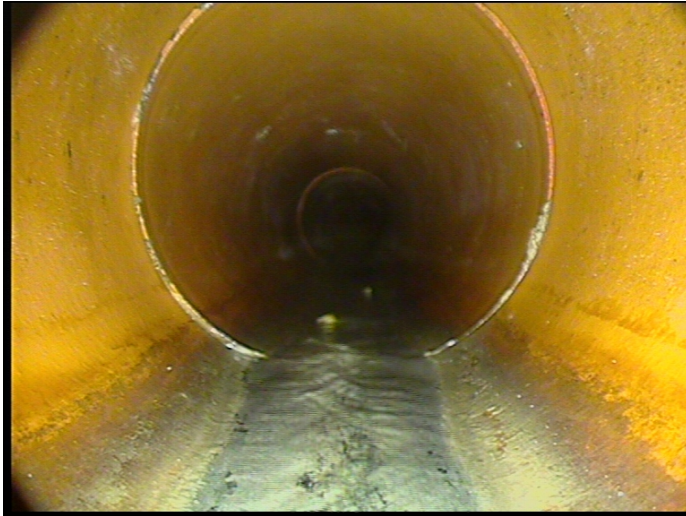
Code: **MWL**
Description: **Water Level**

Distance (ft): **.0**
Structural Grade: **0**
O&M Grade: **0**
Clock Start/From:
Clock To:
1st Value:
2nd Value:
Value Percent: **5.000**
Continuous Index:
Within 8" of Joint: **NO**
Remarks:

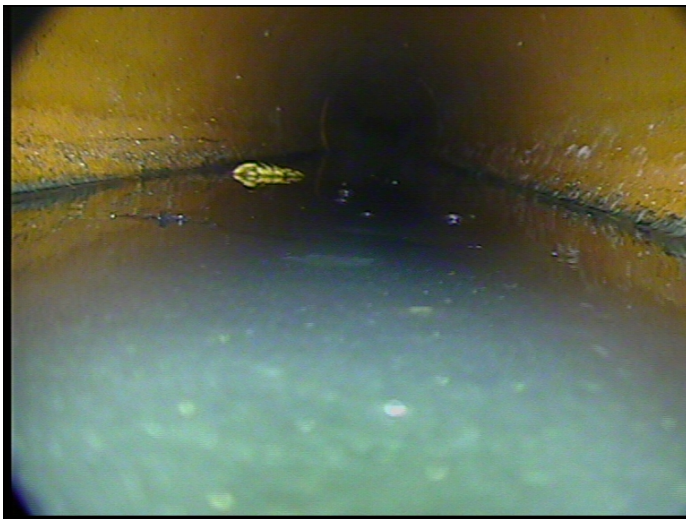
Code: **OBR**
Description: **Obstacle Rocks**

Distance (ft): **30.6**
Structural Grade: **0**
O&M Grade: **2**
Clock Start/From: **5**
Clock To: **7**
1st Value:
2nd Value:
Value Percent: **10.000**
Continuous Index:
Within 8" of Joint: **NO**
Remarks:

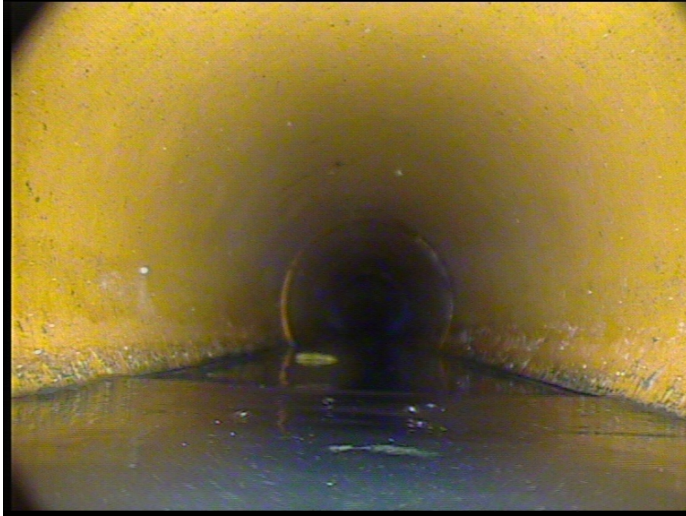
Code:	MSA
Description:	Abandoned Survey
Distance (ft):	34.7
Structural Grade:	0
O&M Grade:	0
Clock Start/From:	
Clock To:	
1st Value:	
2nd Value:	
Value Percent:	
Continuous Index:	
Within 8" of Joint:	NO
Remarks:	Under water debris/rock
