Profile/Photo Observation Report

Date:	04/07/2018	Weather:		Coding:	PACP 6.0
Pipe Length (ft):		Owner:	City of Hobart	Pre Clean:	No Pre-Cleaning
P.O.#:	2-1	Surveyor:	M. Pielacha	PSR:	M-303-027-M-303-033
Customer:	City of Hobart	Clean Date:		Shape:	C

Street:	Ridgelawn Drive	Flow Control:	Not Controlled
City:	Hobart, IN	Year Renewed:	
Location:	Light Highway	Tape/Media #:	DEP 2
Purpose:	Routine Assessment	Dia/Height:	18"
Use:	Sanitary	Material:	VCP
Drain Area:		Lining:	
Category:	NA		
Comment:			
Location Details:		Direction of Survey:	Downstream
US MH:	M-303-027	DS MH:	M-303-033
		Total Length Surveyed (ft):	2.1

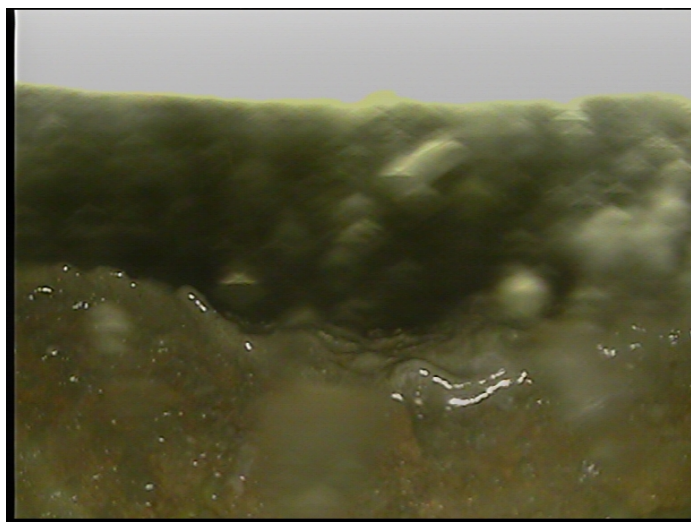
Code: **AMH**
Description: **Manhole**

Distance (ft): **.0**
Structural Grade: **0**
O&M Grade: **0**
Clock Start/From:
Clock To:
1st Value:
2nd Value:
Value Percent:
Continuous Index:
Within 8" of Joint: **NO**
Remarks: **M-303-027**

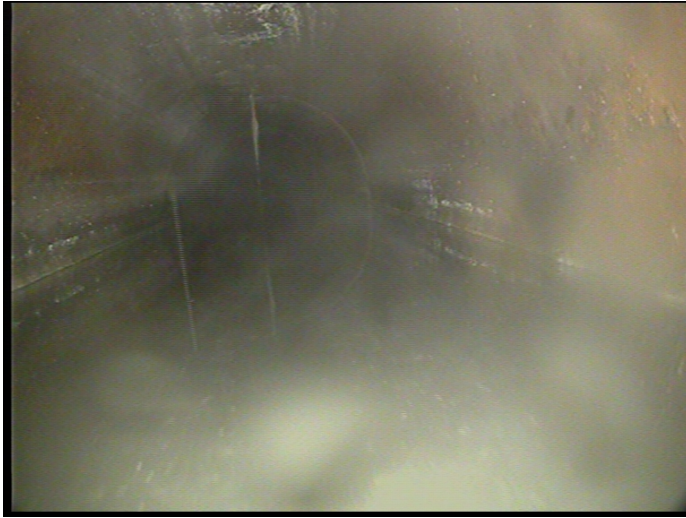
Code: **MWL**
Description: **Water Level**

Distance (ft): **.0**
Structural Grade: **0**
O&M Grade: **0**
Clock Start/From:
Clock To:
1st Value:
2nd Value:
Value Percent: **15.000**
Continuous Index:
Within 8" of Joint: **NO**
Remarks:

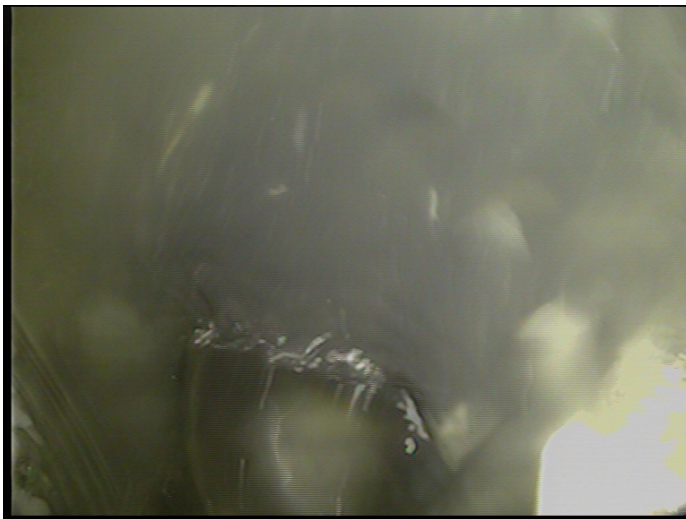
Code: **DSF**
Description: **Deposits Settled Fine**

Distance (ft): **2.1**
Structural Grade: **0**
O&M Grade: **3**
Clock Start/From: **5**
Clock To: **7**
1st Value:
2nd Value:
Value Percent: **15.000**
Continuous Index:
Within 8" of Joint: **YES**
Remarks:

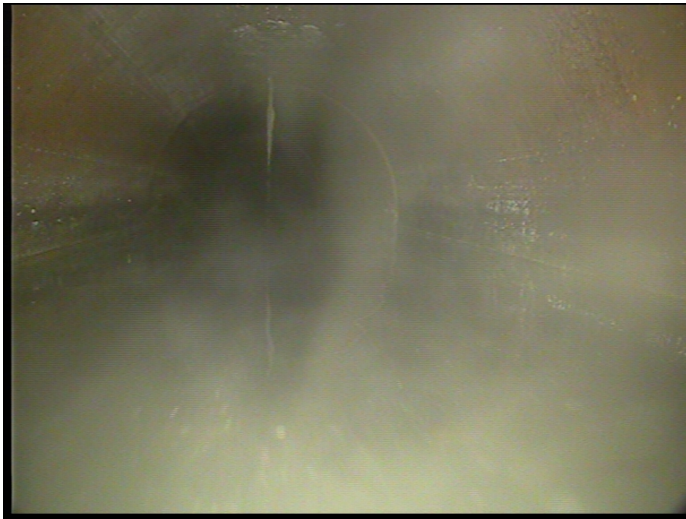
Code:	MSA
Description:	Abandoned Survey
Distance (ft):	2.1
Structural Grade:	0
O&M Grade:	0
Clock Start/From:	
Clock To:	
1st Value:	
2nd Value:	
Value Percent:	
Continuous Index:	
Within 8" of Joint:	NO
Remarks:	sediment/debris
