Profile/Photo Observation Report

Profile/Photo Observation Report								
Date: Pipe Length (ft) P.O.#: Customer:	04/07/2018): 2-1 City of Hobart	Weather: Owner: Surveyor: Clean Date:	City of H		Pre Clean: PSR:	PACP 6.0 No Pre-Cleaning M-303-027-M-303-033 C		
Street:	Ridgelawn Drive	Cican Date.	Flow Conti	ral	Not Controlled			
City:	Hobart, IN		Year Rene	-	Not Controlled			
Location:	Light Highway		Tape/Med		DEP 2			
Purpose:	Routine Assessment		Dia/Height		18"			
Use:	Sanitary		Material:		VCP			
Drain Area:			Lining:					
Category:	NA							
Comment:								
Location Details	S:		Direction of	of Survey:	Downstream			
US MH:	M-303-027	DS MH:	M-303-033		Total Length Surveyed (ft):	2.1		
O&M Index:	3.00	O&M Quick:		3100	O&M Rating:	3.00		
Structural Index:	0.00	Structural Qu		0000	Structural Rating:	0.00		
Overall Index:	3.00	Overall Quicl		3100	Overall Rating:	3.00

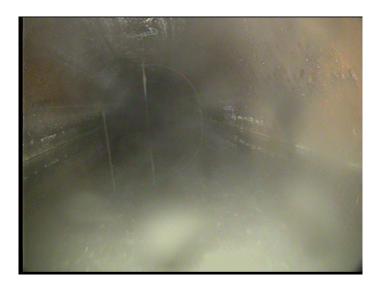
Code: MWL

Description: Water Level

Distance (ft): .0
Structural Grade: 0

O&M Grade: **0**

Value Percent: 15.000

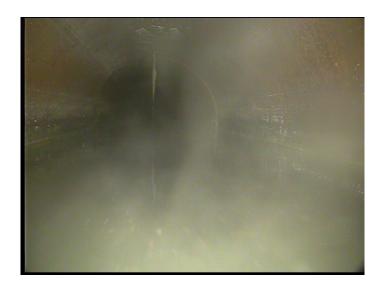
Code: MSA

Description: Abandoned Survey

Distance (ft): 2.1
Structural Grade: 0

Remarks: sediment/debris
