Profile/Photo Observation Report

Date:	03/02/2024	Weather:		Coding:	PACP 7.0
Pipe Length (ft):	333.0	Owner:	City of Hobart	Pre Clean:	Heavy Cleaning
P.O.#:		Surveyor:	S. Bucklin	PSR:	P-303-033-027
Customer:	City of Hobart	Clean Date:	06/26/2023	Shape:	C

Street:	RIDGELAWN DR	Flow Control:	Not Controlled
City:	Hobart, IN	Year Renewed:	
Location:	Easement/Right of Way	Tape/Media #:	
Purpose:	Sewer System Evaluation Survey (SS	Dia/Height:	18"
Use:	Sanitary Sewage Pipe	Material:	VCP
Drain Area:		Lining:	None
Category:	NA		
Comment:			
Location Details:		Direction of Survey:	Downstream
US MH:	M-303-027	DS MH:	M-303-033
		Total Length Surveyed (ft):	336.0

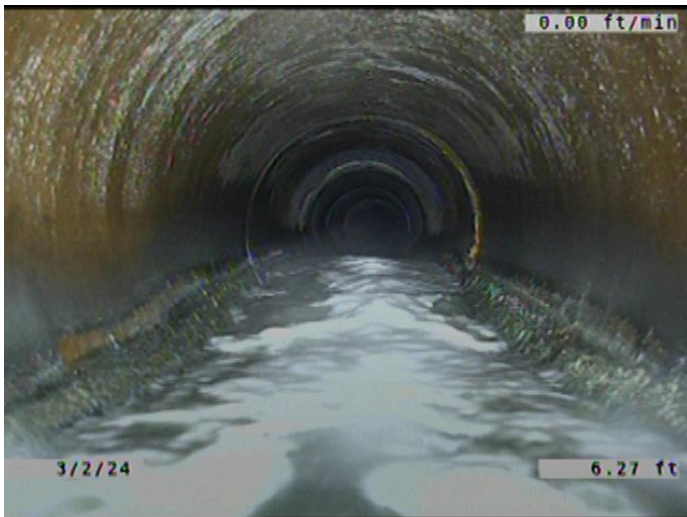
Code: **MGO**
Description: **Miscellaneous General Observation**

Distance (ft): **6.3**
Structural Grade: **0**
O&M Grade: **0**
Clock Start/From:
Clock To:
1st Value:
2nd Value:
Value Percent:
Continuous Index:
Within 8" of Joint: **NO**
Remarks: **FORCE MAIN TURNED ON. RUNS
ROUGHLY EVERY 3 MINUTES FOR 1**

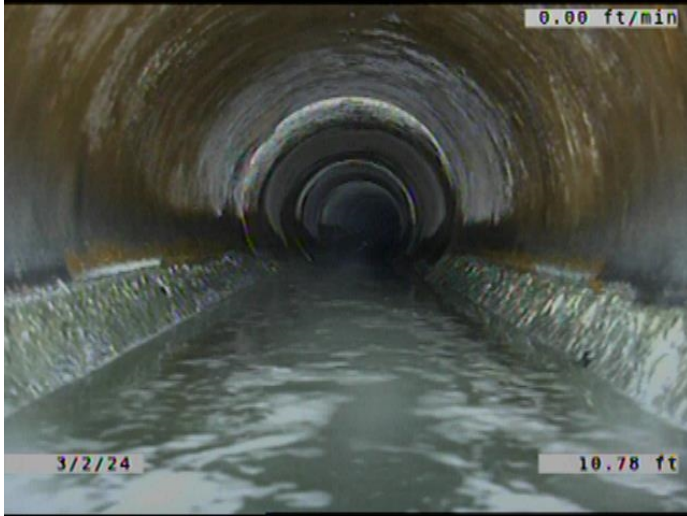
Code: **MWLS**
Description: **Miscellaneous Water Level Sag**

Distance (ft): **10.8**
Structural Grade: **2**
O&M Grade: **0**
Clock Start/From:
Clock To:
1st Value:
2nd Value:
Value Percent: **20.000**
Continuous Index:
Within 8" of Joint: **NO**
Remarks:

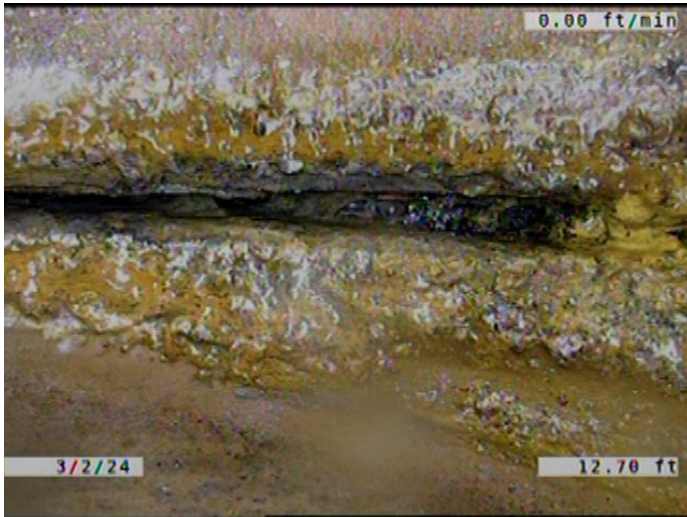
Code: **DAE**
Description: **Deposits Attached Encrustation**

Distance (ft): **12.7**
Structural Grade: **0**
O&M Grade: **2**
Clock Start/From: **8**
Clock To: **4**
1st Value:
2nd Value:
Value Percent: **5.000**
Continuous Index:
Within 8" of Joint: **YES**
Remarks:

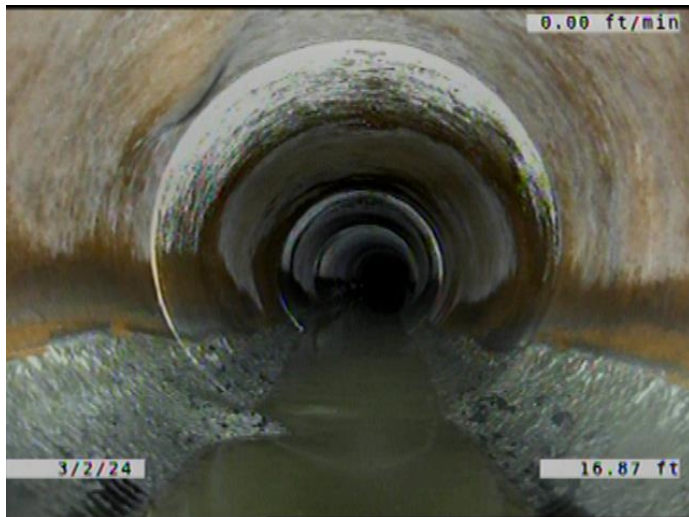
Code:	SZ
Description:	Surface Damage Other
Distance (ft):	16.9
Structural Grade:	0
O&M Grade:	0
Clock Start/From:	7
Clock To:	11
1st Value:	
2nd Value:	
Value Percent:	
Continuous Index:	
Within 8" of Joint:	YES
Remarks:	DIMPLES INTO THE PIPE.. MANUFACTURING DEFECT.

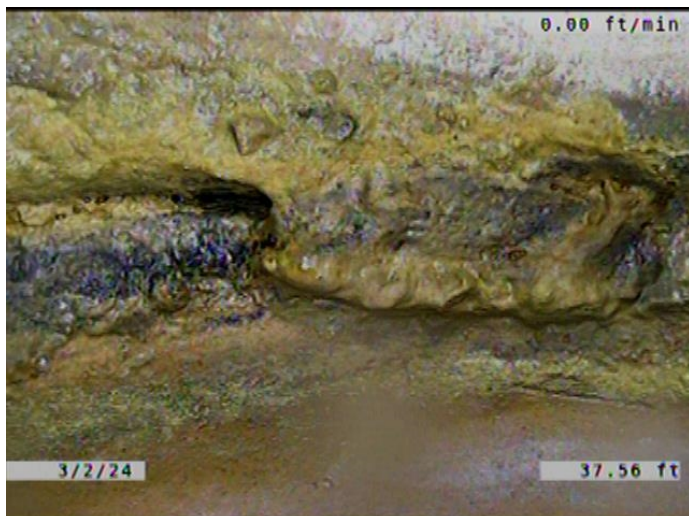
Code:	DAE
Description:	Deposits Attached Encrustation
Distance (ft):	37.6
Structural Grade:	0
O&M Grade:	2
Clock Start/From:	8
Clock To:	4
1st Value:	
2nd Value:	
Value Percent:	5.000
Continuous Index:	
Within 8" of Joint:	YES
Remarks:

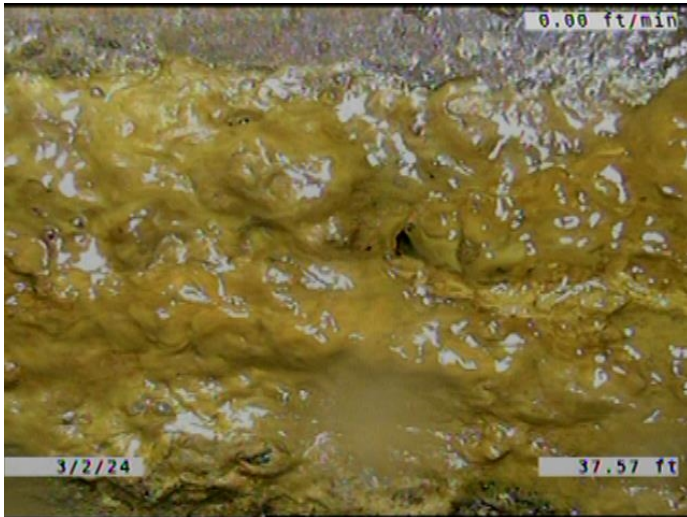
Code: **IRJ**
 Description: **Infiltration Runner Joint**

Distance (ft): **37.6**
 Structural Grade: **0**
 O&M Grade: **4**
 Clock Start/From: **1**
 Clock To: **3**
 1st Value:
 2nd Value:
 Value Percent:
 Continuous Index:
 Within 8" of Joint: **YES**
 Remarks:

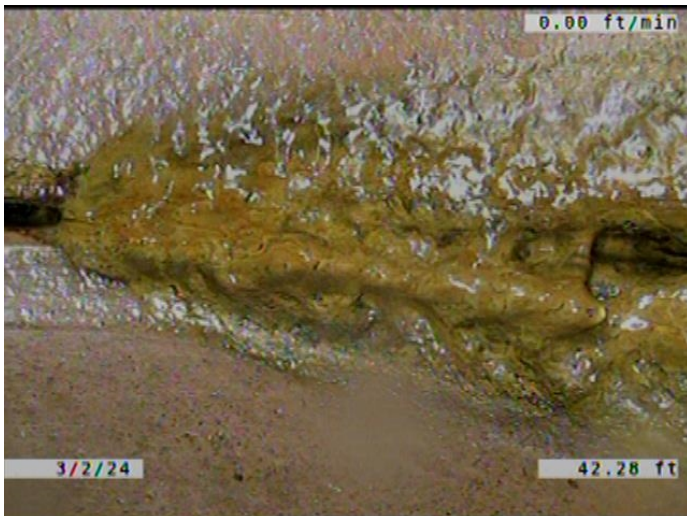
Code: **DAE**
 Description: **Deposits Attached Encrustation**

Distance (ft): **42.3**
 Structural Grade: **0**
 O&M Grade: **2**
 Clock Start/From: **1**
 Clock To: **4**
 1st Value:
 2nd Value:
 Value Percent: **5.000**
 Continuous Index:
 Within 8" of Joint: **YES**
 Remarks:

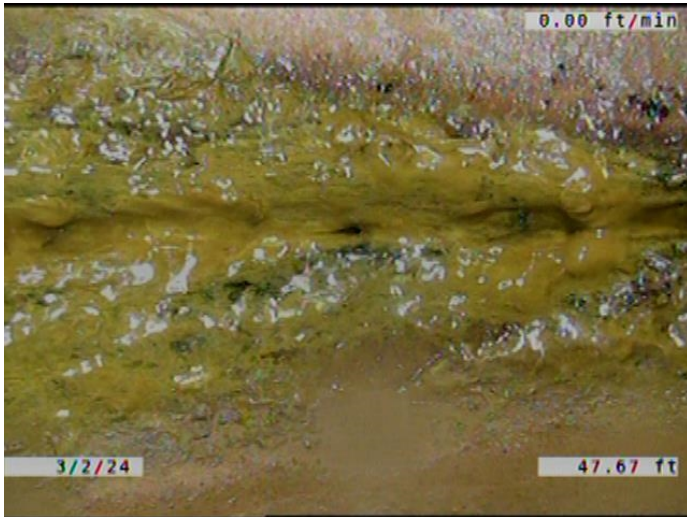
Code: **DAE**
Description: **Deposits Attached Encrustation**

Distance (ft): **47.7**
Structural Grade: **0**
O&M Grade: **2**
Clock Start/From: **8**
Clock To: **4**
1st Value:
2nd Value:
Value Percent: **5.000**
Continuous Index:
Within 8" of Joint: **YES**
Remarks:

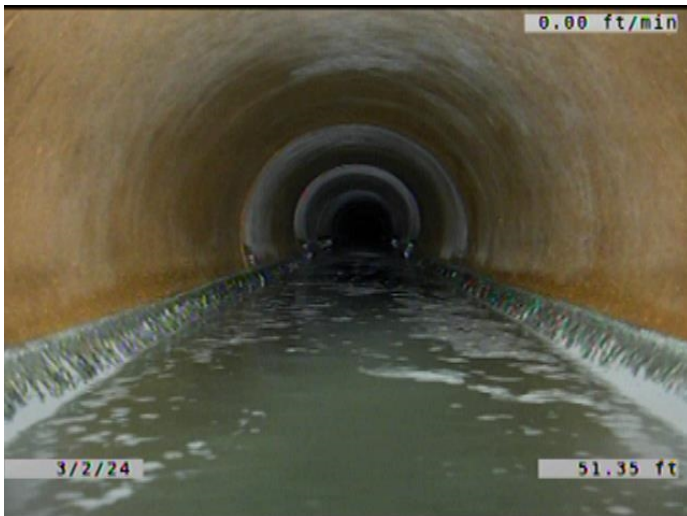
Code: **DAGS**
Description: **Deposits Attached Grease**

Distance (ft): **51.3**
Structural Grade: **0**
O&M Grade: **2**
Clock Start/From: **4**
Clock To: **8**
1st Value:
2nd Value:
Value Percent: **5.000**
Continuous Index: **S01**
Within 8" of Joint: **YES**
Remarks:

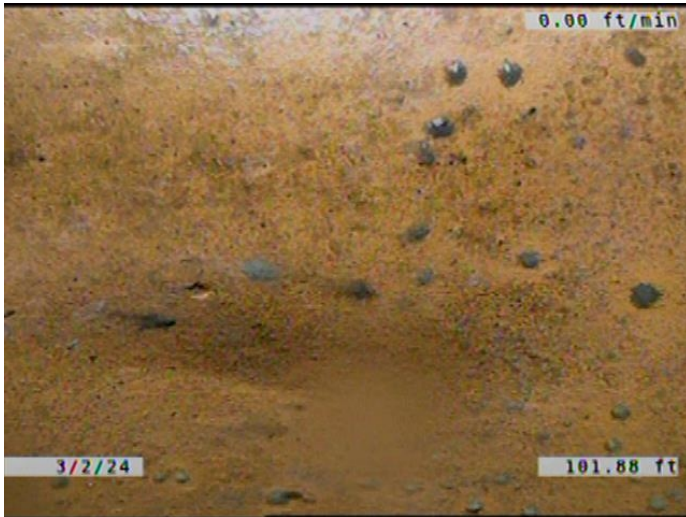
Code: SZ
Description: Surface Damage Other

Distance (ft): 101.9
Structural Grade: 0
O&M Grade: 0
Clock Start/From: 11
Clock To: 12

1st Value:
2nd Value:
Value Percent:
Continuous Index:
Within 8" of Joint: YES
Remarks: DIMPLE INTO THE PIPE..
MANUFACTURING DEFECT.

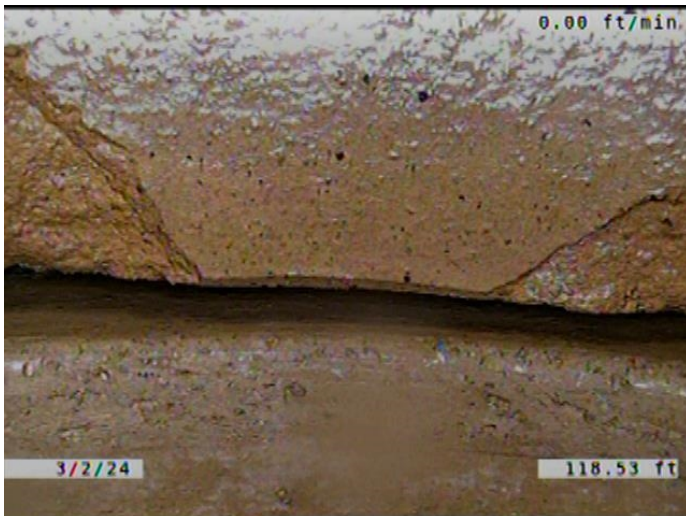
Code: SZ
Description: Surface Damage Other

Distance (ft): 118.5
Structural Grade: 0
O&M Grade: 0
Clock Start/From: 2
Clock To: 4

1st Value:
2nd Value:
Value Percent:
Continuous Index:
Within 8" of Joint: YES
Remarks: PIECES CHIPPED AWAY FROM THE
JOINT.

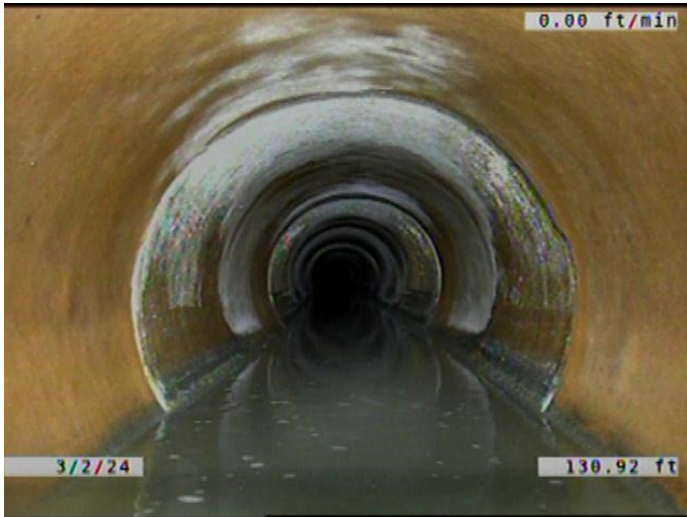
Code: **MWLS**
Description: **Miscellaneous Water Level Sag**

Distance (ft): **130.9**
Structural Grade: **2**
O&M Grade: **0**
Clock Start/From:
Clock To:
1st Value:
2nd Value:
Value Percent: **20.000**
Continuous Index: **S02**
Within 8" of Joint: **NO**
Remarks:

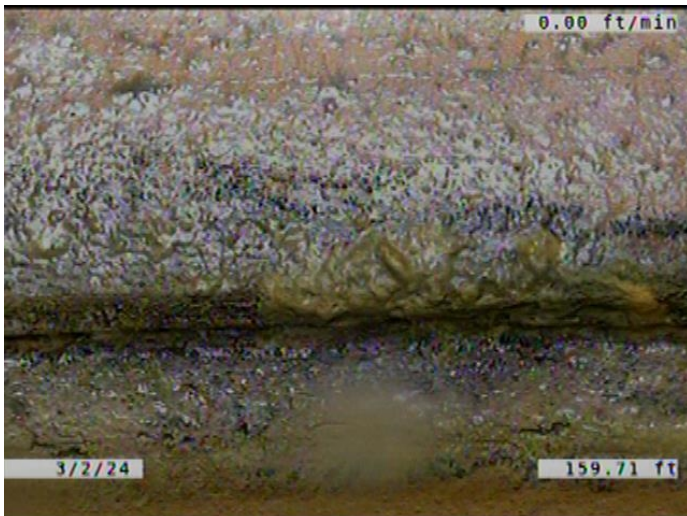
Code: **DAE**
Description: **Deposits Attached Encrustation**

Distance (ft): **159.7**
Structural Grade: **0**
O&M Grade: **2**
Clock Start/From: **8**
Clock To: **4**
1st Value:
2nd Value:
Value Percent: **5.000**
Continuous Index:
Within 8" of Joint: **YES**
Remarks:

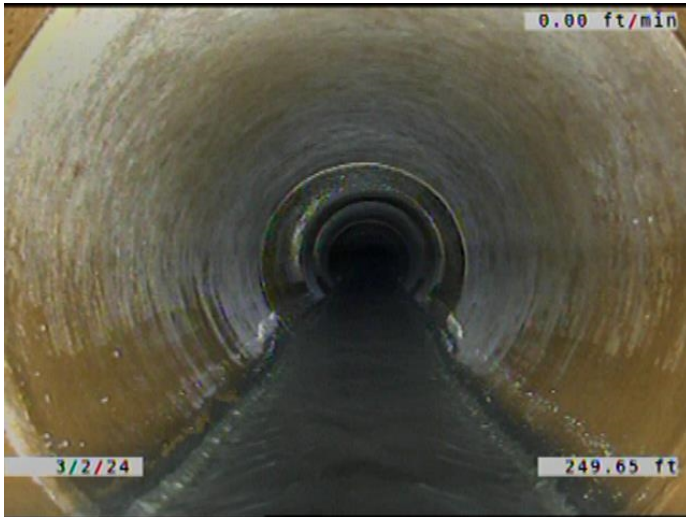
Code: **MWLS**
Description: **Miscellaneous Water Level Sag**

Distance (ft): **249.6**
Structural Grade: **2**
O&M Grade: **0**
Clock Start/From:
Clock To:
1st Value:
2nd Value:
Value Percent: **20.000**
Continuous Index: **F02**
Within 8" of Joint: **NO**
Remarks:

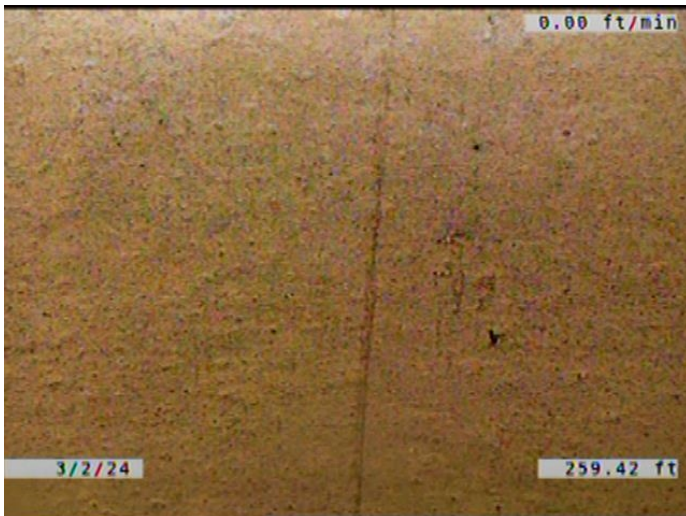
Code: **CL**
Description: **Crack Longitudinal**

Distance (ft): **259.4**
Structural Grade: **2**
O&M Grade: **0**
Clock Start/From: **2**
Clock To:
1st Value:
2nd Value:
Value Percent:
Continuous Index:
Within 8" of Joint: **YES**
Remarks:

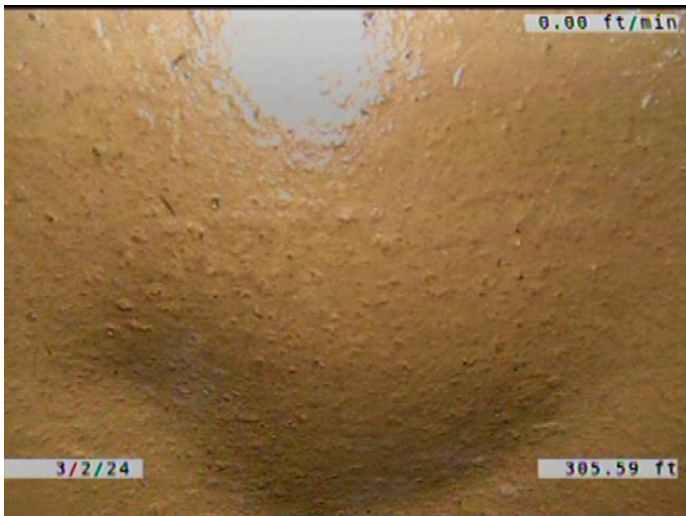
Code: **SZ**
Description: **Surface Damage Other**

Distance (ft): **305.6**
Structural Grade: **0**
O&M Grade: **0**
Clock Start/From: **12**
Clock To: **1**
1st Value:
2nd Value:
Value Percent:
Continuous Index:
Within 8" of Joint: **YES**
Remarks: **DIMPLE INTO THE PIPE..
MANUFACTURING DEFECT.**

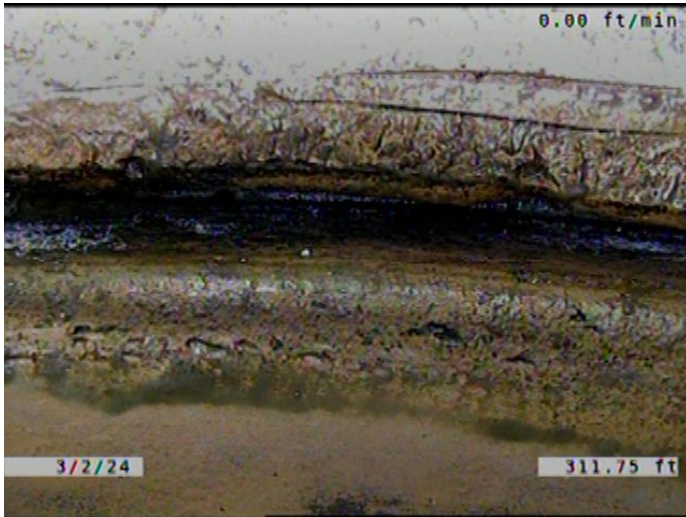
Code:	DAE
Description:	Deposits Attached Encrustation
Distance (ft):	311.8
Structural Grade:	0
O&M Grade:	2
Clock Start/From:	1
Clock To:	4
1st Value:	
2nd Value:	
Value Percent:	5.000
Continuous Index:	
Within 8" of Joint:	YES
Remarks:

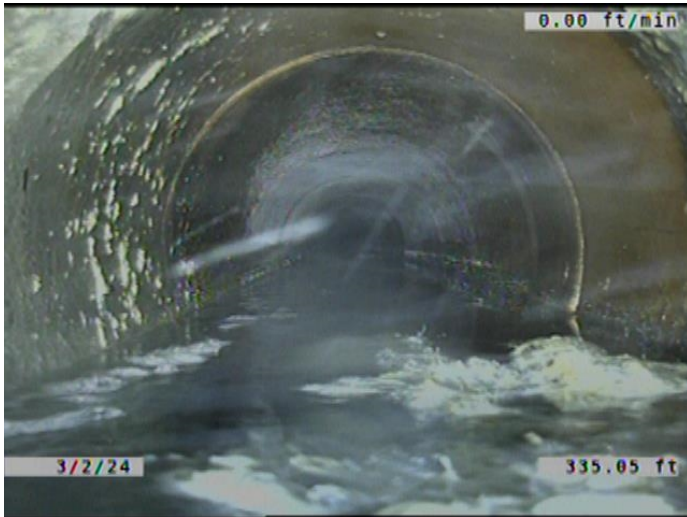
Code: **DAGS**
 Description: **Deposits Attached Grease**

Distance (ft): **335.1**
 Structural Grade: **0**
 O&M Grade: **2**
 Clock Start/From: **4**
 Clock To: **8**
 1st Value:
 2nd Value:
 Value Percent: **5.000**
 Continuous Index: **F01**
 Within 8" of Joint: **YES**
 Remarks:
