Profile/Photo Observation Report

| Street: | KENWOOD ST | Flow Control: | Not Controlled |
| City: | Hobart, IN | Year Renewed: | |

| US MH: | M-303-028 | DS MH: | M-303-029 |

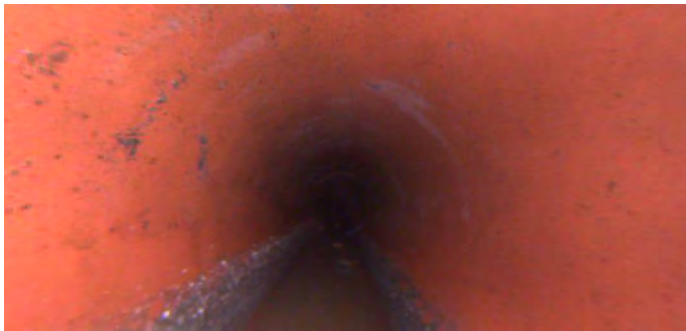
Code: **AMH**
Description: **Manhole**

Distance (ft): **.0**
Structural Grade: **0**
O&M Grade: **0**
Clock Start/From:
Clock To:
1st Value:
2nd Value:
Value Percent:
Continuous Index:
Within 8" of Joint: **NO**
Remarks: **M-303-029**

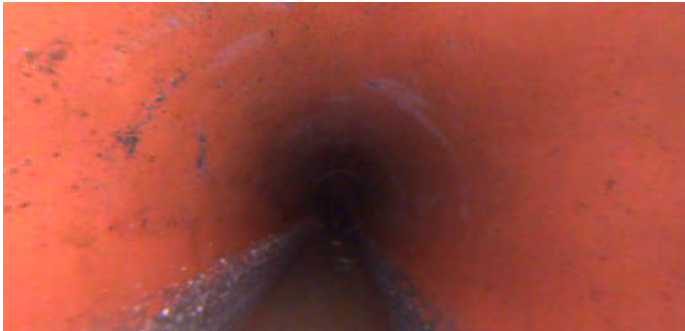
| Code: | MWL |
| Description: | Water Level |

| Value Percent: | 5.000 |

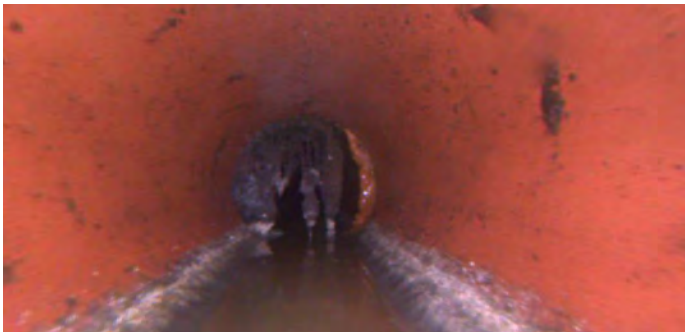
| Code: | RMJ |
| Description: | Roots Medium Joint |

| Distance (ft): | 58.6 |
| O&M Grade: | 3 |
| Value Percent: | 40.000 |

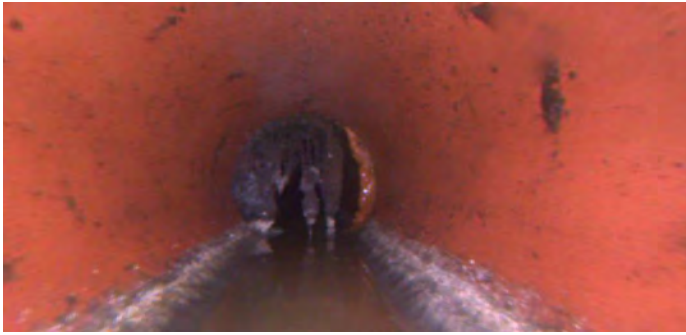
Code: **DAE**
Description: **Deposits Attached Encrustation**

Distance (ft): **58.6**
Structural Grade: **0**
O&M Grade: **2**
Clock Start/From: **1**
Clock To: **5**
1st Value:
2nd Value:
Value Percent: **10.000**
Continuous Index:
Within 8" of Joint: **YES**
Remarks:

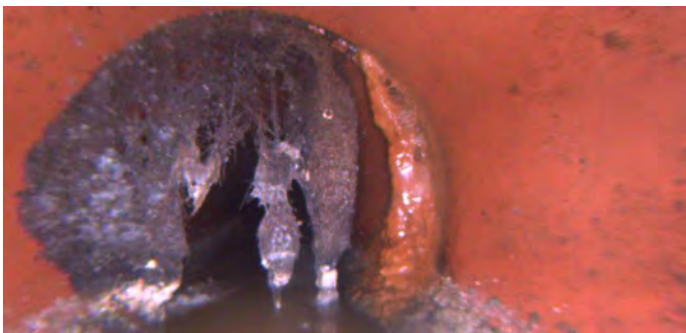
Code: **IW**
Description: **Infil Weeper**

Distance (ft): **59.6**
Structural Grade: **0**
O&M Grade: **2**
Clock Start/From: **1**
Clock To: **4**
1st Value:
2nd Value:
Value Percent:
Continuous Index:
Within 8" of Joint: **YES**
Remarks:

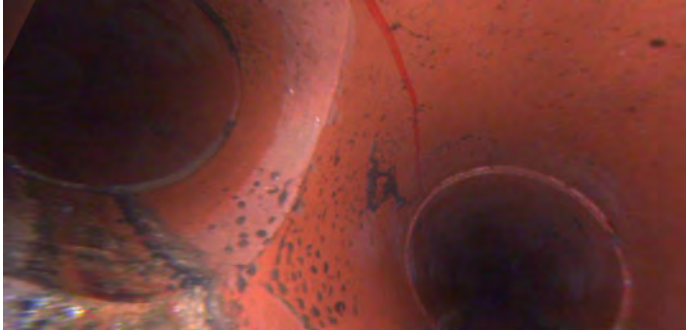
Code: **TFA**
Description: **Tap Factory Active**

Distance (ft): **65.9**
Structural Grade: **0**
O&M Grade: **0**
Clock Start/From: **10**
Clock To:
1st Value: **4.000**
2nd Value:
Value Percent:
Continuous Index:
Within 8" of Joint:
Remarks:

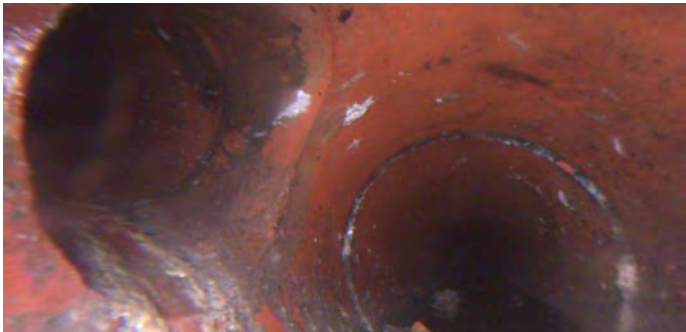
Code: **TFA**
Description: **Tap Factory Active**

Distance (ft): **114.1**
Structural Grade: **0**
O&M Grade: **0**
Clock Start/From: **9**
Clock To:
1st Value: **4.000**
2nd Value:
Value Percent:
Continuous Index:
Within 8" of Joint:
Remarks:

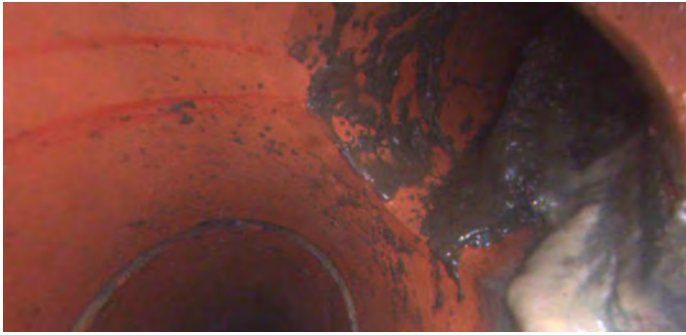
Code: **TFA**
Description: **Tap Factory Active**

Distance (ft): **131.4**
Structural Grade: **0**
O&M Grade: **0**
Clock Start/From: **10**
Clock To:
1st Value: **4.000**
2nd Value:
Value Percent:
Continuous Index:
Within 8" of Joint:
Remarks:

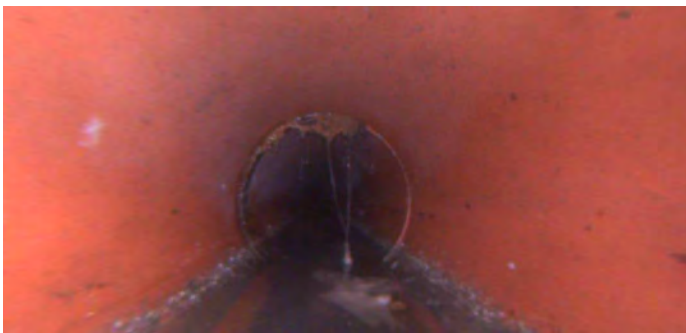
Code: **RFJ**
Description: **Roots Fine Joint**

Distance (ft): **156.1**
Structural Grade: **0**
O&M Grade: **1**
Clock Start/From: **10**
Clock To: **1**
1st Value:
2nd Value:
Value Percent:
Continuous Index:
Within 8" of Joint: **YES**
Remarks:

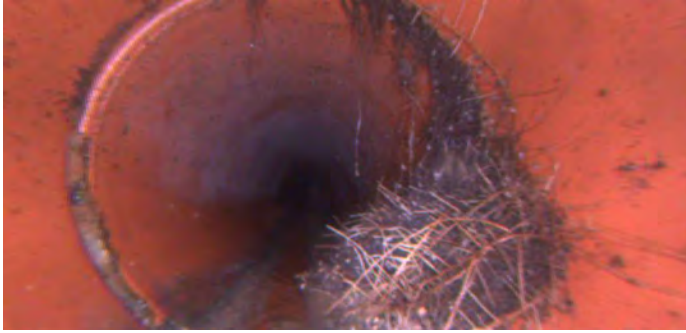
Code: **RMJ**
Description: **Roots Medium Joint**

Distance (ft): **172.0**
Structural Grade: **0**
O&M Grade: **3**
Clock Start/From: **12**
Clock To: **6**
1st Value:
2nd Value:
Value Percent: **40.000**
Continuous Index:
Within 8" of Joint: **YES**
Remarks:

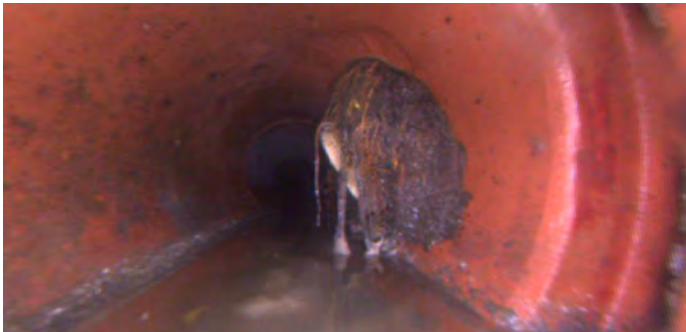
Code: **TFD**
Description: **Tap Factory Defective**

Distance (ft): **177.4**
Structural Grade: **0**
O&M Grade: **2**
Clock Start/From: **2**
Clock To:
1st Value: **4.000**
2nd Value:
Value Percent:
Continuous Index:
Within 8" of Joint:
Remarks: **root infiltration**

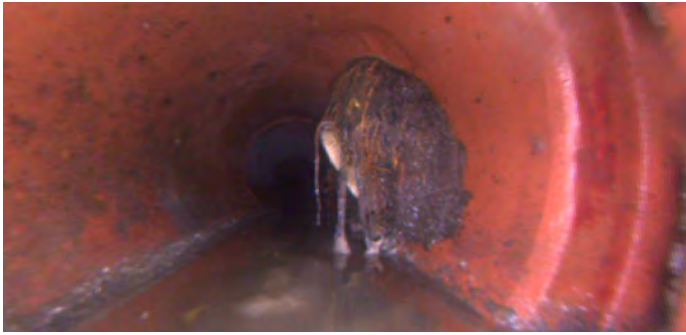
Code: **RML**
Description: **Roots Medium Lateral**

Distance (ft): **177.4**
Structural Grade: **0**
O&M Grade: **3**
Clock Start/From: **1**
Clock To: **4**
1st Value:
2nd Value:
Value Percent: **20.000**
Continuous Index:
Within 8" of Joint: **NO**
Remarks:

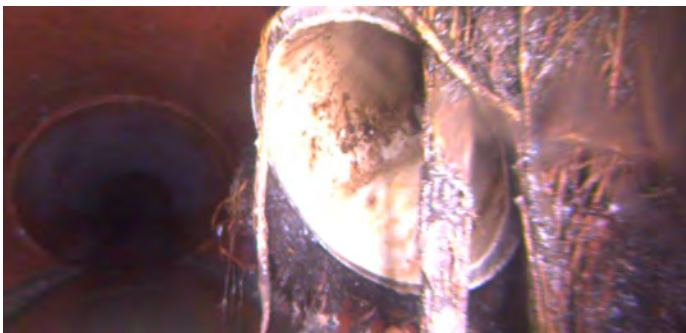
Code: **TBI**
Description: **Tap Break-in Intruding**

Distance (ft): **178.1**
Structural Grade: **0**
O&M Grade: **2**
Clock Start/From: **2**
Clock To:
1st Value: **4.000**
2nd Value: **2.000**
Value Percent:
Continuous Index:
Within 8" of Joint:
Remarks:

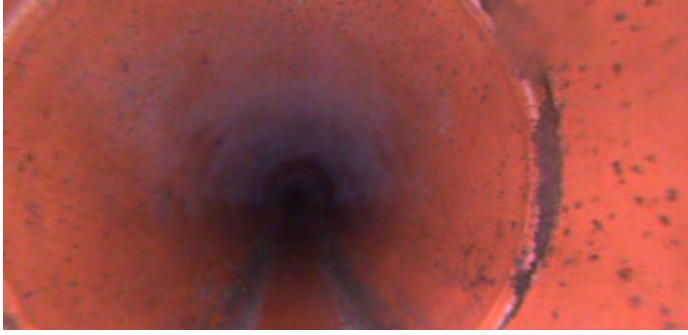
| Code: | MSA |
| Description: | Abandoned Survey |
| Distance (ft): | 179.3 |
| Remarks: | camera stopped |
