Profile/Photo Observation Report

Street:	W 38TH AVE	Flow Control:	Not Controlled
City:	Hobart, IN	Year Renewed:	
Location:	Other	Tape/Media #:	
Purpose:	Not Known	Dia/Height:	10"
Use:	Sanitary	Material:	VCP
Drain Area:	NA	Lining:	
Category:	NA		
Comment:

Location Details:		Direction of Survey:	Upstream
US MH:	M-303-028	DS MH:	M-303-029
		Total Length Surveyed (ft):	179.3

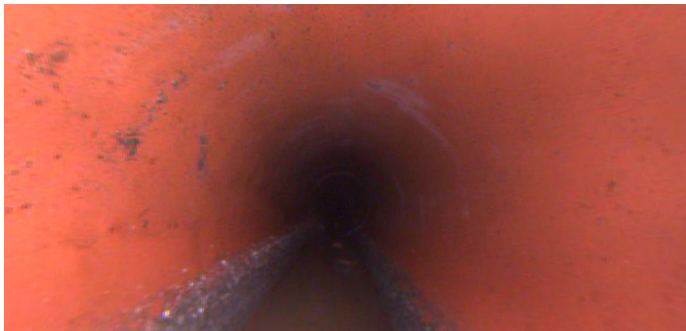
Code: **AMH**
Description: **Manhole**

Distance (ft): **.0**
Structural Grade: **0**
O&M Grade: **0**
Clock Start/From:
Clock To:
1st Value:
2nd Value:
Value Percent:
Continuous Index:
Within 8" of Joint: **NO**
Remarks: **M-303-029**

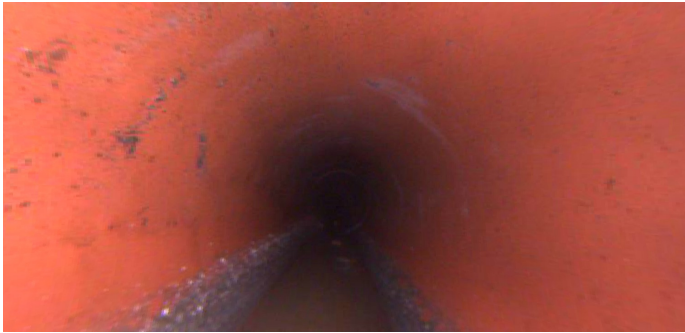
Code:	MWL
Description:	Water Level

Distance (ft):	.0
Structural Grade:	0
O&M Grade:	0
Clock Start/From:	
Clock To:	
1st Value:	
2nd Value:	
Value Percent:	5.000
Continuous Index:	
Within 8" of Joint:	NO
Remarks:

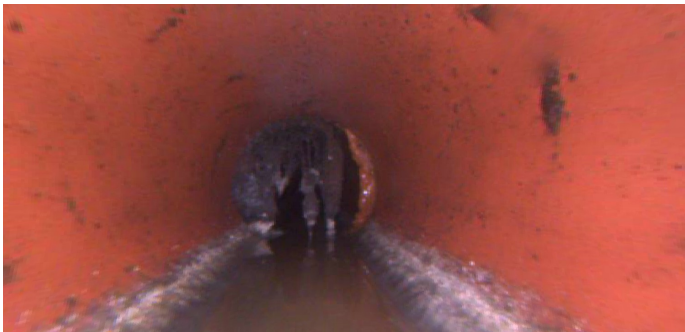
Code:	RMJ
Description:	Roots Medium Joint

Distance (ft):	58.6
Structural Grade:	0
O&M Grade:	3
Clock Start/From:	7
Clock To:	12
1st Value:	
2nd Value:	
Value Percent:	40.000
Continuous Index:	
Within 8" of Joint:	YES
Remarks:

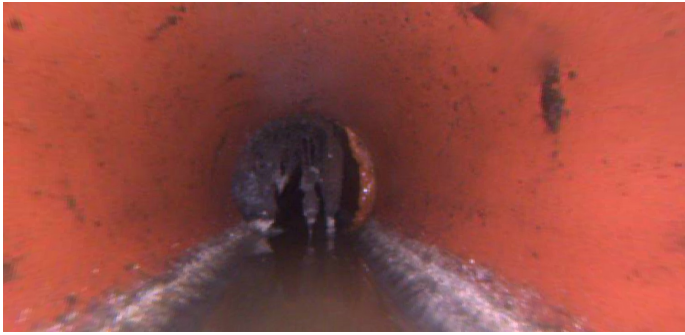
Code: **DAE**
Description: **Deposits Attached Encrustation**

Distance (ft): **58.6**
Structural Grade: **0**
O&M Grade: **2**
Clock Start/From: **1**
Clock To: **5**
1st Value:
2nd Value:
Value Percent: **10.000**
Continuous Index:
Within 8" of Joint: **YES**
Remarks:

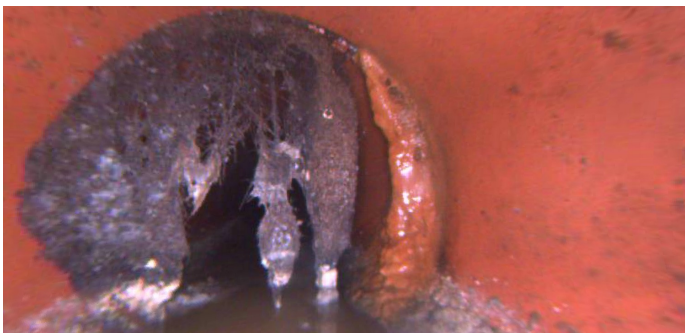
Code: **IW**
Description: **Infil Weeper**

Distance (ft): **59.6**
Structural Grade: **0**
O&M Grade: **2**
Clock Start/From: **1**
Clock To: **4**
1st Value:
2nd Value:
Value Percent:
Continuous Index:
Within 8" of Joint: **YES**
Remarks:

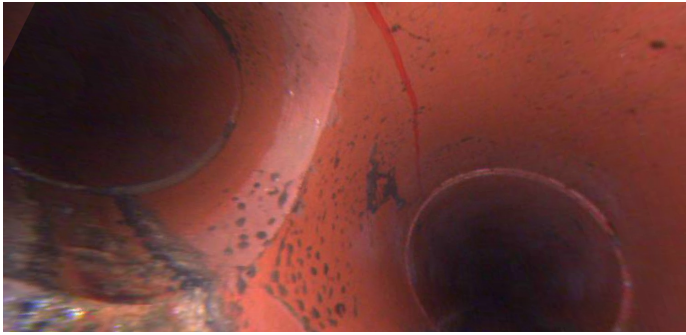
Code: **TFA**
Description: **Tap Factory Active**

Distance (ft): **65.9**
Structural Grade: **0**
O&M Grade: **0**
Clock Start/From: **10**
Clock To:
1st Value: **4.000**
2nd Value:
Value Percent:
Continuous Index:
Within 8" of Joint:
Remarks:

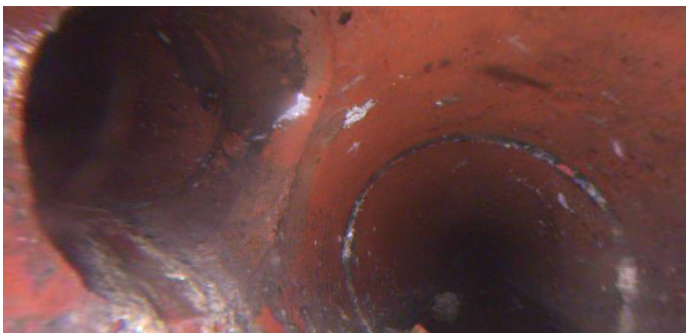
Code: **TFA**
Description: **Tap Factory Active**

Distance (ft): **114.1**
Structural Grade: **0**
O&M Grade: **0**
Clock Start/From: **9**
Clock To:
1st Value: **4.000**
2nd Value:
Value Percent:
Continuous Index:
Within 8" of Joint:
Remarks:

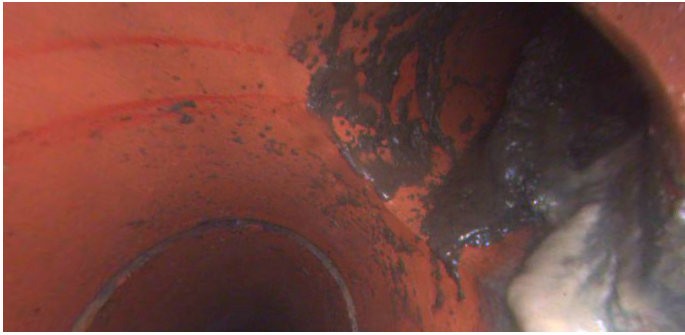
Code: **TFA**
Description: **Tap Factory Active**

Distance (ft): **131.4**
Structural Grade: **0**
O&M Grade: **0**
Clock Start/From: **10**
Clock To:
1st Value: **4.000**
2nd Value:
Value Percent:
Continuous Index:
Within 8" of Joint:
Remarks:

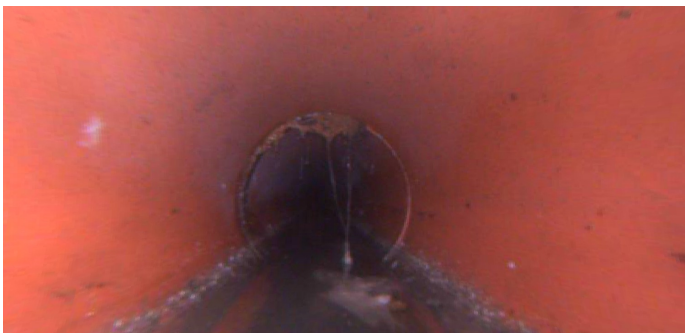
Code: **RFJ**
Description: **Roots Fine Joint**

Distance (ft): **156.1**
Structural Grade: **0**
O&M Grade: **1**
Clock Start/From: **10**
Clock To: **1**
1st Value:
2nd Value:
Value Percent:
Continuous Index:
Within 8" of Joint: **YES**
Remarks:

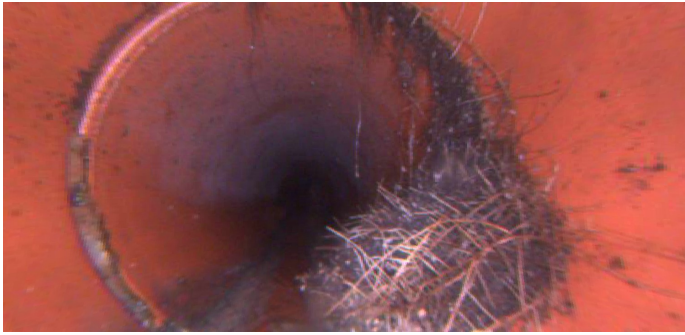
Code: **RMJ**
Description: **Roots Medium Joint**

Distance (ft): **172.0**
Structural Grade: **0**
O&M Grade: **3**
Clock Start/From: **12**
Clock To: **6**
1st Value:
2nd Value:
Value Percent: **40.000**
Continuous Index:
Within 8" of Joint: **YES**
Remarks:

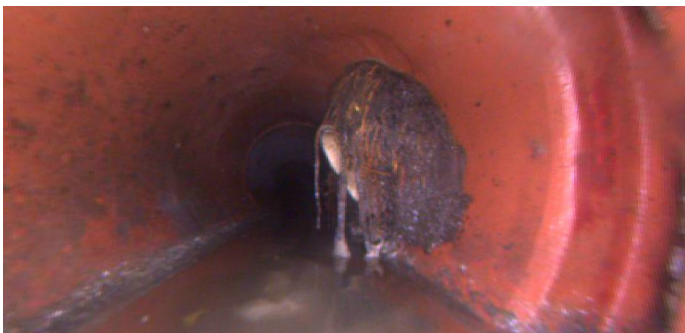
Code: **TFD**
Description: **Tap Factory Defective**

Distance (ft): **177.4**
Structural Grade: **0**
O&M Grade: **2**
Clock Start/From: **2**
Clock To:
1st Value: **4.000**
2nd Value:
Value Percent:
Continuous Index:
Within 8" of Joint:
Remarks: **root infiltration**

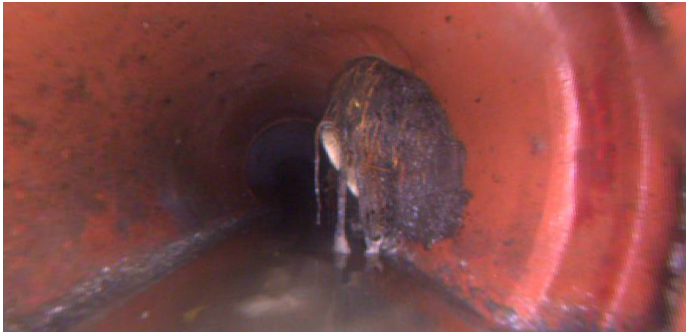
Code: **RML**
Description: **Roots Medium Lateral**

Distance (ft): **177.4**
Structural Grade: **0**
O&M Grade: **3**
Clock Start/From: **1**
Clock To: **4**
1st Value:
2nd Value:
Value Percent: **20.000**
Continuous Index:
Within 8" of Joint: **NO**
Remarks:

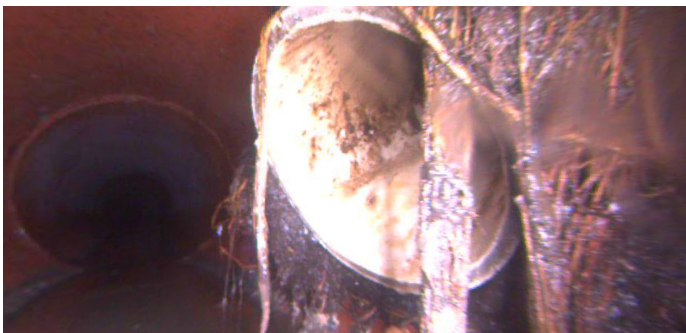
Code: **TBI**
Description: **Tap Break-in Intruding**

Distance (ft): **178.1**
Structural Grade: **0**
O&M Grade: **2**
Clock Start/From: **2**
Clock To:
1st Value: **4.000**
2nd Value: **2.000**
Value Percent:
Continuous Index:
Within 8" of Joint:
Remarks:

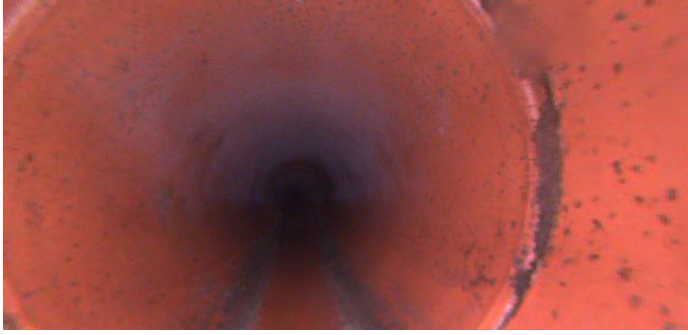
Code:	MSA
Description:	Abandoned Survey
Distance (ft):	179.3
Structural Grade:	0
O&M Grade:	0
Clock Start/From:	
Clock To:	
1st Value:	
2nd Value:	
Value Percent:	
Continuous Index:	
Within 8" of Joint:	NO
Remarks:	camera stopped
