Profile/Photo Observation Report

Date:	03/28/2018	Weather:		Coding:	PACP 6.0
Pipe Length (ft):	333.7	Owner:	NA	Pre Clean:	Not Known
P.O.#:		Surveyor:	Selasie Honu	PSR:	P-303-030-029
Customer:		Clean Date:	01/01/1900	Shape:	C

Street:	KENWOOD ST	Flow Control:	Not Controlled
City:	Hobart, IN	Year Renewed:	
Location:	Other	Tape/Media #:	
Purpose:	Not Known	Dia/Height:	10"
Use:	Sanitary	Material:	VCP
Drain Area:	NA	Lining:	
Category:	NA		
Comment:

Location Details:		Direction of Survey:	Downstream
US MH:	M-303-029	DS MH:	M-303-030
		Total Length Surveyed (ft):	328.1

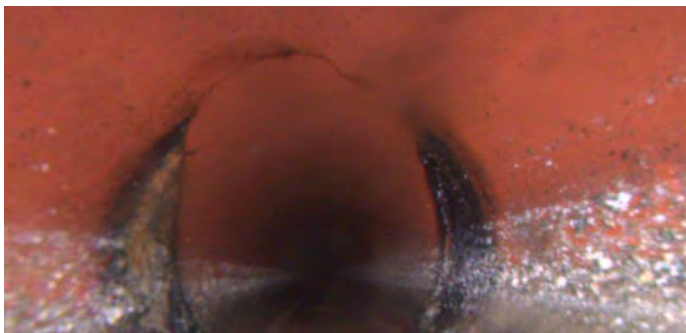
Code: **FC**
Description: **Fracture Circumferential**

Distance (ft): **.0**
Structural Grade: **2**
O&M Grade: **0**
Clock Start/From: **8**
Clock To: **4**
1st Value:
2nd Value:
Value Percent:
Continuous Index:
Within 8" of Joint:
Remarks:

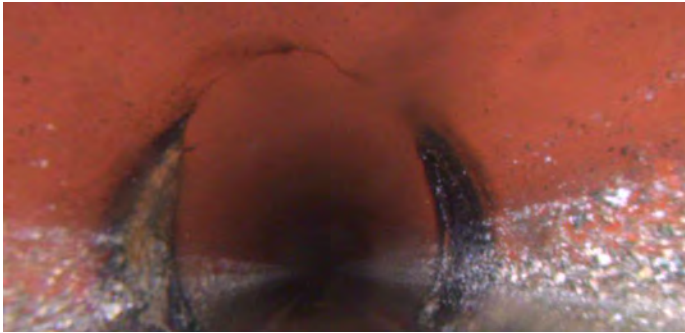
Code:	DAGS
Description:	Deposits Attached Grease

Distance (ft):	.0
Structural Grade:	0
O&M Grade:	2
Clock Start/From:	8
Clock To:	4
1st Value:	
2nd Value:	
Value Percent:	5.000
Continuous Index:	S01
Within 8" of Joint:	NO
Remarks:

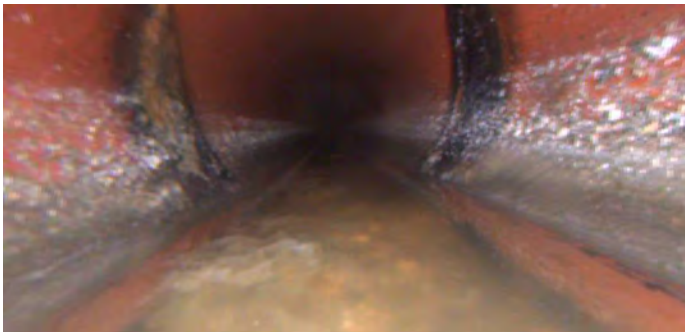
Code:	AMH
Description:	Manhole

Distance (ft):	.0
Structural Grade:	0
O&M Grade:	0
Clock Start/From:	
Clock To:	
1st Value:	
2nd Value:	
Value Percent:	
Continuous Index:	
Within 8" of Joint:	NO
Remarks:	M-303-029

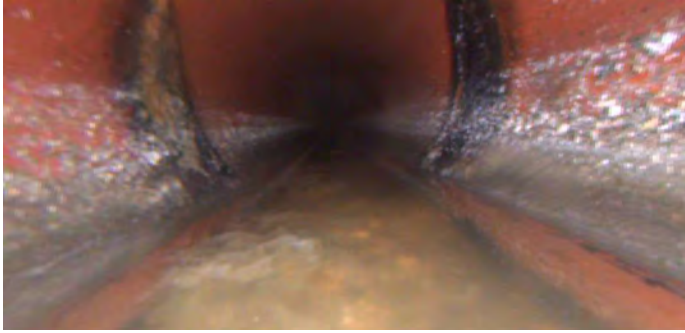
Code: **MWL**
Description: **Water Level**

Distance (ft): **.0**
Structural Grade: **0**
O&M Grade: **0**
Clock Start/From:
Clock To:
1st Value:
2nd Value:
Value Percent: **5.000**
Continuous Index:
Within 8" of Joint: **NO**
Remarks:

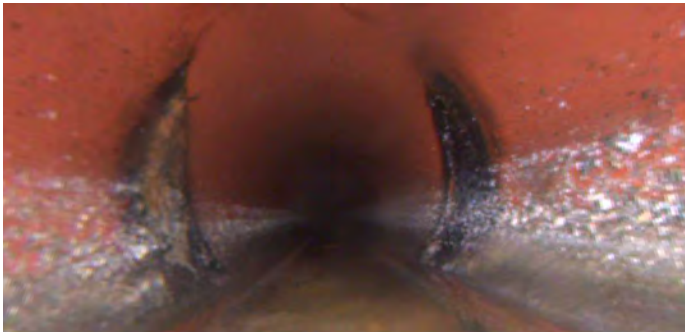
Code: **IS**
Description: **Infil Stain**

Distance (ft): **.0**
Structural Grade: **0**
O&M Grade: **0**
Clock Start/From: **7**
Clock To: **5**
1st Value:
2nd Value:
Value Percent:
Continuous Index:
Within 8" of Joint: **YES**
Remarks:

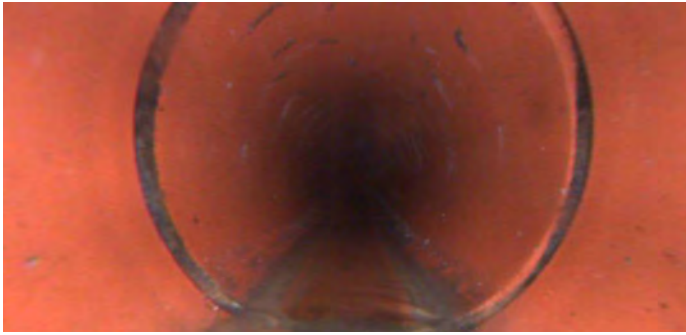
Code: **DAGS**
Description: **Deposits Attached Grease**

Distance (ft): **29.2**
Structural Grade: **0**
O&M Grade: **2**
Clock Start/From: **8**
Clock To: **4**
1st Value:
2nd Value:
Value Percent: **5.000**
Continuous Index: **F01**
Within 8" of Joint: **NO**
Remarks:

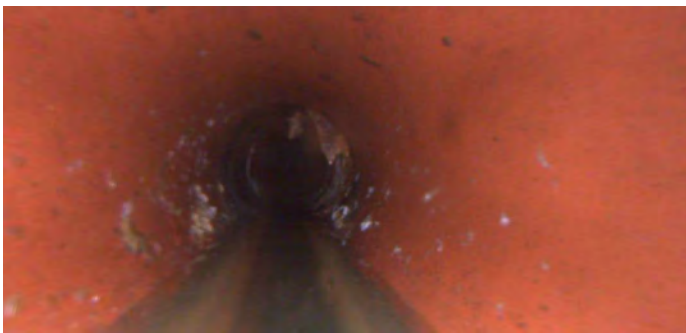
Code: **DAE**
Description: **Deposits Attached Encrustation**

Distance (ft): **57.0**
Structural Grade: **0**
O&M Grade: **2**
Clock Start/From: **12**
Clock To: **5**
1st Value:
2nd Value:
Value Percent: **10.000**
Continuous Index:
Within 8" of Joint: **YES**
Remarks:

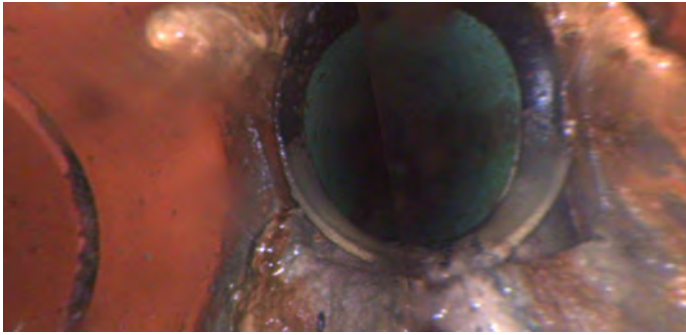
Code: **TBA**
Description: **Tap Break-in Active**

Distance (ft): **59.3**
Structural Grade: **0**
O&M Grade: **0**
Clock Start/From: **2**
Clock To:
1st Value: **4.000**
2nd Value:
Value Percent:
Continuous Index:
Within 8" of Joint:
Remarks:

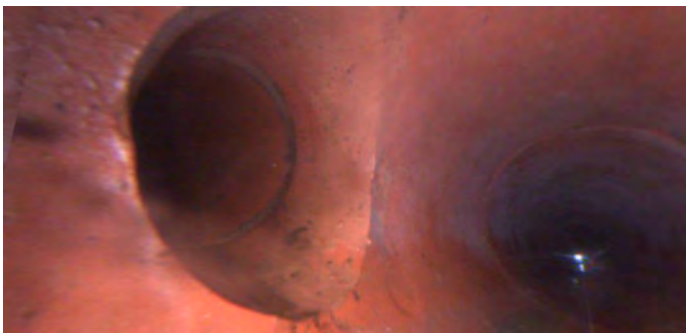
Code: **TF**
Description: **Tap Factory**

Distance (ft): **76.6**
Structural Grade: **0**
O&M Grade: **0**
Clock Start/From: **3**
Clock To:
1st Value: **4.000**
2nd Value:
Value Percent:
Continuous Index:
Within 8" of Joint:
Remarks:

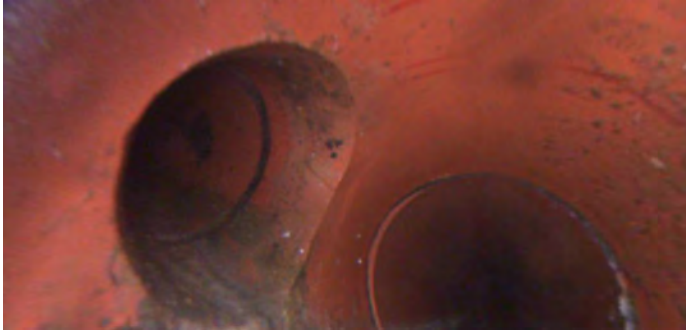
Code: **TF**
Description: **Tap Factory**

Distance (ft): **77.9**
Structural Grade: **0**
O&M Grade: **0**
Clock Start/From: **10**
Clock To:
1st Value: **4.000**
2nd Value:
Value Percent:
Continuous Index:
Within 8" of Joint:
Remarks:

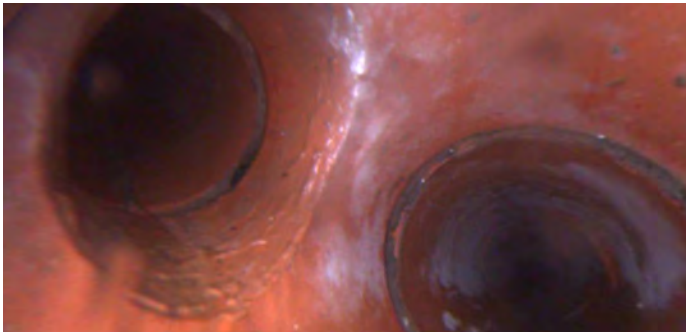
Code: **TF**
Description: **Tap Factory**

Distance (ft): **120.2**
Structural Grade: **0**
O&M Grade: **0**
Clock Start/From: **10**
Clock To:
1st Value: **4.000**
2nd Value:
Value Percent:
Continuous Index:
Within 8" of Joint:
Remarks:

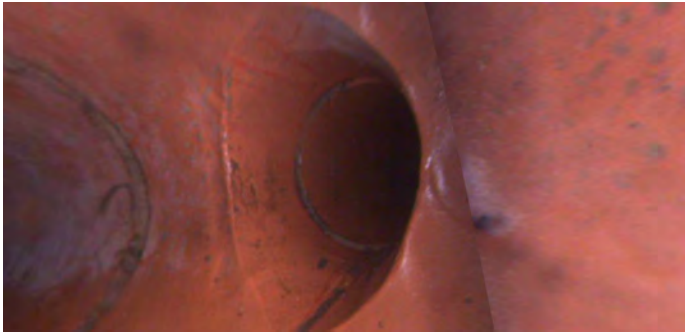
Code: **TF**
Description: **Tap Factory**

Distance (ft): **122.3**
Structural Grade: **0**
O&M Grade: **0**
Clock Start/From: **3**
Clock To:
1st Value: **4.000**
2nd Value:
Value Percent:
Continuous Index:
Within 8" of Joint:
Remarks:

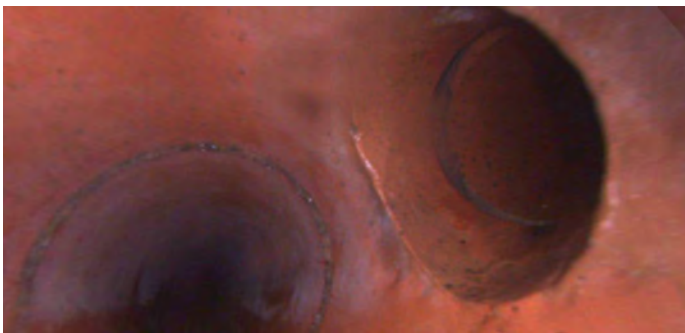
Code: **TF**
Description: **Tap Factory**

Distance (ft): **154.5**
Structural Grade: **0**
O&M Grade: **0**
Clock Start/From: **2**
Clock To:
1st Value: **4.000**
2nd Value:
Value Percent:
Continuous Index:
Within 8" of Joint:
Remarks:

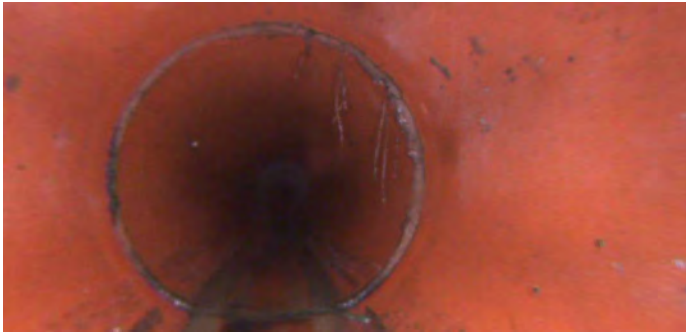
Code: **RFJ**
Description: **Roots Fine Joint**

Distance (ft): **180.0**
Structural Grade: **0**
O&M Grade: **1**
Clock Start/From: **12**
Clock To: **2**
1st Value:
2nd Value:
Value Percent:
Continuous Index:
Within 8" of Joint: **YES**
Remarks:

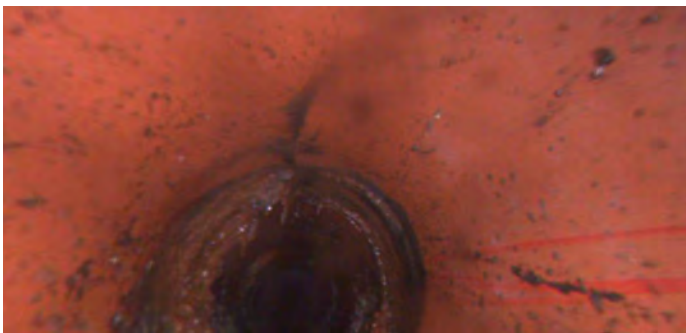
Code: **FL**
Description: **Fracture Longitudinal**

Distance (ft): **194.6**
Structural Grade: **3**
O&M Grade: **0**
Clock Start/From: **12**
Clock To:
1st Value:
2nd Value:
Value Percent:
Continuous Index:
Within 8" of Joint: **YES**
Remarks:

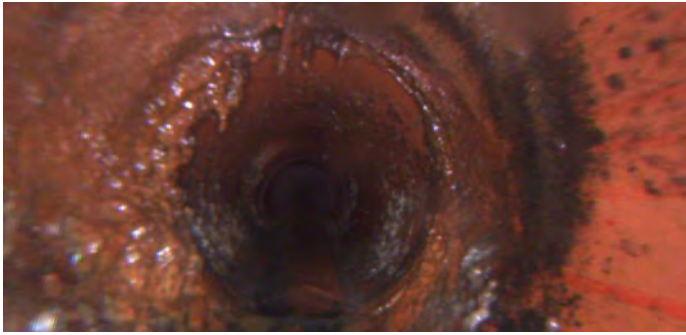
Code:	DAE
Description:	Deposits Attached Encrustation

Distance (ft):	195.1
Structural Grade:	0
O&M Grade:	3
Clock Start/From:	12
Clock To:	12
1st Value:	
2nd Value:	
Value Percent:	20.000
Continuous Index:	
Within 8" of Joint:	YES
Remarks:

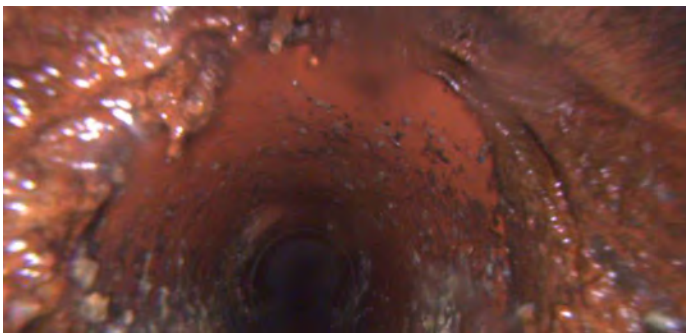
Code:	ID
Description:	Infil Dripper

Distance (ft):	195.5
Structural Grade:	0
O&M Grade:	3
Clock Start/From:	11
Clock To:	1
1st Value:	
2nd Value:	
Value Percent:	
Continuous Index:	
Within 8" of Joint:	YES
Remarks:

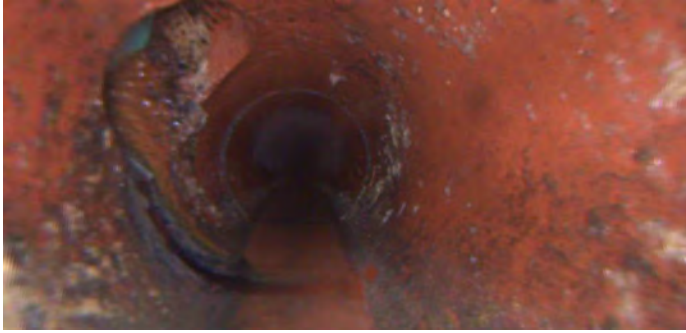
Code: **DAE**
Description: **Deposits Attached Encrustation**

Distance (ft): **196.3**
Structural Grade: **0**
O&M Grade: **2**
Clock Start/From: **7**
Clock To: **10**
1st Value:
2nd Value:
Value Percent: **5.000**
Continuous Index:
Within 8" of Joint: **NO**
Remarks:

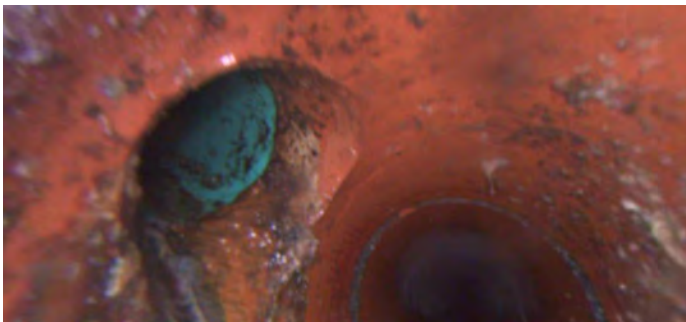
Code: **TFA**
Description: **Tap Factory Active**

Distance (ft): **196.7**
Structural Grade: **0**
O&M Grade: **0**
Clock Start/From: **10**
Clock To:
1st Value: **4.000**
2nd Value:
Value Percent:
Continuous Index:
Within 8" of Joint:
Remarks:

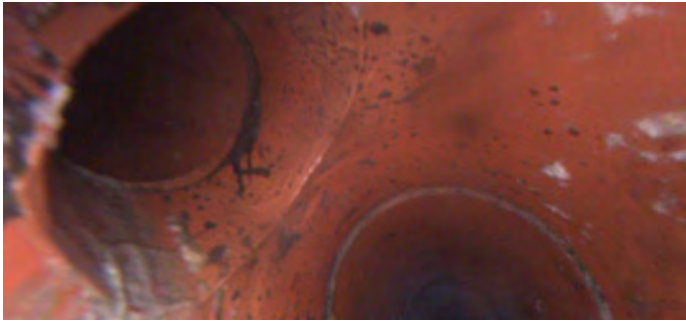
Code: **TF**
Description: **Tap Factory**

Distance (ft): **254.4**
Structural Grade: **0**
O&M Grade: **0**
Clock Start/From: **10**
Clock To:
1st Value: **4.000**
2nd Value:
Value Percent:
Continuous Index:
Within 8" of Joint:
Remarks:

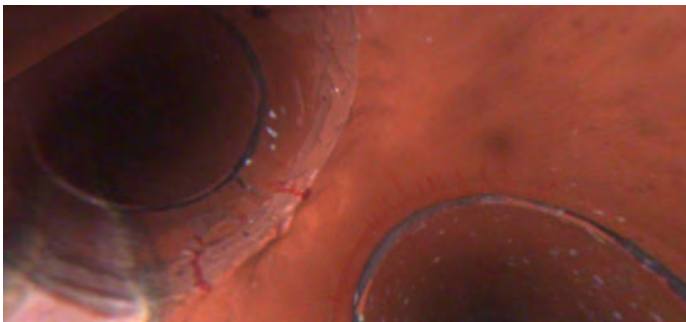
Code: **TF**
Description: **Tap Factory**

Distance (ft): **306.9**
Structural Grade: **0**
O&M Grade: **0**
Clock Start/From: **10**
Clock To:
1st Value: **4.000**
2nd Value:
Value Percent:
Continuous Index:
Within 8" of Joint:
Remarks:

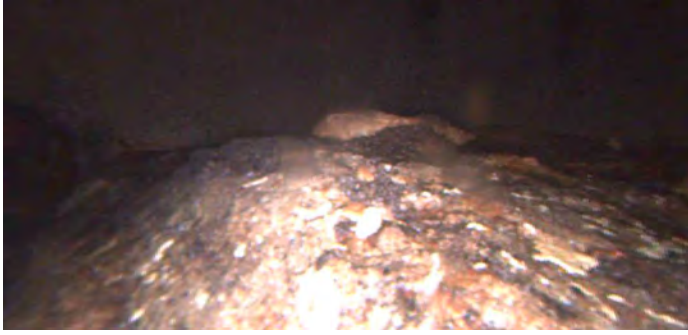
Code:	AMH
Description:	Manhole
Distance (ft):	328.1
Structural Grade:	0
O&M Grade:	0
Clock Start/From:	
Clock To:	
1st Value:	
2nd Value:	
Value Percent:	
Continuous Index:	
Within 8" of Joint:	NO
Remarks:	M-303-030
