Profile/Photo Observation Report

Street:	W 38TH AVE	Flow Control:	Not Controlled
City:	Hobart, IN	Year Renewed:	
Location:	Other	Tape/Media #:	
Purpose:	Not Known	Dia/Height:	10"
Use:	Sanitary	Material:	VCP
Drain Area:	NA	Lining:	
Category:	NA		
Comment:

Location Details:		Direction of Survey:	Downstream
US MH:	M-303-029	DS MH:	M-303-030
		Total Length Surveyed (ft):	328.1

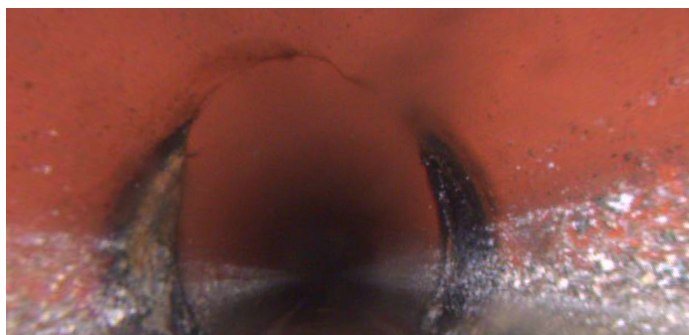
Code: **FC**
Description: **Fracture Circumferential**

Distance (ft): **.0**
Structural Grade: **2**
O&M Grade: **0**
Clock Start/From: **8**
Clock To: **4**
1st Value:
2nd Value:
Value Percent:
Continuous Index:
Within 8" of Joint:
Remarks:

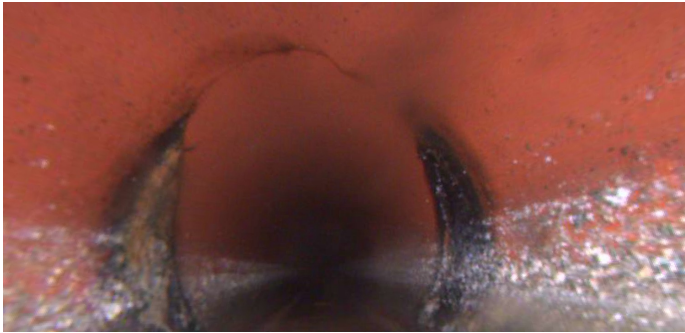
Code:	DAGS
Description:	Deposits Attached Grease

Distance (ft):	.0
Structural Grade:	0
O&M Grade:	2
Clock Start/From:	8
Clock To:	4
1st Value:	
2nd Value:	
Value Percent:	5.000
Continuous Index:	S01
Within 8" of Joint:	NO
Remarks:

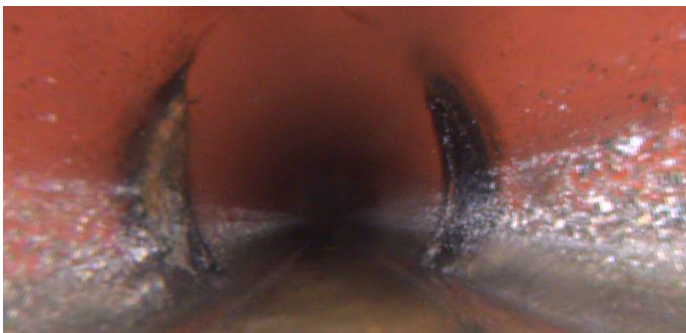
Code: **IS**
Description: **Infil Stain**

Distance (ft): **.0**
Structural Grade: **0**
O&M Grade: **0**
Clock Start/From: **7**
Clock To: **5**
1st Value:
2nd Value:
Value Percent:
Continuous Index:
Within 8" of Joint: **YES**
Remarks:

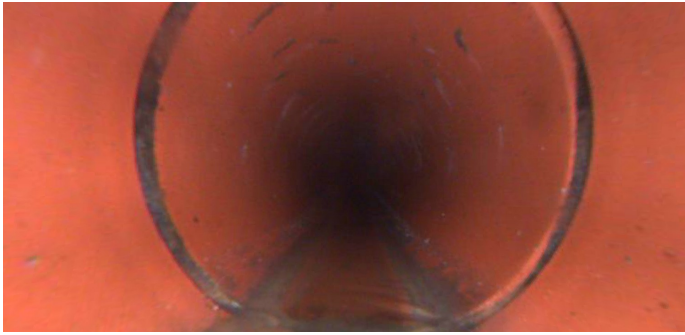
Code: **DAGS**
Description: **Deposits Attached Grease**

Distance (ft): **29.2**
Structural Grade: **0**
O&M Grade: **2**
Clock Start/From: **8**
Clock To: **4**
1st Value:
2nd Value:
Value Percent: **5.000**
Continuous Index: **F01**
Within 8" of Joint: **NO**
Remarks:

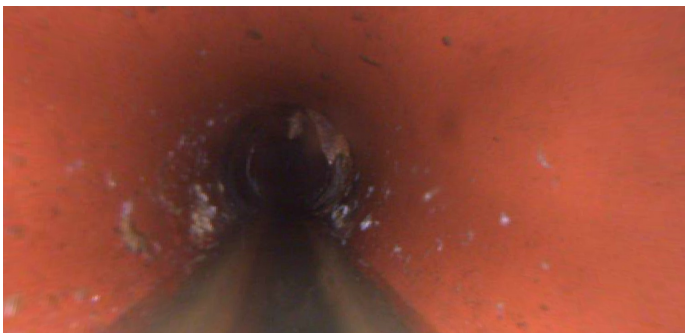
Code: **DAE**
Description: **Deposits Attached Encrustation**

Distance (ft): **57.0**
Structural Grade: **0**
O&M Grade: **2**
Clock Start/From: **12**
Clock To: **5**
1st Value:
2nd Value:
Value Percent: **10.000**
Continuous Index:
Within 8" of Joint: **YES**
Remarks:

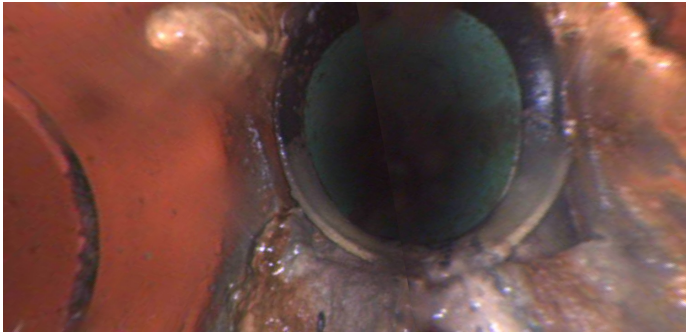
Code: **TBA**
Description: **Tap Break-in Active**

Distance (ft): **59.3**
Structural Grade: **0**
O&M Grade: **0**
Clock Start/From: **2**
Clock To:
1st Value: **4.000**
2nd Value:
Value Percent:
Continuous Index:
Within 8" of Joint:
Remarks:

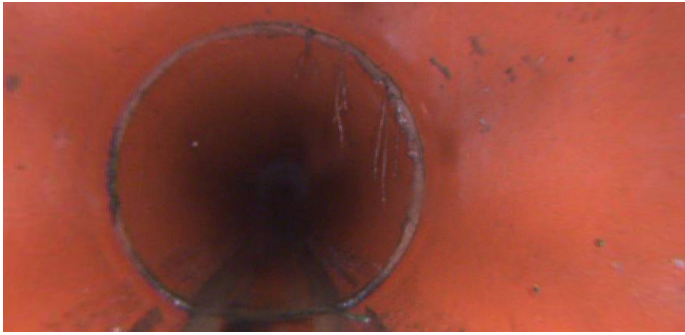
Code: **RFJ**
Description: **Roots Fine Joint**

Distance (ft): **180.0**
Structural Grade: **0**
O&M Grade: **1**
Clock Start/From: **12**
Clock To: **2**
1st Value:
2nd Value:
Value Percent:
Continuous Index:
Within 8" of Joint: **YES**
Remarks:

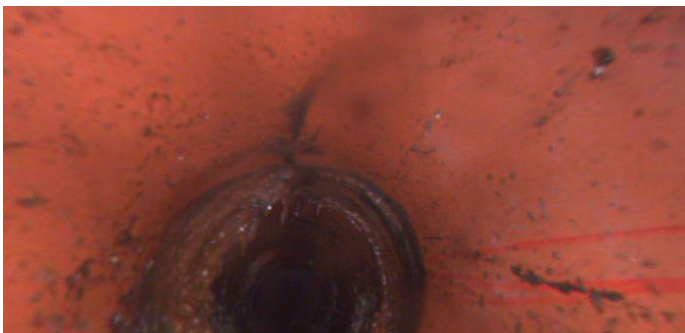
Code: **FL**
Description: **Fracture Longitudinal**

Distance (ft): **194.6**
Structural Grade: **3**
O&M Grade: **0**
Clock Start/From: **12**
Clock To:
1st Value:
2nd Value:
Value Percent:
Continuous Index:
Within 8" of Joint: **YES**
Remarks:

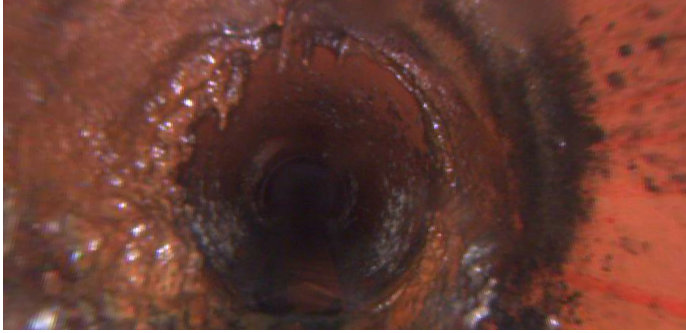
Code: **DAE**
Description: **Deposits Attached Encrustation**

Distance (ft): **195.1**
Structural Grade: **0**
O&M Grade: **3**
Clock Start/From: **12**
Clock To: **12**
1st Value:
2nd Value:
Value Percent: **20.000**
Continuous Index:
Within 8" of Joint: **YES**
Remarks:

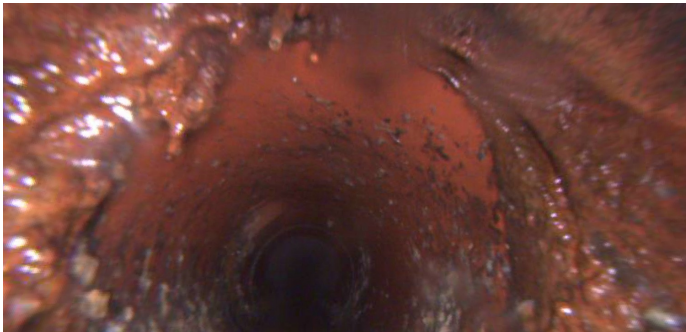
Code: **ID**
Description: **Infil Dripper**

Distance (ft): **195.5**
Structural Grade: **0**
O&M Grade: **3**
Clock Start/From: **11**
Clock To: **1**
1st Value:
2nd Value:
Value Percent:
Continuous Index:
Within 8" of Joint: **YES**
Remarks:

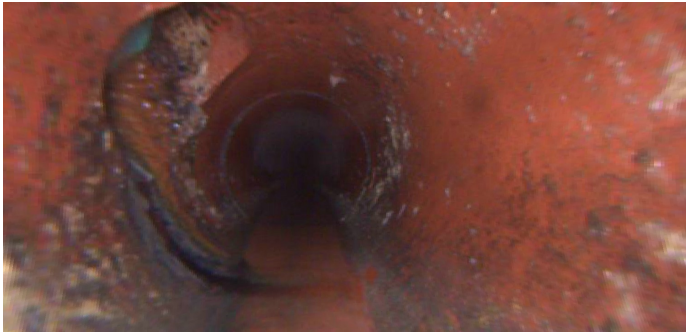
Code: **DAE**
Description: **Deposits Attached Encrustation**

Distance (ft): **196.3**
Structural Grade: **0**
O&M Grade: **2**
Clock Start/From: **7**
Clock To: **10**
1st Value:
2nd Value:
Value Percent: **5.000**
Continuous Index:
Within 8" of Joint: **NO**
Remarks:
