Profile/Photo Observation Report

Date:	09/25/2018	Weather:		Coding:	PACP 6.0
Pipe Length (ft):	130.7	Owner:	NA	Pre Clean:	Not Known
P.O.#:		Surveyor:	Selasie Honu	PSR:	P-303-031-030
Customer:		Clean Date:	01/01/1900	Shape:	C

Street:	ALLEY BETWEEN W 38TH AVE & W 3	Flow Control:	Not Controlled
City:	Hobart, IN	Year Renewed:	
Location:	Light Highway	Tape/Media #:	
Purpose:	Routine Assessment	Dia/Height:	8"
Use:	Sanitary	Material:	VCP
Drain Area:	NA	Lining:	
Category:	NA		
Comment:

Location Details:		Direction of Survey:	Upstream
US MH:	M-303-030	DS MH:	M-303-031
		Total Length Surveyed (ft):	118.5

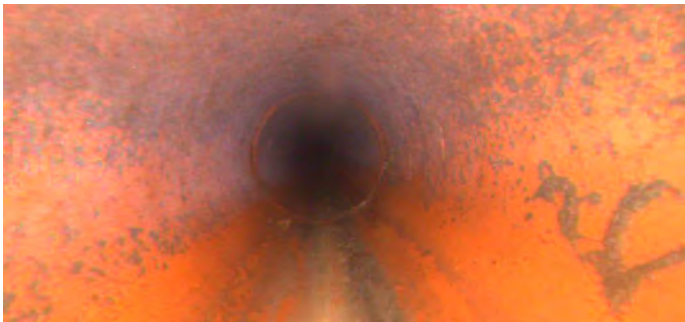
Code: **AMH**
Description: **Manhole**

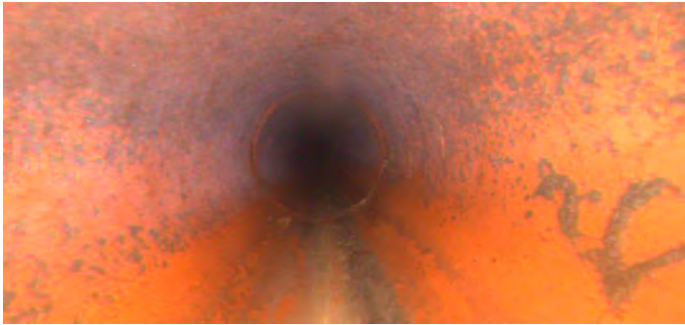
Code:	MWL
Description:	Water Level

Distance (ft):	.0
Structural Grade:	0
O&M Grade:	0
Clock Start/From:	
Clock To:	
1st Value:	
2nd Value:	
Value Percent:	5.000
Continuous Index:	
Within 8" of Joint:	NO
Remarks:

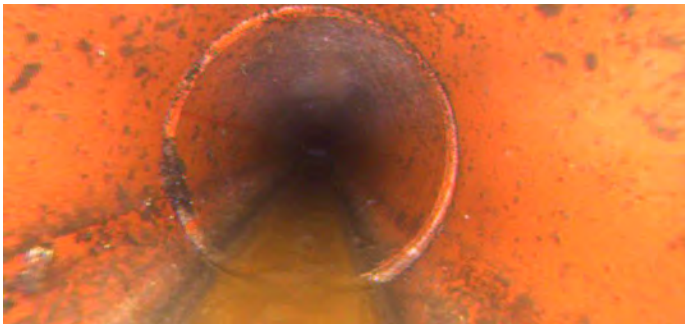
Code:	RFJ
Description:	Roots Fine Joint

Distance (ft):	16.6
Structural Grade:	0
O&M Grade:	1
Clock Start/From:	8
Clock To:	9
1st Value:	
2nd Value:	
Value Percent:	
Continuous Index:	
Within 8" of Joint:	YES
Remarks:

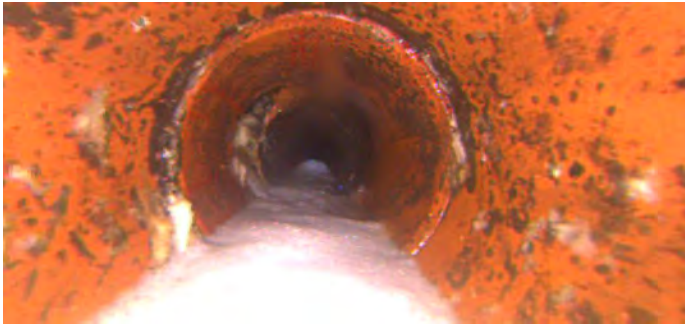
Code: **TFA**
Description: **Tap Factory Active**

Distance (ft): **21.6**
Structural Grade: **0**
O&M Grade: **0**
Clock Start/From: **9**
Clock To:
1st Value: **4.000**
2nd Value:
Value Percent:
Continuous Index:
Within 8" of Joint:
Remarks:

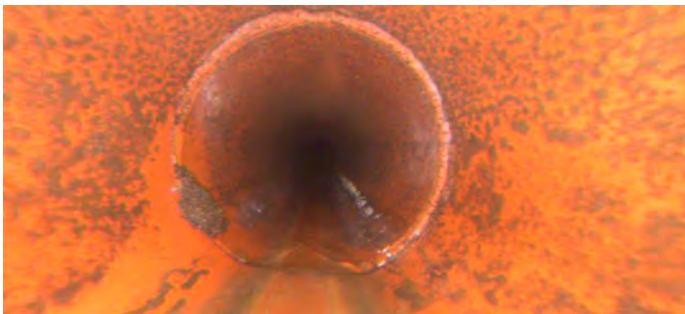
Code: **RFJ**
Description: **Roots Fine Joint**

Distance (ft): **48.6**
Structural Grade: **0**
O&M Grade: **1**
Clock Start/From: **8**
Clock To: **9**
1st Value:
2nd Value:
Value Percent:
Continuous Index:
Within 8" of Joint: **YES**
Remarks:

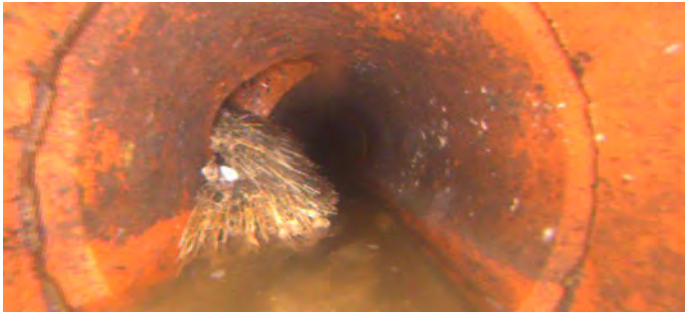
Code: **TFD**
Description: **Tap Factory Defective**

Distance (ft): **68.8**
Structural Grade: **0**
O&M Grade: **2**
Clock Start/From: **9**
Clock To:
1st Value: **4.000**
2nd Value:
Value Percent:
Continuous Index:
Within 8" of Joint:
Remarks: **root infiltration**

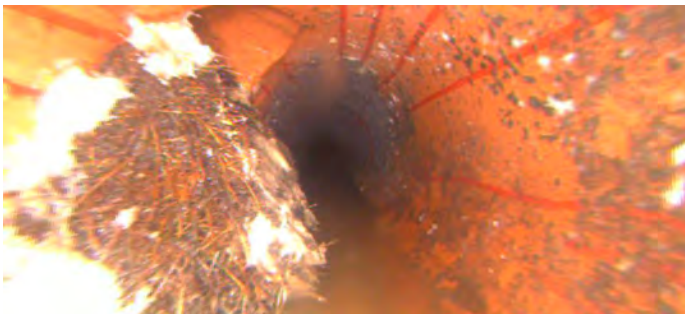
Code: **TFD**
Description: **Tap Factory Defective**

Distance (ft): **105.9**
Structural Grade: **0**
O&M Grade: **2**
Clock Start/From: **10**
Clock To:
1st Value: **4.000**
2nd Value:
Value Percent:
Continuous Index:
Within 8" of Joint:
Remarks: **root infiltration**

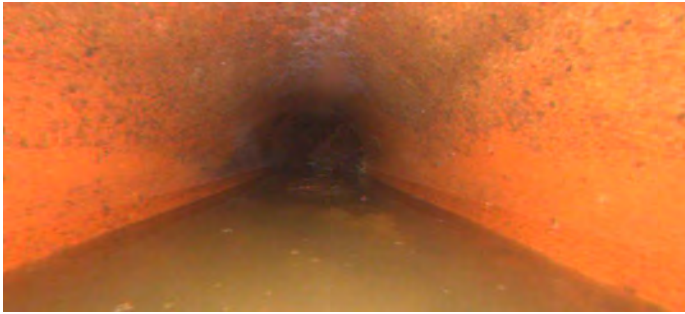
Code: **RMJ**
Description: **Roots Medium Joint**

Distance (ft): **115.7**
Structural Grade: **0**
O&M Grade: **3**
Clock Start/From: **3**
Clock To: **6**
1st Value:
2nd Value:
Value Percent: **30.000**
Continuous Index:
Within 8" of Joint: **YES**
Remarks:

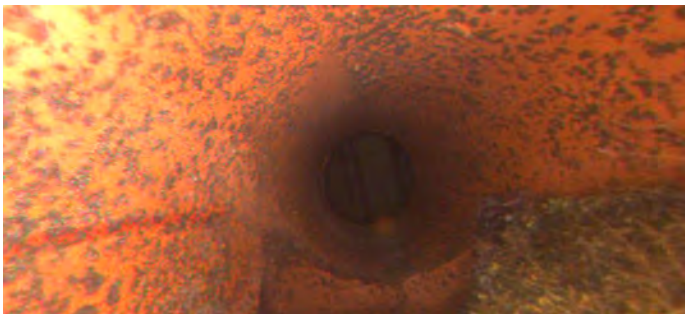
Code: **AMH**
Description: **Manhole**

Distance (ft): **118.5**
Structural Grade: **0**
O&M Grade: **0**
Clock Start/From:
Clock To:
1st Value:
2nd Value:
Value Percent:
Continuous Index:
Within 8" of Joint: **NO**
Remarks: **M-303-030**
