Profile/Photo Observation Report

Date:	09/25/2018	Weather:		Coding:	PACP 6.0
Pipe Length (ft):	130.7	Owner:	NA	Pre Clean:	Not Known
P.O.#:		Surveyor:	Selasie Honu	PSR:	P-303-031-030
Customer:		Clean Date:	01/01/1900	Shape:	C

Street:	39th. Ave.	Flow Control:	Not Controlled
City:	Hobart, IN	Year Renewed:	
Location:	Light Highway	Tape/Media #:	
Purpose:	Routine Assessment	Dia/Height:	8"
Use:	Sanitary	Material:	VCP
Drain Area:	NA	Lining:	
Category:	NA		
Comment:

Location Details:		Direction of Survey:	Upstream
US MH:	M-303-030	DS MH:	M-303-031
		Total Length Surveyed (ft):	118.5

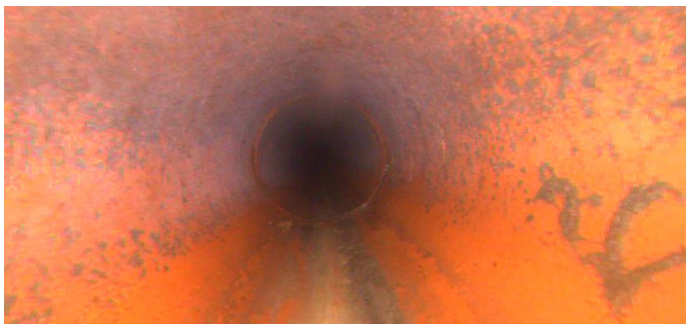
Code: **AMH**
Description: **Manhole**

Distance (ft): **.0**
Structural Grade: **0**
O&M Grade: **0**
Clock Start/From:
Clock To:
1st Value:
2nd Value:
Value Percent:
Continuous Index:
Within 8" of Joint: **NO**
Remarks: **M-303-031**

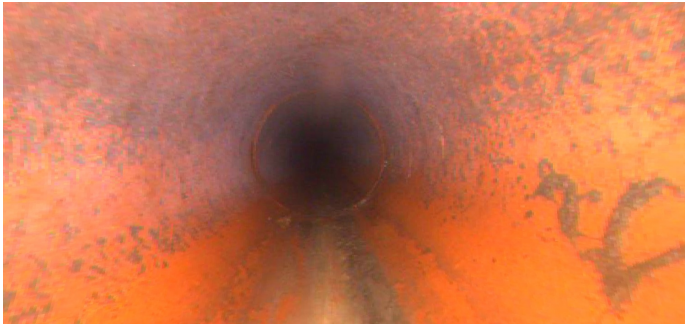
Code:	MWL
Description:	Water Level

Distance (ft):	.0
Structural Grade:	0
O&M Grade:	0
Clock Start/From:	
Clock To:	
1st Value:	
2nd Value:	
Value Percent:	5.000
Continuous Index:	
Within 8" of Joint:	NO
Remarks:

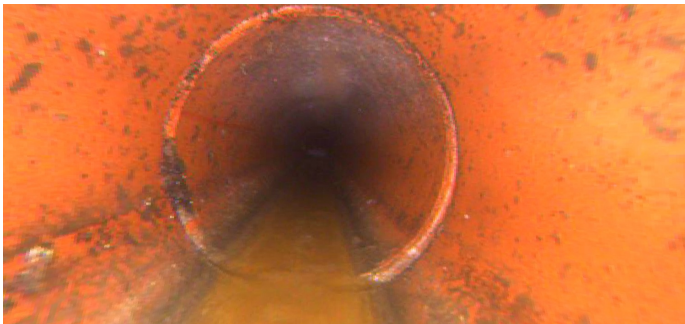
Code:	RFJ
Description:	Roots Fine Joint

Distance (ft):	16.6
Structural Grade:	0
O&M Grade:	1
Clock Start/From:	8
Clock To:	9
1st Value:	
2nd Value:	
Value Percent:	
Continuous Index:	
Within 8" of Joint:	YES
Remarks:

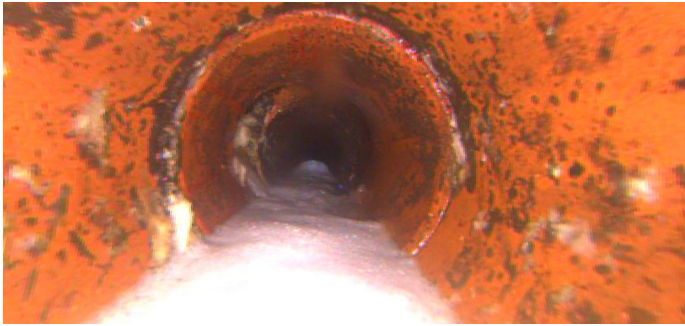
Code: **TFA**
Description: **Tap Factory Active**

Distance (ft): **21.6**
Structural Grade: **0**
O&M Grade: **0**
Clock Start/From: **9**
Clock To:
1st Value: **4.000**
2nd Value:
Value Percent:
Continuous Index:
Within 8" of Joint:
Remarks:

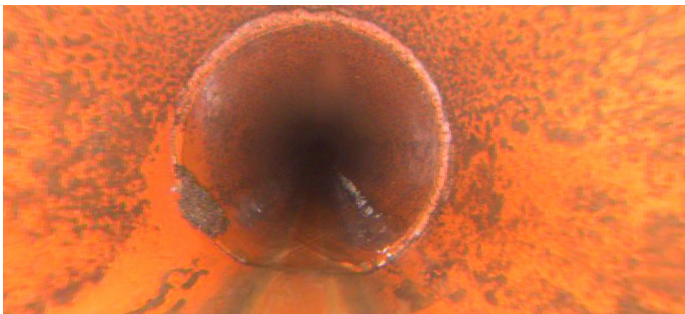
Code: **RFJ**
Description: **Roots Fine Joint**

Distance (ft): **48.6**
Structural Grade: **0**
O&M Grade: **1**
Clock Start/From: **8**
Clock To: **9**
1st Value:
2nd Value:
Value Percent:
Continuous Index:
Within 8" of Joint: **YES**
Remarks:

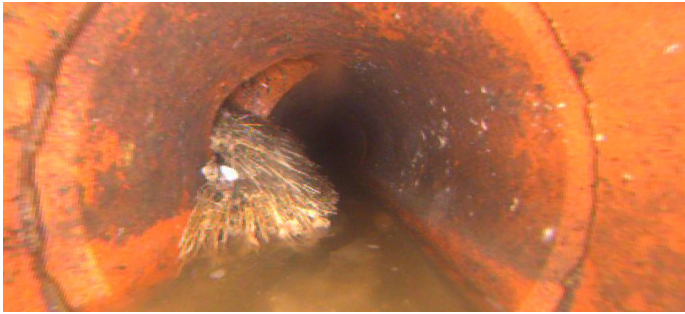
Code: **TFD**
Description: **Tap Factory Defective**

Distance (ft): **68.8**
Structural Grade: **0**
O&M Grade: **2**
Clock Start/From: **9**
Clock To:
1st Value: **4.000**
2nd Value:
Value Percent:
Continuous Index:
Within 8" of Joint:
Remarks: **root infiltration**

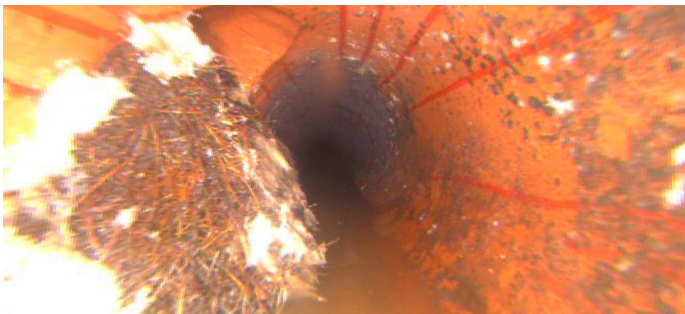
Code: **TFD**
Description: **Tap Factory Defective**

Distance (ft): **105.9**
Structural Grade: **0**
O&M Grade: **2**
Clock Start/From: **10**
Clock To:
1st Value: **4.000**
2nd Value:
Value Percent:
Continuous Index:
Within 8" of Joint:
Remarks: **root infiltration**

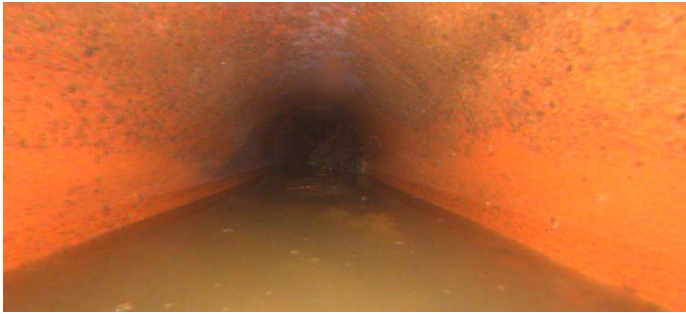
Code: **RMJ**
Description: **Roots Medium Joint**

Distance (ft): **115.7**
Structural Grade: **0**
O&M Grade: **3**
Clock Start/From: **3**
Clock To: **6**
1st Value:
2nd Value:
Value Percent: **30.000**
Continuous Index:
Within 8" of Joint: **YES**
Remarks:

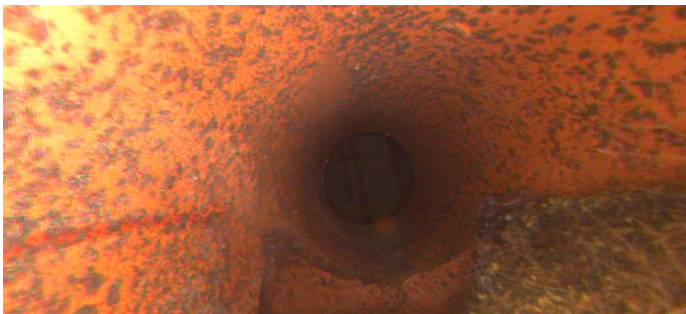
Code: **AMH**
Description: **Manhole**

Distance (ft): **118.5**
Structural Grade: **0**
O&M Grade: **0**
Clock Start/From:
Clock To:
1st Value:
2nd Value:
Value Percent:
Continuous Index:
Within 8" of Joint: **NO**
Remarks: **M-303-030**
