Profile/Photo Observation Report

| Street: | RIDGELAWN DR | Flow Control: | Not Controlled |
| City: | Hobart, IN | Year Renewed: | |

| US MH: | M-303-033 | DS MH: | M-303-034 |

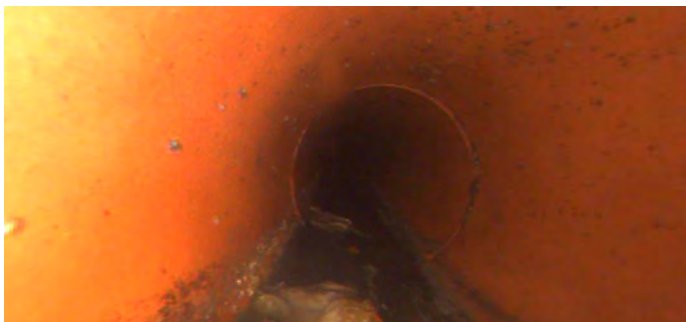
Code: **AMH**
Description: **Manhole**

Distance (ft): **.0**
Structural Grade: **0**
O&M Grade: **0**
Clock Start/From:
Clock To:
1st Value:
2nd Value:
Value Percent:
Continuous Index:
Within 8" of Joint: **NO**
Remarks: **M-303-034**

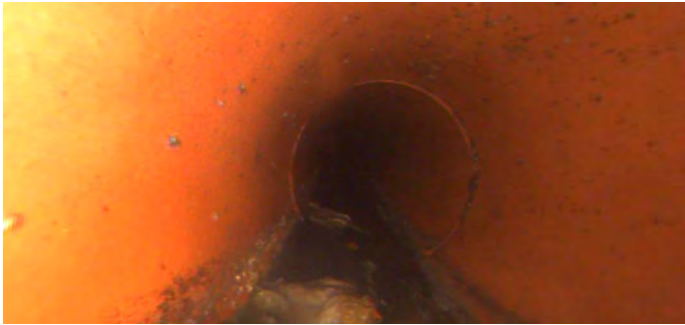
| Code: | MWL |
| Description: | Water Level |

| Distance (ft): | .0 |
| Value Percent: | 5.000 |

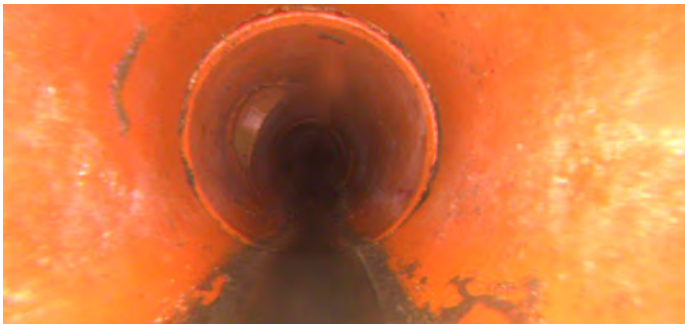
| Code: | TF |
| Description: | Tap Factory |

| Distance (ft): | 31.6 |
| Clock Start/From: | 9 |
| 1st Value: | 4.000 |

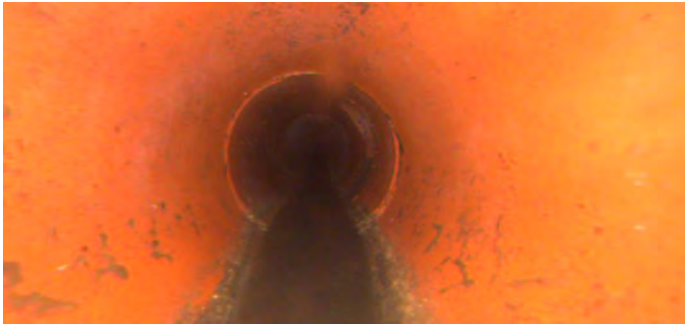
Code: **TF**
Description: **Tap Factory**

Distance (ft): **33.2**
Structural Grade: **0**
O&M Grade: **0**
Clock Start/From: **2**
Clock To:
1st Value: **4.000**
2nd Value:
Value Percent:
Continuous Index:
Within 8" of Joint:
Remarks:

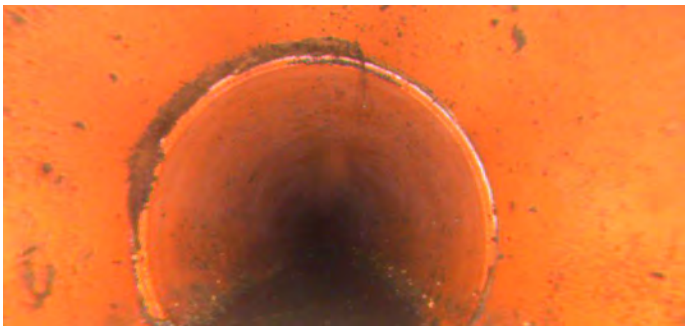
Code: **RFJ**
Description: **Roots Fine Joint**

Distance (ft): **55.9**
Structural Grade: **0**
O&M Grade: **1**
Clock Start/From: **9**
Clock To: **12**
1st Value:
2nd Value:
Value Percent:
Continuous Index:
Within 8" of Joint: **YES**
Remarks:

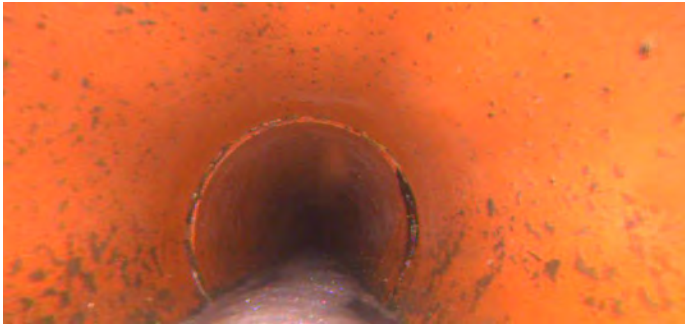
Code: **DAE**
Description: **Deposits Attached Encrustation**

Distance (ft): **65.6**
Structural Grade: **0**
O&M Grade: **2**
Clock Start/From: **8**
Clock To: **4**
1st Value:
2nd Value:
Value Percent: **10.000**
Continuous Index:
Within 8" of Joint: **YES**
Remarks:

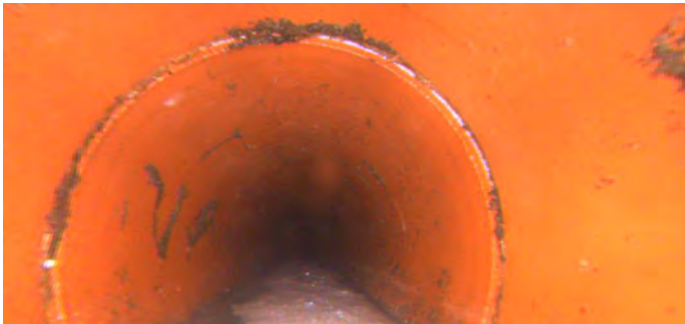
Code: **RFJ**
Description: **Roots Fine Joint**

Distance (ft): **81.2**
Structural Grade: **0**
O&M Grade: **1**
Clock Start/From: **8**
Clock To: **3**
1st Value:
2nd Value:
Value Percent:
Continuous Index:
Within 8" of Joint: **YES**
Remarks:

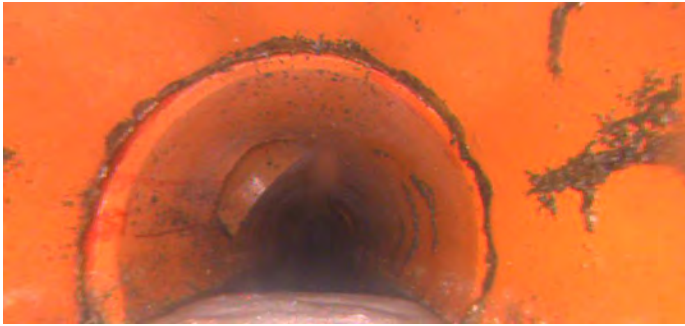
Code: **TF**
Description: **Tap Factory**

Distance (ft): **86.1**
Structural Grade: **0**
O&M Grade: **0**
Clock Start/From: **10**
Clock To:
1st Value: **4.000**
2nd Value:
Value Percent:
Continuous Index:
Within 8" of Joint:
Remarks:

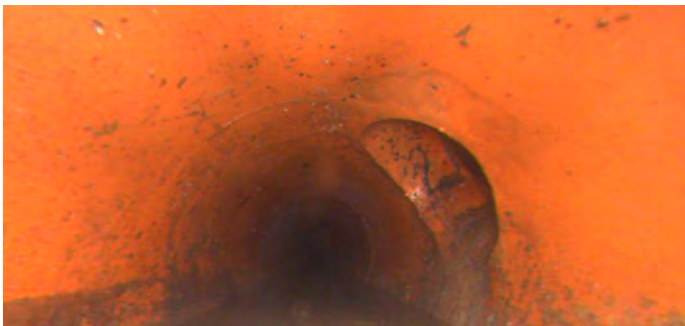
Code: **TF**
Description: **Tap Factory**

Distance (ft): **88.6**
Structural Grade: **0**
O&M Grade: **0**
Clock Start/From: **2**
Clock To:
1st Value: **4.000**
2nd Value:
Value Percent:
Continuous Index:
Within 8" of Joint:
Remarks:

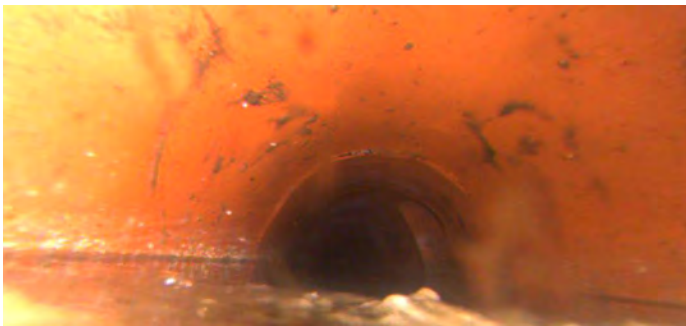
Code: **TF**
Description: **Tap Factory**

Distance (ft): **144.0**
Structural Grade: **0**
O&M Grade: **0**
Clock Start/From: **2**
Clock To:
1st Value: **4.000**
2nd Value:
Value Percent:
Continuous Index:
Within 8" of Joint:
Remarks:

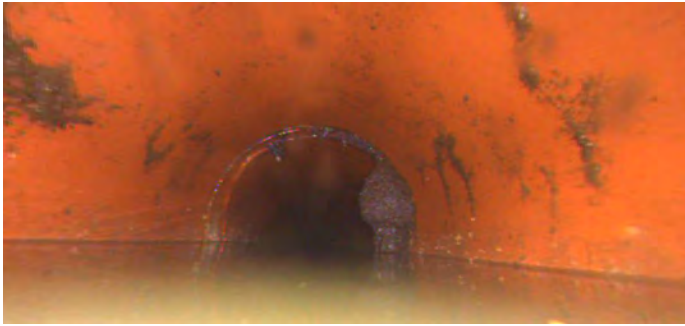
Code: **RFJ**
Description: **Roots Fine Joint**

Distance (ft): **155.7**
Structural Grade: **0**
O&M Grade: **1**
Clock Start/From: **9**
Clock To: **3**
1st Value:
2nd Value:
Value Percent:
Continuous Index:
Within 8" of Joint: **YES**
Remarks:

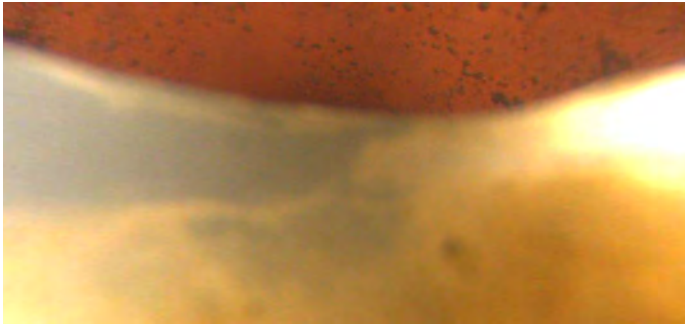
Code: **MWLS**
Description: **Water Level Sag**

Distance (ft): **167.8**
Structural Grade: **2**
O&M Grade: **3**
Clock Start/From:
Clock To:
1st Value:
2nd Value:
Value Percent: **20.000**
Continuous Index: **S01**
Within 8" of Joint: **NO**
Remarks:
