Profile/Photo Observation Report

Date:	03/28/2018	Weather:		Coding:	PACP 6.0
Pipe Length (ft):	280.1	Owner:	NA	Pre Clean:	Not Known
P.O.#:		Surveyor:	Selasie Honu	PSR:	P-303-035-034
Customer:		Clean Date:	01/01/1900	Shape:	C

Street:	OFF W 38TH AVE	Flow Control:	Not Controlled
City:	Hobart, IN	Year Renewed:	
Location:	Other	Tape/Media #:	
Purpose:	Not Known	Dia/Height:	10"
Use:	Sanitary	Material:	VCP
Drain Area:	NA	Lining:	
Category:	NA		
Comment:

Location Details:		Direction of Survey:	Upstream
US MH:	M-303-034	DS MH:	M-303-035
		Total Length Surveyed (ft):	91.0

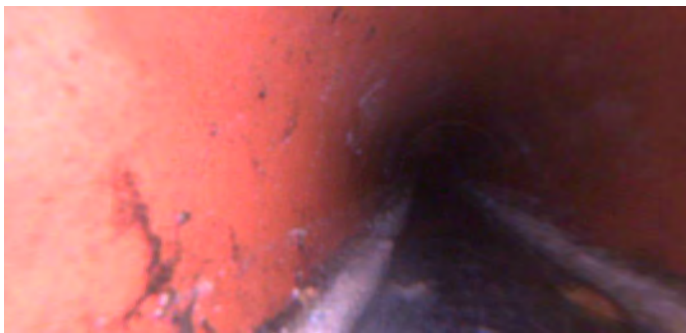
Code: **AMH**
Description: **Manhole**

Distance (ft): **.0**
Structural Grade: **0**
O&M Grade: **0**
Clock Start/From:
Clock To:
1st Value:
2nd Value:
Value Percent:
Continuous Index:
Within 8" of Joint: **NO**
Remarks: **M-303-035**

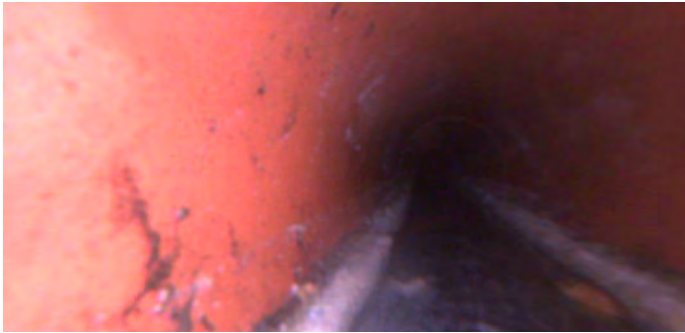
Code:	MWL
Description:	Water Level

Distance (ft):	.0
Structural Grade:	0
O&M Grade:	0
Clock Start/From:	
Clock To:	
1st Value:	
2nd Value:	
Value Percent:	5.000
Continuous Index:	
Within 8" of Joint:	NO
Remarks:

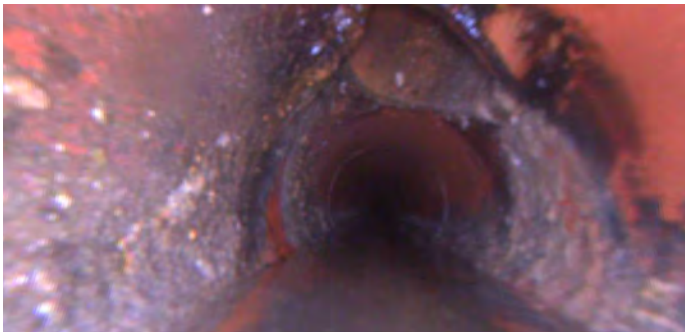
Code:	IS
Description:	Infil Stain

Distance (ft):	5.7
Structural Grade:	0
O&M Grade:	0
Clock Start/From:	7
Clock To:	5
1st Value:	
2nd Value:	
Value Percent:	
Continuous Index:	
Within 8" of Joint:	
Remarks:

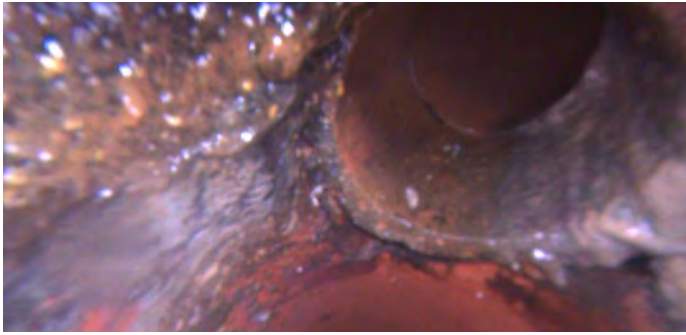
Code: **TBI**
Description: **Tap Break-in Intruding**

Distance (ft): **6.4**
Structural Grade: **0**
O&M Grade: **2**
Clock Start/From: **1**
Clock To:
1st Value: **4.000**
2nd Value: **1.000**
Value Percent:
Continuous Index:
Within 8" of Joint:
Remarks: **active**

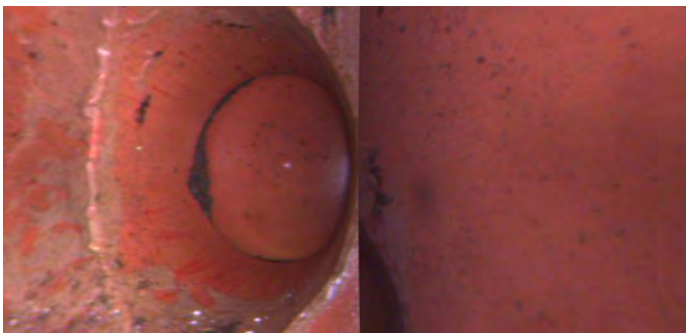
Code: **TFC**
Description: **Tap Factory Capped**

Distance (ft): **18.4**
Structural Grade: **0**
O&M Grade: **0**
Clock Start/From: **9**
Clock To:
1st Value: **4.000**
2nd Value:
Value Percent:
Continuous Index:
Within 8" of Joint:
Remarks:

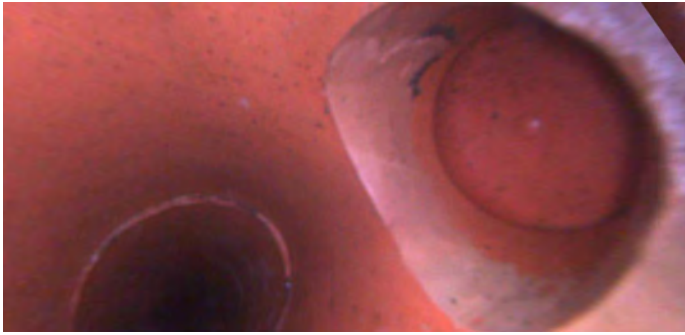
Code: **TFC**
Description: **Tap Factory Capped**

Distance (ft): **19.9**
Structural Grade: **0**
O&M Grade: **0**
Clock Start/From: **2**
Clock To:
1st Value: **4.000**
2nd Value:
Value Percent:
Continuous Index:
Within 8" of Joint:
Remarks:

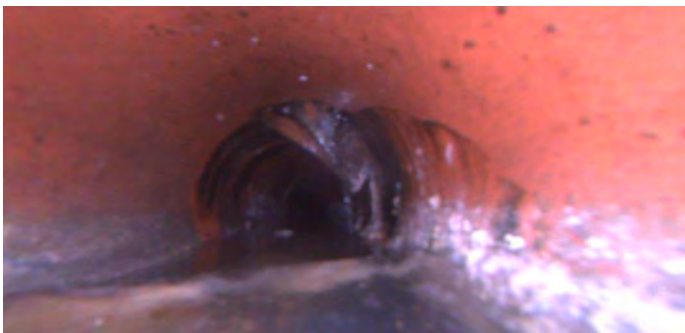
Code: **FS**
Description: **Fracture Spiral**

Distance (ft): **65.9**
Structural Grade: **3**
O&M Grade: **0**
Clock Start/From: **1**
Clock To: **3**
1st Value:
2nd Value:
Value Percent:
Continuous Index:
Within 8" of Joint:
Remarks:

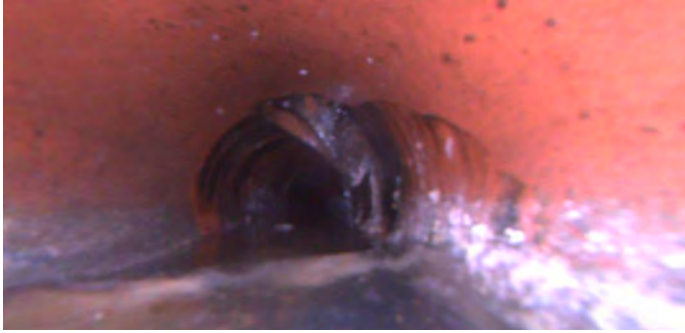
Code: **IS**
Description: **Infil Stain**

Distance (ft): **65.9**
Structural Grade: **0**
O&M Grade: **0**
Clock Start/From: **7**
Clock To: **5**
1st Value:
2nd Value:
Value Percent:
Continuous Index:
Within 8" of Joint: **NO**
Remarks:

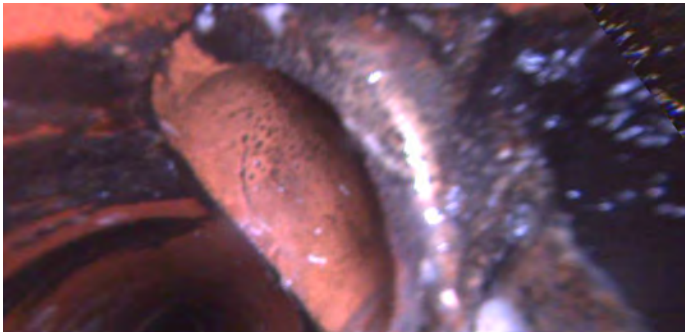
Code: **TBI**
Description: **Tap Break-in Intruding**

Distance (ft): **66.9**
Structural Grade: **0**
O&M Grade: **2**
Clock Start/From: **2**
Clock To:
1st Value: **4.000**
2nd Value: **1.000**
Value Percent:
Continuous Index:
Within 8" of Joint:
Remarks:

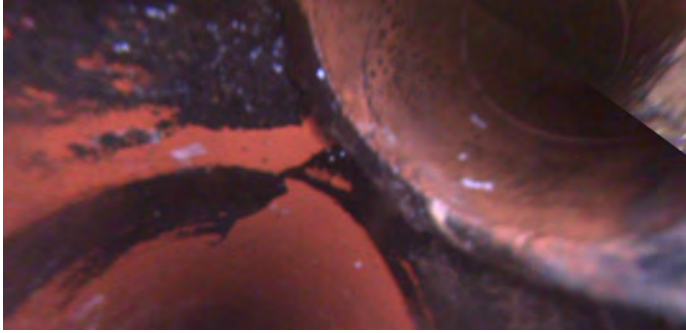
Code: **FL**
Description: **Fracture Longitudinal**

Distance (ft): **67.3**
Structural Grade: **3**
O&M Grade: **0**
Clock Start/From: **12**
Clock To:
1st Value:
2nd Value:
Value Percent:
Continuous Index:
Within 8" of Joint:
Remarks:

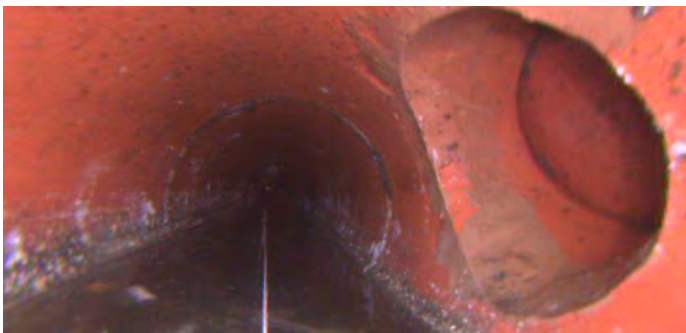
Code: **TFC**
Description: **Tap Factory Capped**

Distance (ft): **71.7**
Structural Grade: **0**
O&M Grade: **0**
Clock Start/From: **9**
Clock To:
1st Value: **4.000**
2nd Value:
Value Percent:
Continuous Index:
Within 8" of Joint: **NO**
Remarks:

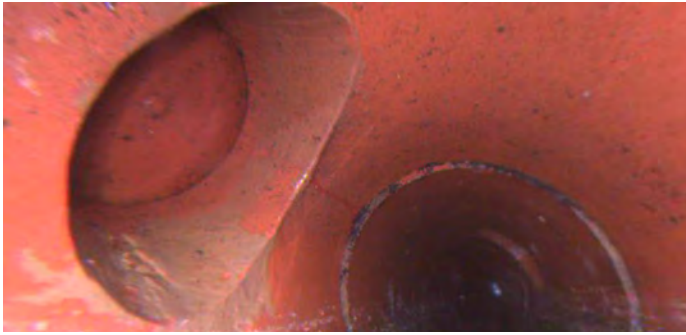
Code: **TFC**
Description: **Tap Factory Capped**

Distance (ft): **73.5**
Structural Grade: **0**
O&M Grade: **0**
Clock Start/From: **2**
Clock To:
1st Value: **4.000**
2nd Value:
Value Percent:
Continuous Index:
Within 8" of Joint:
Remarks:

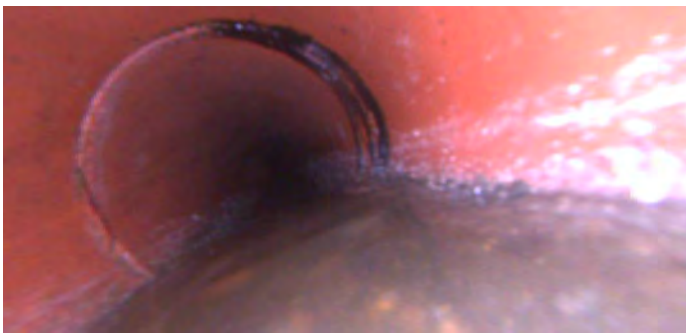
Code: **IS**
Description: **Infil Stain**

Distance (ft): **73.6**
Structural Grade: **0**
O&M Grade: **0**
Clock Start/From: **12**
Clock To: **5**
1st Value:
2nd Value:
Value Percent:
Continuous Index:
Within 8" of Joint: **YES**
Remarks:

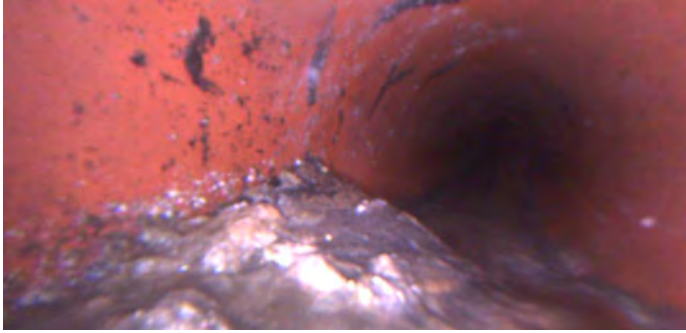
Code: **OBB**
Description: **Obstacle Brick**

Distance (ft): **89.8**
Structural Grade: **0**
O&M Grade: **3**
Clock Start/From: **6**
Clock To: **9**
1st Value:
2nd Value:
Value Percent: **20.000**
Continuous Index:
Within 8" of Joint: **NO**
Remarks:
