Profile/Photo Observation Report

Date:	03/28/2018	Weather:		Coding:	PACP 6.0
Pipe Length (ft):	280.1	Owner:	NA	Pre Clean:	Not Known
P.O.#:		Surveyor:	Selasie Honu	PSR:	P-303-035-034
Customer:		Clean Date:	01/01/1900	Shape:	C

Street:	W 38TH AVE	Flow Control:	Not Controlled
City:	Hobart, IN	Year Renewed:	
Location:	Other	Tape/Media #:	
Purpose:	Not Known	Dia/Height:	10"
Use:	Sanitary	Material:	VCP
Drain Area:	NA	Lining:	
Category:	NA		
Comment:

Location Details:		Direction of Survey:	Upstream
US MH:	M-303-034	DS MH:	M-303-035
		Total Length Surveyed (ft):	91.0

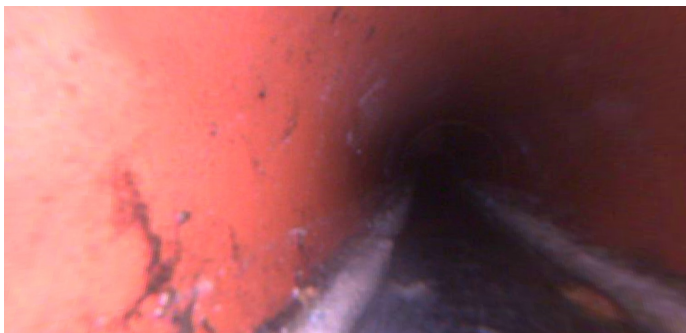
Code: **AMH**
Description: **Manhole**

Distance (ft): **.0**
Structural Grade: **0**
O&M Grade: **0**
Clock Start/From:
Clock To:
1st Value:
2nd Value:
Value Percent:
Continuous Index:
Within 8" of Joint: **NO**
Remarks: **M-303-035**

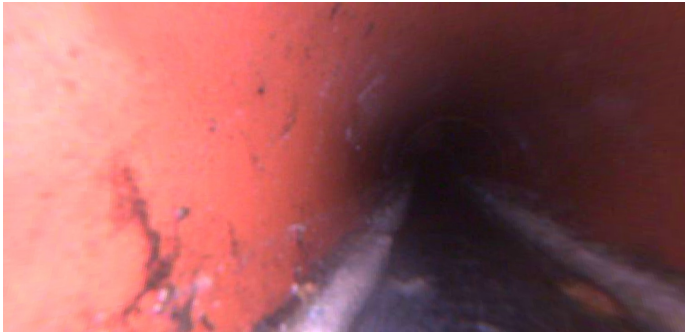
Code:	MWL
Description:	Water Level

Distance (ft):	.0
Structural Grade:	0
O&M Grade:	0
Clock Start/From:	
Clock To:	
1st Value:	
2nd Value:	
Value Percent:	5.000
Continuous Index:	
Within 8" of Joint:	NO
Remarks:

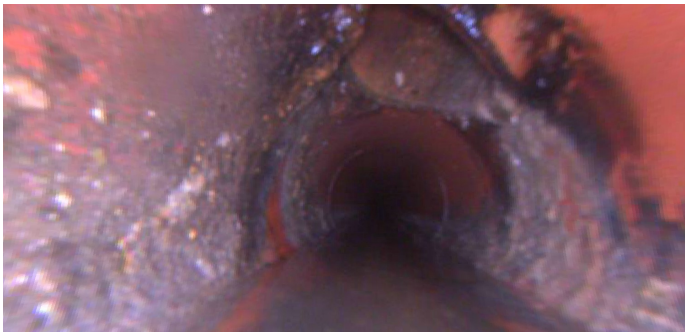
Code:	IS
Description:	Infil Stain

Distance (ft):	5.7
Structural Grade:	0
O&M Grade:	0
Clock Start/From:	7
Clock To:	5
1st Value:	
2nd Value:	
Value Percent:	
Continuous Index:	
Within 8" of Joint:	
Remarks:

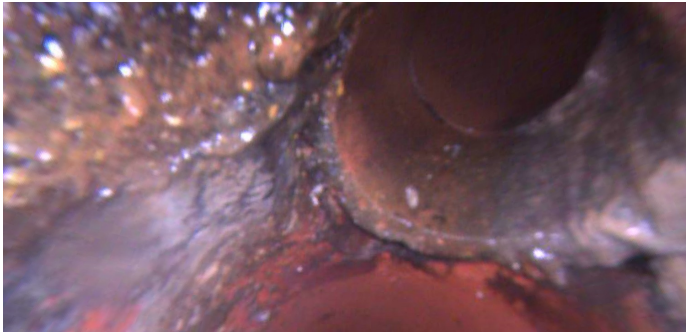
Code: **TBI**
Description: **Tap Break-in Intruding**

Distance (ft): **6.4**
Structural Grade: **0**
O&M Grade: **2**
Clock Start/From: **1**
Clock To:
1st Value: **4.000**
2nd Value: **1.000**
Value Percent:
Continuous Index:
Within 8" of Joint:
Remarks: **active**

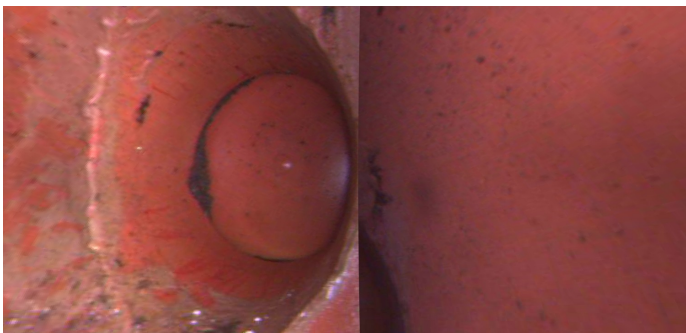
Code: **TFC**
Description: **Tap Factory Capped**

Distance (ft): **18.4**
Structural Grade: **0**
O&M Grade: **0**
Clock Start/From: **9**
Clock To:
1st Value: **4.000**
2nd Value:
Value Percent:
Continuous Index:
Within 8" of Joint:
Remarks:

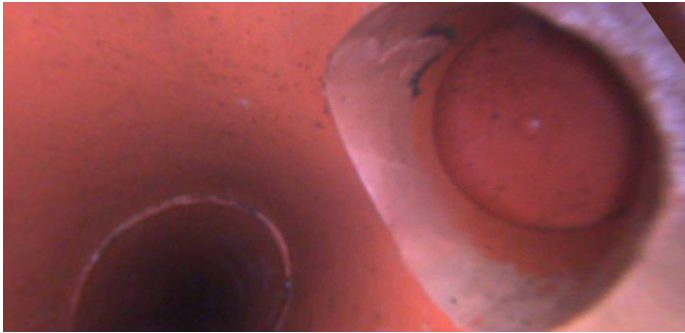
Code: **TFC**
Description: **Tap Factory Capped**

Distance (ft): **19.9**
Structural Grade: **0**
O&M Grade: **0**
Clock Start/From: **2**
Clock To:
1st Value: **4.000**
2nd Value:
Value Percent:
Continuous Index:
Within 8" of Joint:
Remarks:

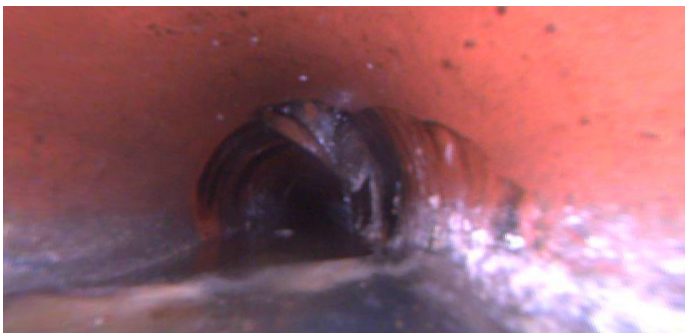
Code: **FS**
Description: **Fracture Spiral**

Distance (ft): **65.9**
Structural Grade: **3**
O&M Grade: **0**
Clock Start/From: **1**
Clock To: **3**
1st Value:
2nd Value:
Value Percent:
Continuous Index:
Within 8" of Joint:
Remarks:

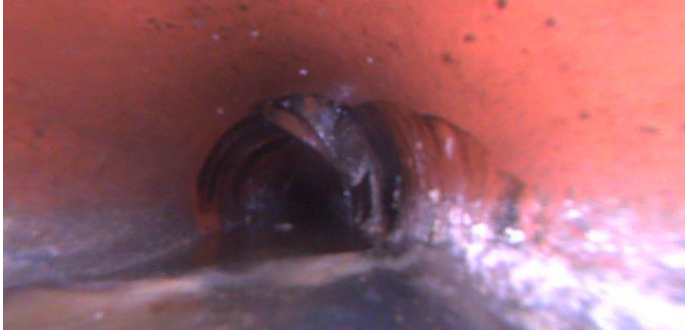
Code: **IS**
Description: **Infil Stain**

Distance (ft): **65.9**
Structural Grade: **0**
O&M Grade: **0**
Clock Start/From: **7**
Clock To: **5**
1st Value:
2nd Value:
Value Percent:
Continuous Index:
Within 8" of Joint: **NO**
Remarks:

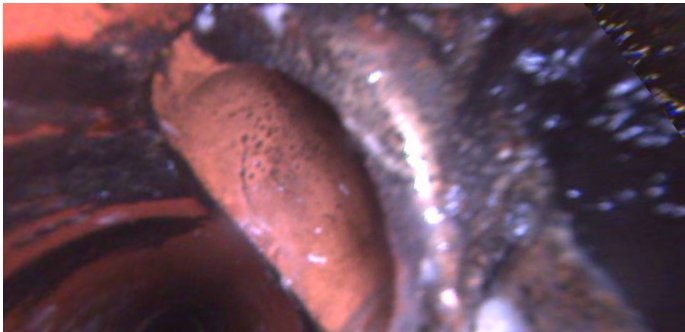
Code: **TBI**
Description: **Tap Break-in Intruding**

Distance (ft): **66.9**
Structural Grade: **0**
O&M Grade: **2**
Clock Start/From: **2**
Clock To:
1st Value: **4.000**
2nd Value: **1.000**
Value Percent:
Continuous Index:
Within 8" of Joint:
Remarks:

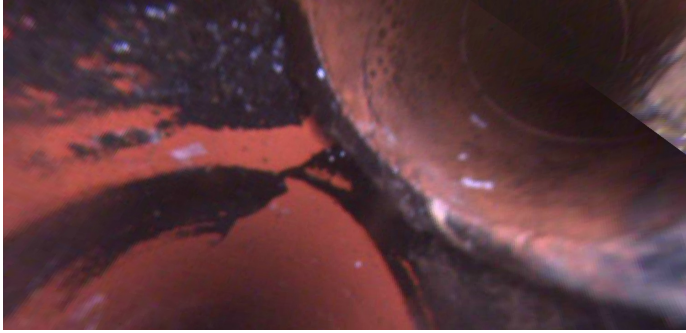
Code: **FL**
Description: **Fracture Longitudinal**

Distance (ft): **67.3**
Structural Grade: **3**
O&M Grade: **0**
Clock Start/From: **12**
Clock To:
1st Value:
2nd Value:
Value Percent:
Continuous Index:
Within 8" of Joint:
Remarks:

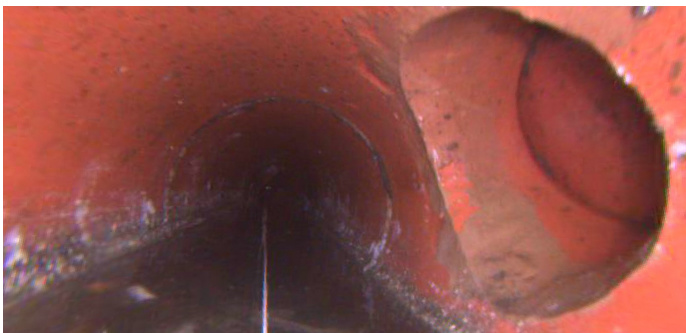
Code: **TFC**
Description: **Tap Factory Capped**

Distance (ft): **71.7**
Structural Grade: **0**
O&M Grade: **0**
Clock Start/From: **9**
Clock To:
1st Value: **4.000**
2nd Value:
Value Percent:
Continuous Index:
Within 8" of Joint: **NO**
Remarks:

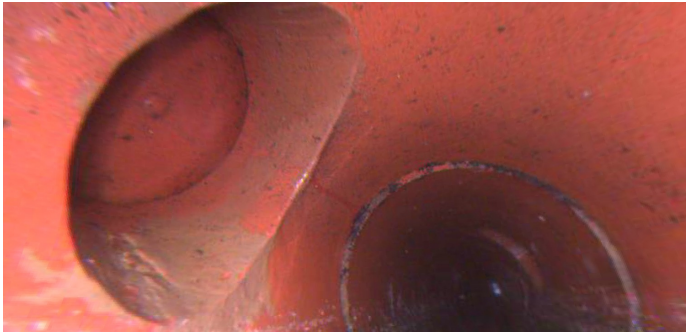
Code: **TFC**
Description: **Tap Factory Capped**

Distance (ft): **73.5**
Structural Grade: **0**
O&M Grade: **0**
Clock Start/From: **2**
Clock To:
1st Value: **4.000**
2nd Value:
Value Percent:
Continuous Index:
Within 8" of Joint:
Remarks:

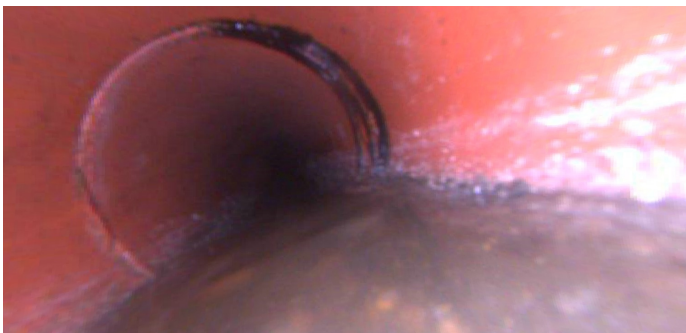
Code: **IS**
Description: **Infil Stain**

Distance (ft): **73.6**
Structural Grade: **0**
O&M Grade: **0**
Clock Start/From: **12**
Clock To: **5**
1st Value:
2nd Value:
Value Percent:
Continuous Index:
Within 8" of Joint: **YES**
Remarks:

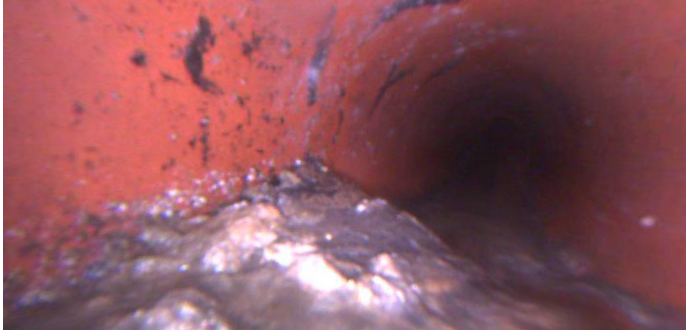
Code: **OBB**
Description: **Obstacle Brick**

Distance (ft): **89.8**
Structural Grade: **0**
O&M Grade: **3**
Clock Start/From: **6**
Clock To: **9**
1st Value:
2nd Value:
Value Percent: **20.000**
Continuous Index:
Within 8" of Joint: **NO**
Remarks:

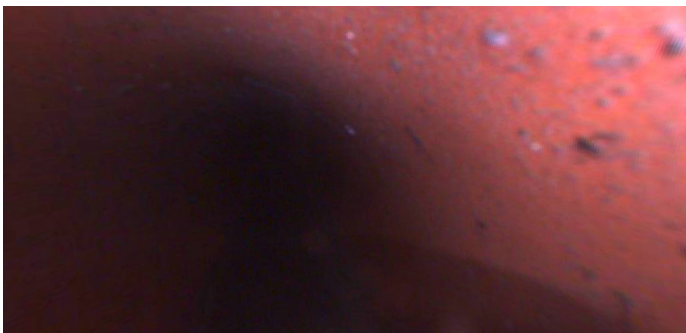
Code: **MSA**
Description: **Abandoned Survey**

Distance (ft): **91.0**
Structural Grade: **0**
O&M Grade: **0**
Clock Start/From:
Clock To:
1st Value:
2nd Value:
Value Percent:
Continuous Index:
Within 8" of Joint: **NO**
Remarks: **camera stopped**
