Profile/Photo Observation Report

Street:	OFF W 38TH AVE	Flow Control:	Not Controlled
City:	Hobart, IN	Year Renewed:	
Location:	Light Highway	Tape/Media #:	
Purpose:	Routine Assessment	Dia/Height:	10"
Use:	Sanitary	Material:	VCP
Drain Area:	NA	Lining:	
Category:	NA		
Comment:

Location Details:		Direction of Survey:	Upstream
US MH:	M-303-034	DS MH:	M-303-035
		Total Length Surveyed (ft):	70.8

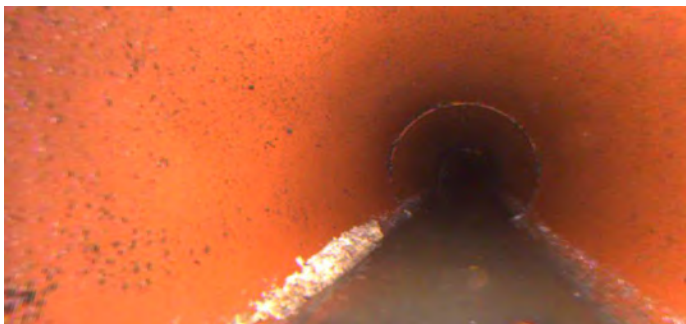
Code: **AMH**
Description: **Manhole**

Distance (ft): **.0**
Structural Grade: **0**
O&M Grade: **0**
Clock Start/From:
Clock To:
1st Value:
2nd Value:
Value Percent:
Continuous Index:
Within 8" of Joint: **NO**
Remarks: **M-303-035**

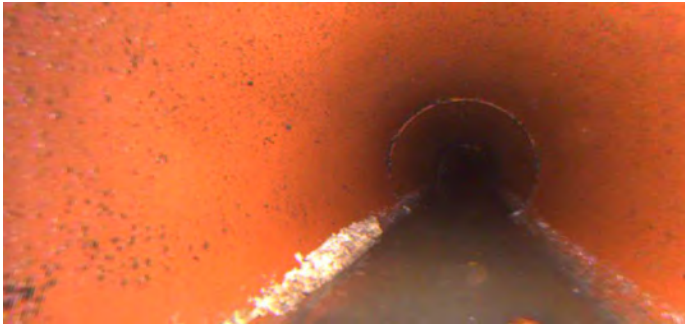
Code:	MWL
Description:	Water Level

Distance (ft):	.0
Structural Grade:	0
O&M Grade:	0
Clock Start/From:	
Clock To:	
1st Value:	
2nd Value:	
Value Percent:	5.000
Continuous Index:	
Within 8" of Joint:	NO
Remarks:

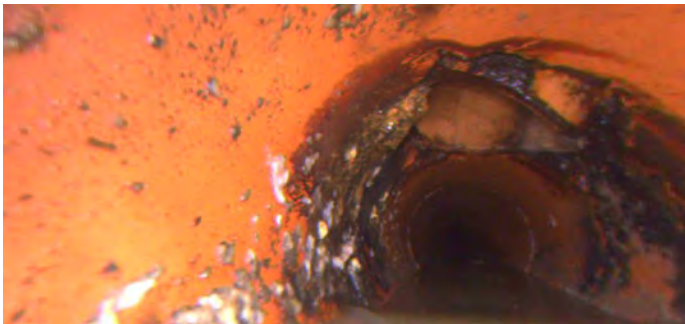
Code:	TF
Description:	Tap Factory

Distance (ft):	5.8
Structural Grade:	0
O&M Grade:	0
Clock Start/From:	12
Clock To:	
1st Value:	4.000
2nd Value:	
Value Percent:	
Continuous Index:	
Within 8" of Joint:	
Remarks:

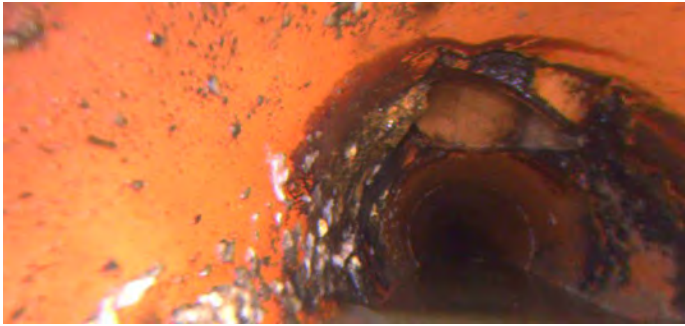
Code: **DAE**
Description: **Deposits Attached Encrustation**

Distance (ft): **5.8**
Structural Grade: **0**
O&M Grade: **3**
Clock Start/From: **8**
Clock To: **4**
1st Value:
2nd Value:
Value Percent: **20.000**
Continuous Index:
Within 8" of Joint:
Remarks:

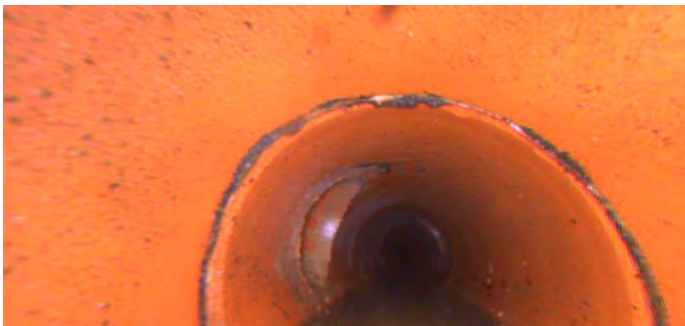
Code: **TF**
Description: **Tap Factory**

Distance (ft): **17.4**
Structural Grade: **0**
O&M Grade: **0**
Clock Start/From: **9**
Clock To:
1st Value: **4.000**
2nd Value:
Value Percent:
Continuous Index:
Within 8" of Joint:
Remarks:

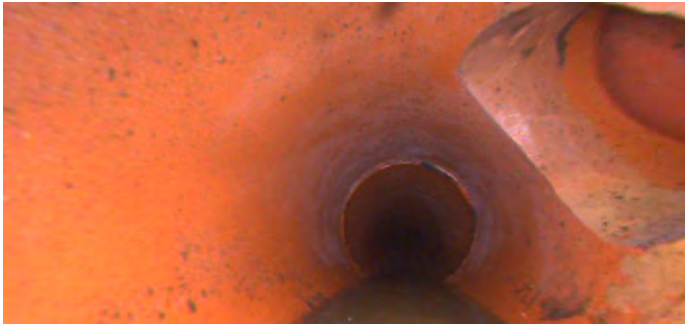
Code: **TF**
Description: **Tap Factory**

Distance (ft): **20.2**
Structural Grade: **0**
O&M Grade: **0**
Clock Start/From: **2**
Clock To:
1st Value: **4.000**
2nd Value:
Value Percent:
Continuous Index:
Within 8" of Joint:
Remarks:

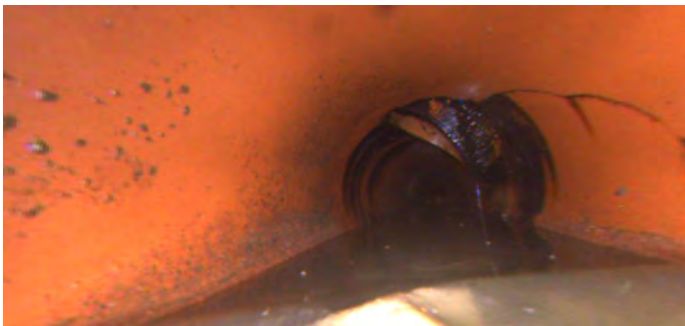
Code: **DAE**
Description: **Deposits Attached Encrustation**

Distance (ft): **67.7**
Structural Grade: **0**
O&M Grade: **3**
Clock Start/From: **8**
Clock To: **4**
1st Value:
2nd Value:
Value Percent: **20.000**
Continuous Index:
Within 8" of Joint: **NO**
Remarks:

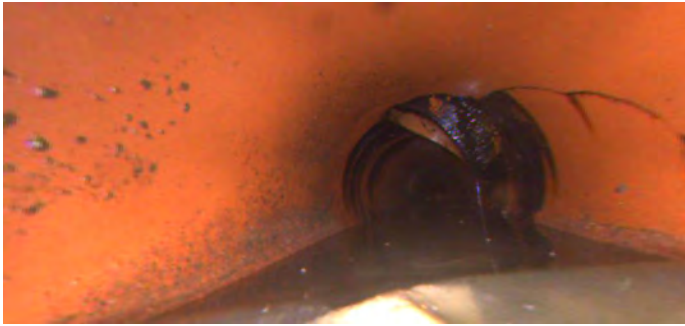
Code: **FC**
Description: **Fracture Circumferential**

Distance (ft): **67.7**
Structural Grade: **2**
O&M Grade: **0**
Clock Start/From: **1**
Clock To: **4**
1st Value:
2nd Value:
Value Percent:
Continuous Index:
Within 8" of Joint:
Remarks:

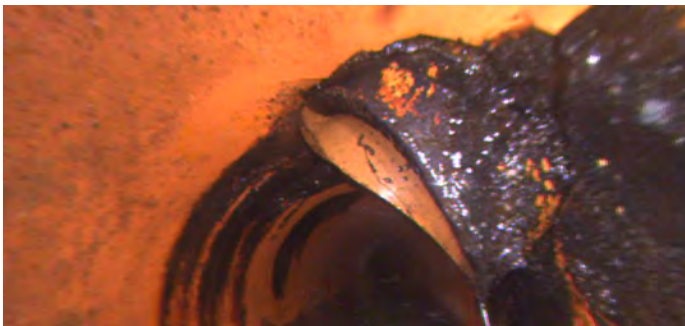
Code: **TFB**
Description: **Tap Factory Abandoned**

Distance (ft): **68.6**
Structural Grade: **0**
O&M Grade: **0**
Clock Start/From: **1**
Clock To:
1st Value: **4.000**
2nd Value:
Value Percent:
Continuous Index:
Within 8" of Joint:
Remarks:

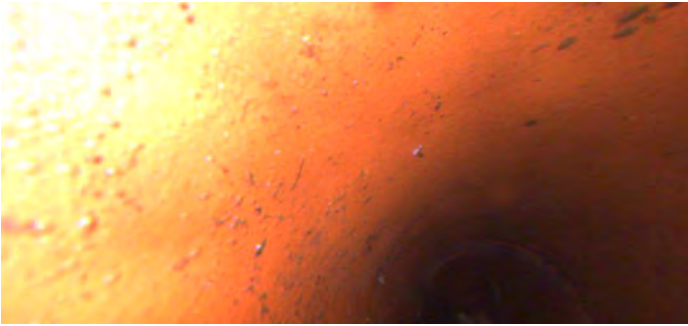
Code:	MSA
Description:	Abandoned Survey
Distance (ft):	70.8
Structural Grade:	0
O&M Grade:	0
Clock Start/From:	
Clock To:	
1st Value:	
2nd Value:	
Value Percent:	
Continuous Index:	
Within 8" of Joint:	NO
Remarks:	camera stopped
