Profile/Photo Observation Report

Date:	09/25/2018	Weather:		Coding:	PACP 6.0
Pipe Length (ft):	280.1	Owner:	NA	Pre Clean:	Not Known
P.O.#:		Surveyor:	Selasie Honu	PSR:	P-303-035-034
Customer:		Clean Date:	01/01/1900	Shape:	C

Street:	38th. Ave.	Flow Control:	Not Controlled
City:	Hobart, IN	Year Renewed:	
Location:	Light Highway	Tape/Media #:	
Purpose:	Routine Assessment	Dia/Height:	10"
Use:	Sanitary	Material:	VCP
Drain Area:	NA	Lining:	
Category:	NA		
Comment:

Location Details:		Direction of Survey:	Upstream
US MH:	M-303-034	DS MH:	M-303-035
		Total Length Surveyed (ft):	70.8

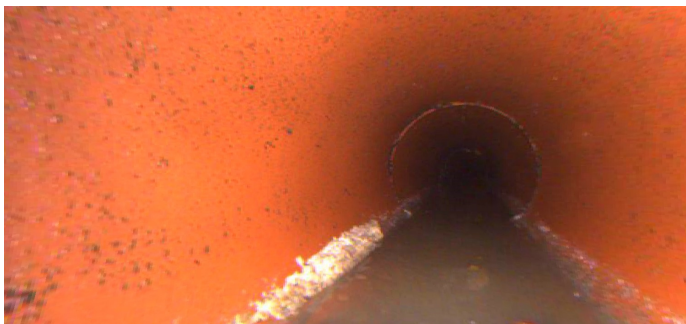
Code: **AMH**
Description: **Manhole**

Distance (ft): **.0**
Structural Grade: **0**
O&M Grade: **0**
Clock Start/From:
Clock To:
1st Value:
2nd Value:
Value Percent:
Continuous Index:
Within 8" of Joint: **NO**
Remarks: **M-303-035**

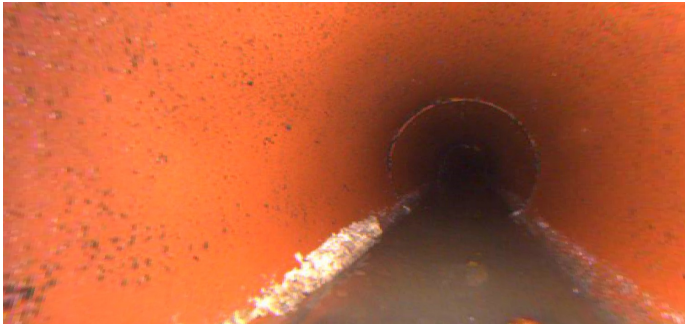
Code:	MWL
Description:	Water Level

Distance (ft):	.0
Structural Grade:	0
O&M Grade:	0
Clock Start/From:	
Clock To:	
1st Value:	
2nd Value:	
Value Percent:	5.000
Continuous Index:	
Within 8" of Joint:	NO
Remarks:

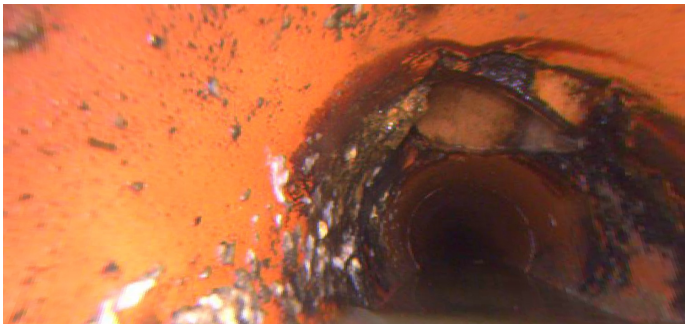
Code:	TF
Description:	Tap Factory

Distance (ft):	5.8
Structural Grade:	0
O&M Grade:	0
Clock Start/From:	12
Clock To:	
1st Value:	4.000
2nd Value:	
Value Percent:	
Continuous Index:	
Within 8" of Joint:	
Remarks:

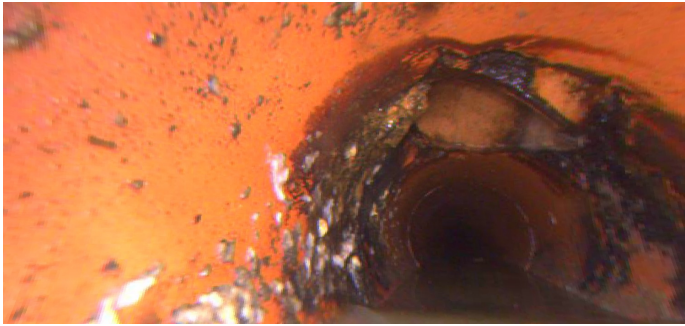
Code: **DAE**
Description: **Deposits Attached Encrustation**

Distance (ft): **5.8**
Structural Grade: **0**
O&M Grade: **3**
Clock Start/From: **8**
Clock To: **4**
1st Value:
2nd Value:
Value Percent: **20.000**
Continuous Index:
Within 8" of Joint:
Remarks:

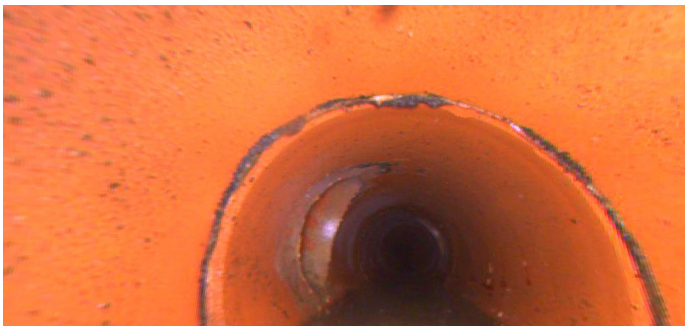
Code: **TF**
Description: **Tap Factory**

Distance (ft): **17.4**
Structural Grade: **0**
O&M Grade: **0**
Clock Start/From: **9**
Clock To:
1st Value: **4.000**
2nd Value:
Value Percent:
Continuous Index:
Within 8" of Joint:
Remarks:

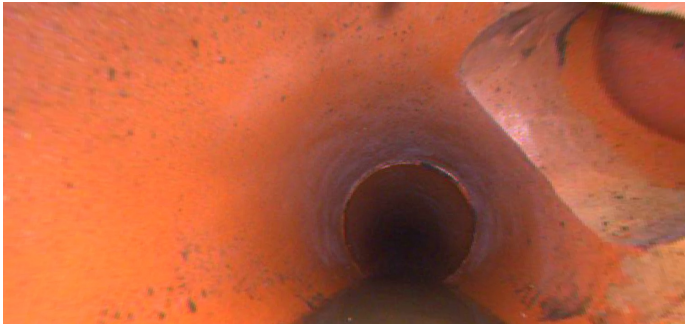
Code: **TF**
Description: **Tap Factory**

Distance (ft): **20.2**
Structural Grade: **0**
O&M Grade: **0**
Clock Start/From: **2**
Clock To:
1st Value: **4.000**
2nd Value:
Value Percent:
Continuous Index:
Within 8" of Joint:
Remarks:

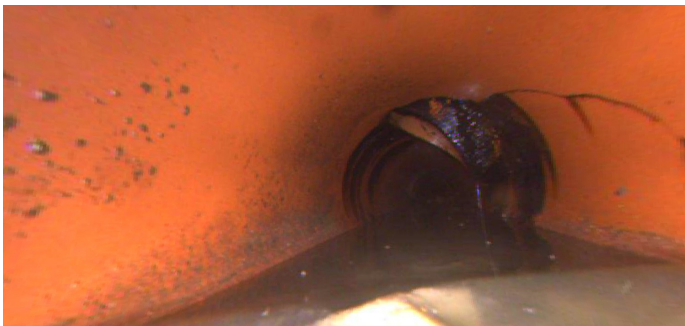
Code: **DAE**
Description: **Deposits Attached Encrustation**

Distance (ft): **67.7**
Structural Grade: **0**
O&M Grade: **3**
Clock Start/From: **8**
Clock To: **4**
1st Value:
2nd Value:
Value Percent: **20.000**
Continuous Index:
Within 8" of Joint: **NO**
Remarks:

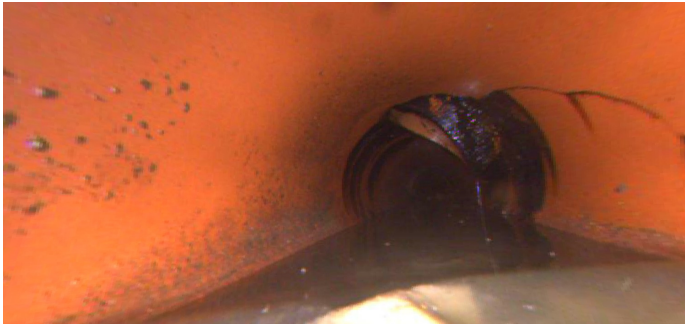
Code: **FC**
Description: **Fracture Circumferential**

Distance (ft): **67.7**
Structural Grade: **2**
O&M Grade: **0**
Clock Start/From: **1**
Clock To: **4**
1st Value:
2nd Value:
Value Percent:
Continuous Index:
Within 8" of Joint:
Remarks:

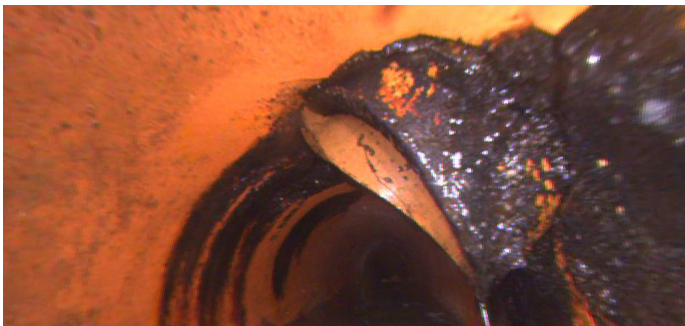
Code: **TFB**
Description: **Tap Factory Abandoned**

Distance (ft): **68.6**
Structural Grade: **0**
O&M Grade: **0**
Clock Start/From: **1**
Clock To:
1st Value: **4.000**
2nd Value:
Value Percent:
Continuous Index:
Within 8" of Joint:
Remarks:

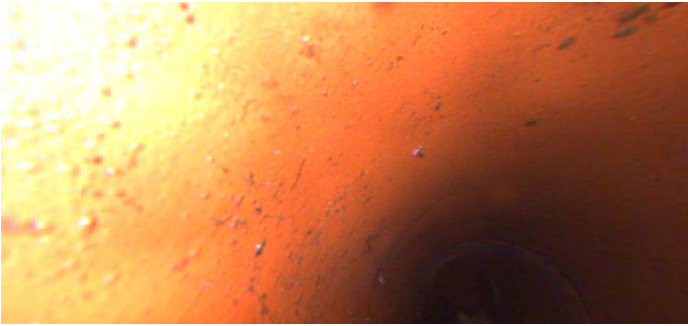
Code:	MSA
Description:	Abandoned Survey
Distance (ft):	70.8
Structural Grade:	0
O&M Grade:	0
Clock Start/From:	
Clock To:	
1st Value:	
2nd Value:	
Value Percent:	
Continuous Index:	
Within 8" of Joint:	NO
Remarks:	camera stopped
