Profile/Photo Observation Report

Street:	38th. Ave.	Flow Control:	Not Controlled
City:	Hobart, IN	Year Renewed:	
Location:	Light Highway	Tape/Media #:	
Purpose:	Routine Assessment	Dia/Height:	10"
Use:	Sanitary	Material:	VCP
Drain Area:	NA	Lining:	
Category:	NA		
Comment:

Location Details:		Direction of Survey:	Downstream
US MH:	M-303-034	DS MH:	M-303-035
		Total Length Surveyed (ft):	4.6

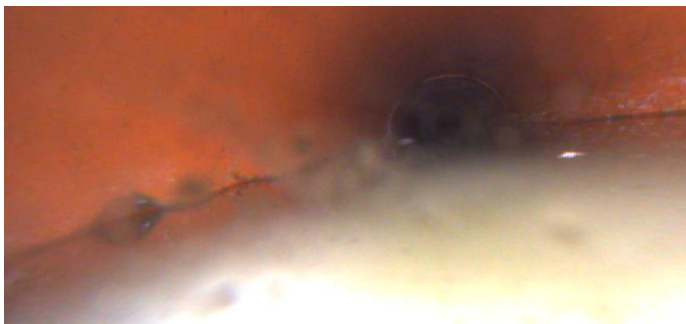
Code: **AMH**
Description: **Manhole**

Distance (ft): **.0**
Structural Grade: **0**
O&M Grade: **0**
Clock Start/From:
Clock To:
1st Value:
2nd Value:
Value Percent:
Continuous Index:
Within 8" of Joint: **NO**
Remarks: **M-303-034**

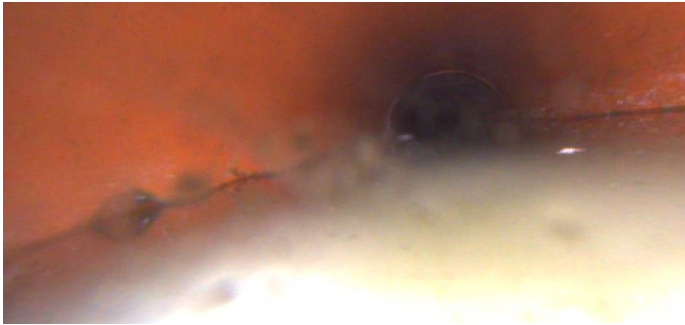
Code:	MWL
Description:	Water Level

Distance (ft):	.0
Structural Grade:	0
O&M Grade:	0
Clock Start/From:	
Clock To:	
1st Value:	
2nd Value:	
Value Percent:	5.000
Continuous Index:	
Within 8" of Joint:	NO
Remarks:

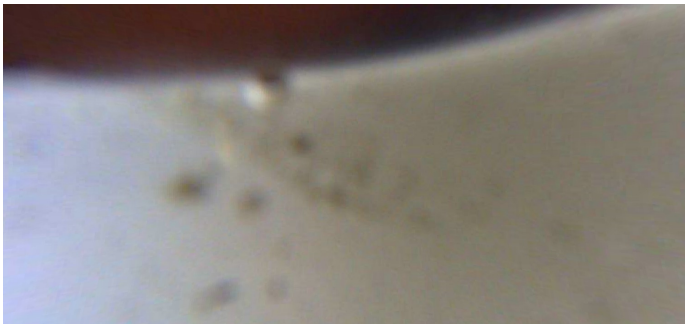
Code:	MWLS
Description:	Water Level Sag

Distance (ft):	1.8
Structural Grade:	2
O&M Grade:	3
Clock Start/From:	
Clock To:	
1st Value:	
2nd Value:	
Value Percent:	10.000
Continuous Index:	
Within 8" of Joint:	NO
Remarks:
