Profile/Photo Observation Report

Street:	OFF W 38TH AVE	Flow Control:	Not Controlled
City:	Hobart, IN	Year Renewed:	
Location:	Other	Tape/Media #:	
Purpose:	Not Known	Dia/Height:	10"
Use:	Sanitary	Material:	VCP
Drain Area:	NA	Lining:	
Category:	NA		
Comment:

Location Details:		Direction of Survey:	Downstream
US MH:	M-303-035	DS MH:	M-303-036
		Total Length Surveyed (ft):	158.7

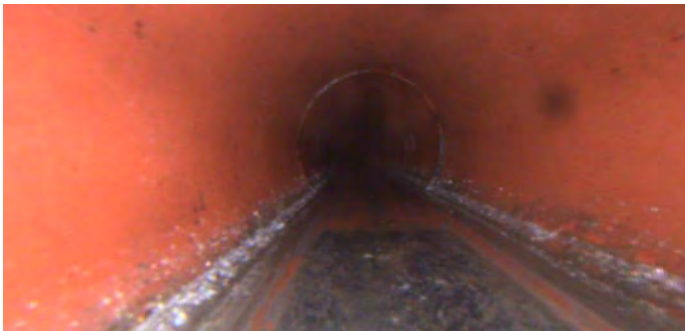
Code: **AMH**
Description: **Manhole**

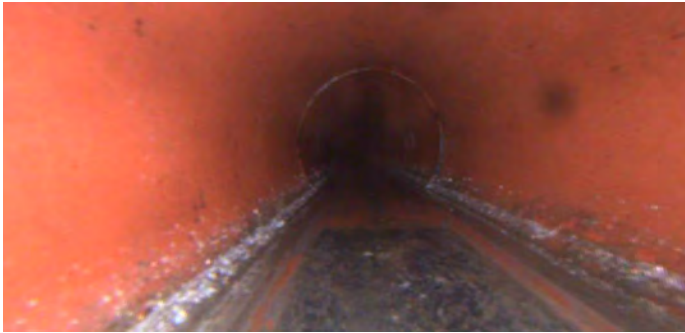
Code:	MWL
Description:	Water Level

Distance (ft):	.0
Structural Grade:	0
O&M Grade:	0
Clock Start/From:	
Clock To:	
1st Value:	
2nd Value:	
Value Percent:	5.000
Continuous Index:	
Within 8" of Joint:	NO
Remarks:

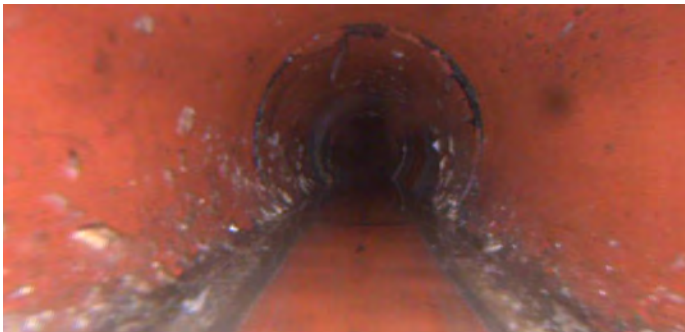
Code:	RFJ
Description:	Roots Fine Joint

Distance (ft):	36.9
Structural Grade:	0
O&M Grade:	1
Clock Start/From:	12
Clock To:	3
1st Value:	
2nd Value:	
Value Percent:	
Continuous Index:	
Within 8" of Joint:	YES
Remarks:

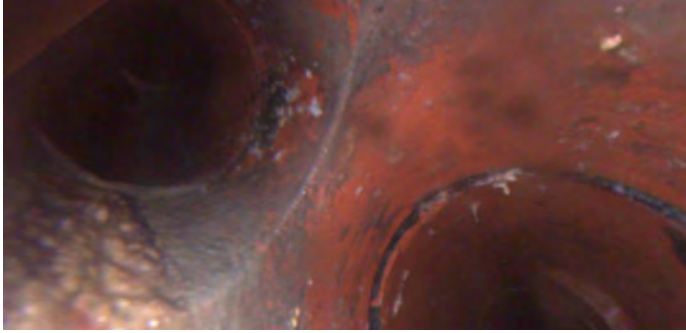
Code: **TF**
Description: **Tap Factory**

Distance (ft): **38.9**
Structural Grade: **0**
O&M Grade: **0**
Clock Start/From: **10**
Clock To:
1st Value: **4.000**
2nd Value:
Value Percent:
Continuous Index:
Within 8" of Joint:
Remarks:

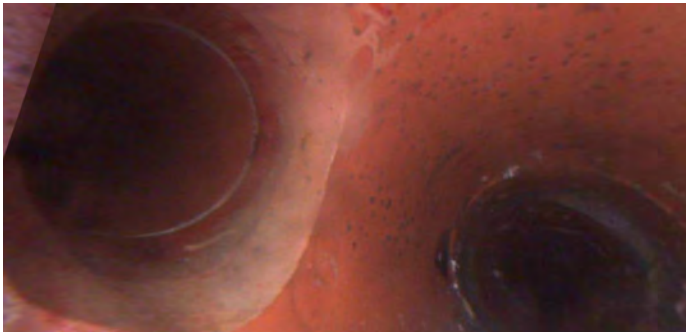
Code: **TF**
Description: **Tap Factory**

Distance (ft): **41.3**
Structural Grade: **0**
O&M Grade: **0**
Clock Start/From: **2**
Clock To:
1st Value: **4.000**
2nd Value:
Value Percent:
Continuous Index:
Within 8" of Joint:
Remarks:

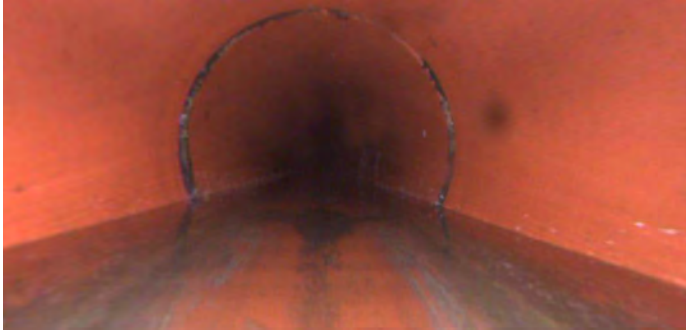
Code: **MWL**
Description: **Water Level**

Distance (ft): **51.0**
Structural Grade: **0**
O&M Grade: **0**
Clock Start/From:
Clock To:
1st Value:
2nd Value:
Value Percent: **30.000**
Continuous Index:
Within 8" of Joint: **NO**
Remarks:

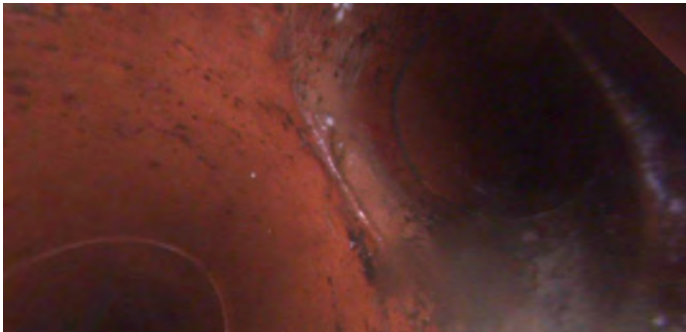
Code: **TF**
Description: **Tap Factory**

Distance (ft): **98.6**
Structural Grade: **0**
O&M Grade: **0**
Clock Start/From: **10**
Clock To:
1st Value: **4.000**
2nd Value:
Value Percent:
Continuous Index:
Within 8" of Joint:
Remarks:

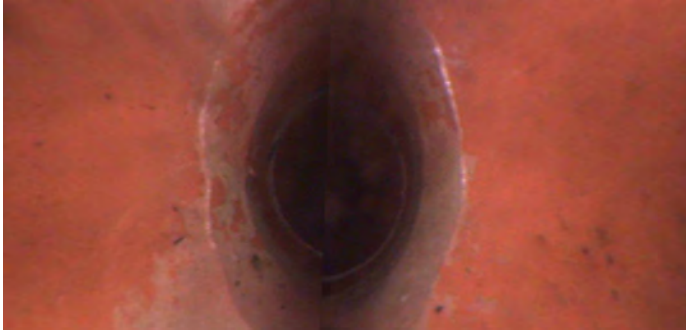
Code: **TF**
Description: **Tap Factory**

Distance (ft): **100.3**
Structural Grade: **0**
O&M Grade: **0**
Clock Start/From: **2**
Clock To:
1st Value: **4.000**
2nd Value:
Value Percent:
Continuous Index:
Within 8" of Joint:
Remarks:

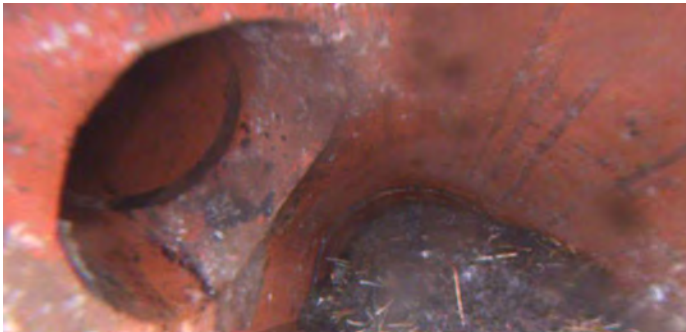
Code: **TF**
Description: **Tap Factory**

Distance (ft): **157.3**
Structural Grade: **0**
O&M Grade: **0**
Clock Start/From: **10**
Clock To:
1st Value: **4.000**
2nd Value:
Value Percent:
Continuous Index:
Within 8" of Joint:
Remarks:

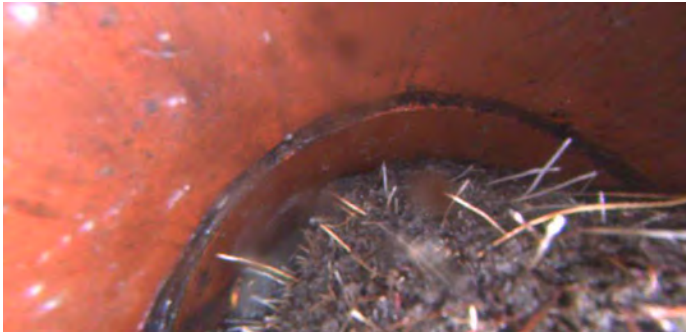
Code: **RBJ**
Description: **Roots Ball Joint**

Distance (ft): **158.7**
Structural Grade: **0**
O&M Grade: **4**
Clock Start/From: **12**
Clock To: **12**
1st Value:
2nd Value:
Value Percent: **90.000**
Continuous Index:
Within 8" of Joint: **YES**
Remarks:

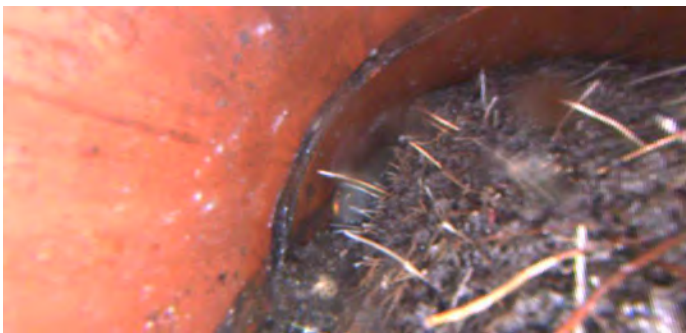
Code: **MSA**
Description: **Abandoned Survey**

Distance (ft): **158.7**
Structural Grade: **0**
O&M Grade: **0**
Clock Start/From:
Clock To:
1st Value:
2nd Value:
Value Percent:
Continuous Index:
Within 8" of Joint: **NO**
Remarks: **root ball infiltration**
