Profile/Photo Observation Report

Date:	03/28/2018	Weather:		Coding:	PACP 6.0
Pipe Length (ft):	240.6	Owner:	NA	Pre Clean:	Not Known
P.O.#:		Surveyor:	Selasie Honu	PSR:	P-303-036-035
Customer:		Clean Date:	01/01/1900	Shape:	C

Street:	W 38TH AVE	Flow Control:	Not Controlled
City:	Hobart, IN	Year Renewed:	
Location:	Other	Tape/Media #:	
Purpose:	Not Known	Dia/Height:	10"
Use:	Sanitary	Material:	VCP
Drain Area:	NA	Lining:	
Category:	NA		
Comment:

Location Details:		Direction of Survey:	Downstream
US MH:	M-303-035	DS MH:	M-303-036
		Total Length Surveyed (ft):	158.7

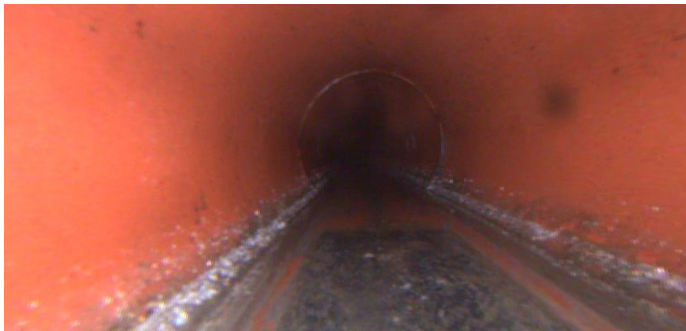
Code: **AMH**
Description: **Manhole**

Distance (ft): **.0**
Structural Grade: **0**
O&M Grade: **0**
Clock Start/From:
Clock To:
1st Value:
2nd Value:
Value Percent:
Continuous Index:
Within 8" of Joint: **NO**
Remarks: **M-303-035**

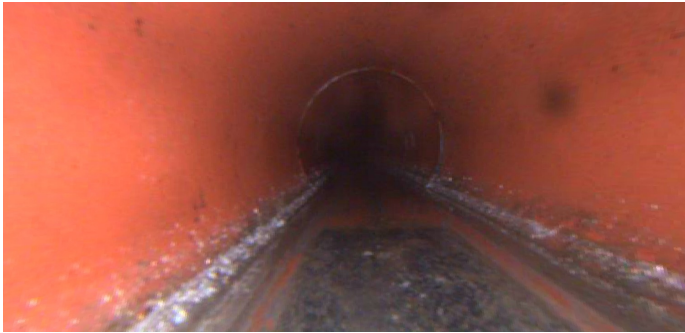
Code:	MWL
Description:	Water Level

Distance (ft):	.0
Structural Grade:	0
O&M Grade:	0
Clock Start/From:	
Clock To:	
1st Value:	
2nd Value:	
Value Percent:	5.000
Continuous Index:	
Within 8" of Joint:	NO
Remarks:

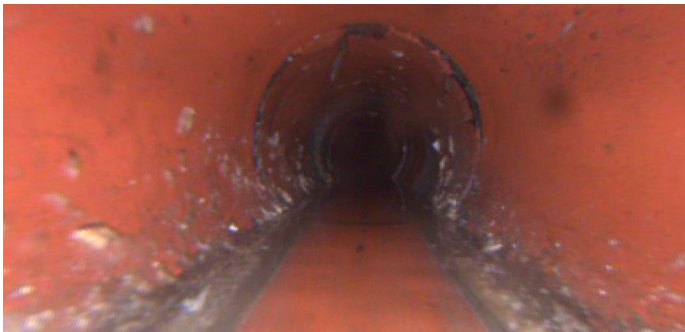
Code:	RFJ
Description:	Roots Fine Joint

Distance (ft):	36.9
Structural Grade:	0
O&M Grade:	1
Clock Start/From:	12
Clock To:	3
1st Value:	
2nd Value:	
Value Percent:	
Continuous Index:	
Within 8" of Joint:	YES
Remarks:

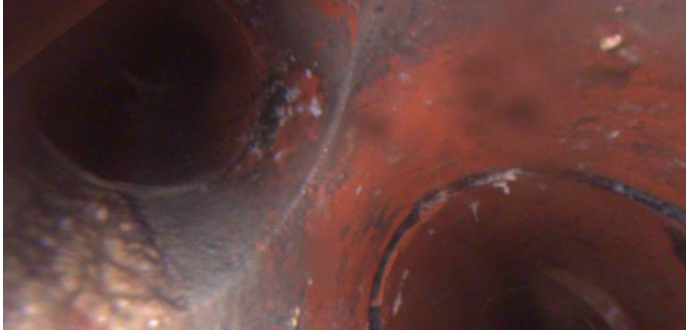
Code: **TF**
Description: **Tap Factory**

Distance (ft): **38.9**
Structural Grade: **0**
O&M Grade: **0**
Clock Start/From: **10**
Clock To:
1st Value: **4.000**
2nd Value:
Value Percent:
Continuous Index:
Within 8" of Joint:
Remarks:

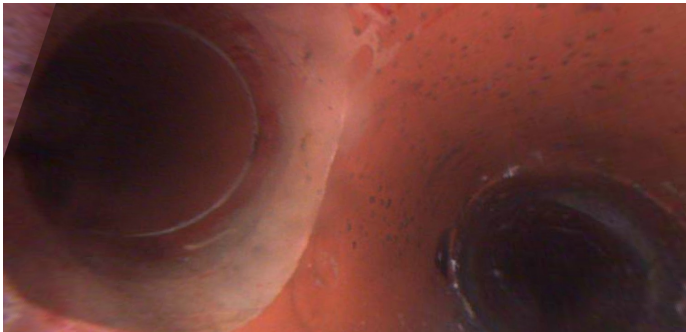
Code: **TF**
Description: **Tap Factory**

Distance (ft): **41.3**
Structural Grade: **0**
O&M Grade: **0**
Clock Start/From: **2**
Clock To:
1st Value: **4.000**
2nd Value:
Value Percent:
Continuous Index:
Within 8" of Joint:
Remarks:

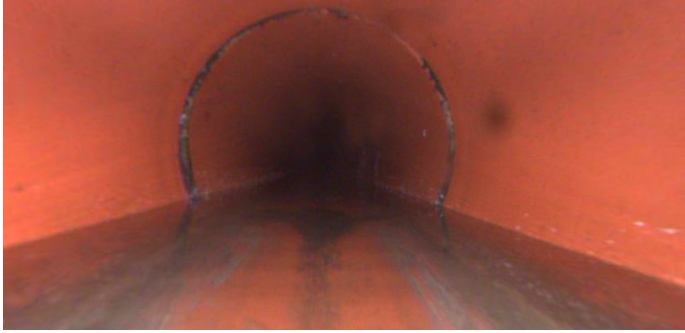
Code: **MWL**
Description: **Water Level**

Distance (ft): **51.0**
Structural Grade: **0**
O&M Grade: **0**
Clock Start/From:
Clock To:
1st Value:
2nd Value:
Value Percent: **30.000**
Continuous Index:
Within 8" of Joint: **NO**
Remarks:

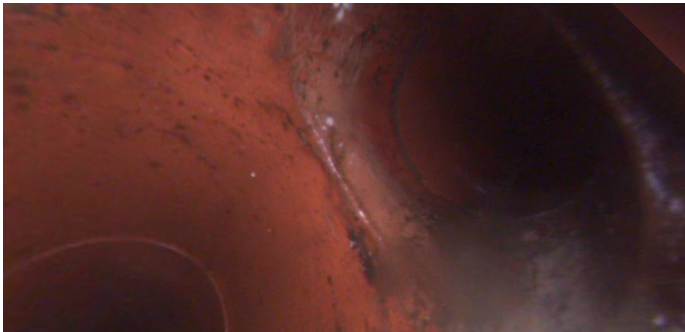
Code: **TF**
Description: **Tap Factory**

Distance (ft): **98.6**
Structural Grade: **0**
O&M Grade: **0**
Clock Start/From: **10**
Clock To:
1st Value: **4.000**
2nd Value:
Value Percent:
Continuous Index:
Within 8" of Joint:
Remarks:

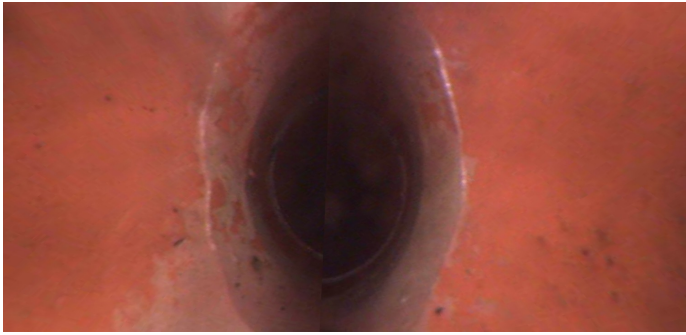
Code: **TF**
Description: **Tap Factory**

Distance (ft): **100.3**
Structural Grade: **0**
O&M Grade: **0**
Clock Start/From: **2**
Clock To:
1st Value: **4.000**
2nd Value:
Value Percent:
Continuous Index:
Within 8" of Joint:
Remarks:

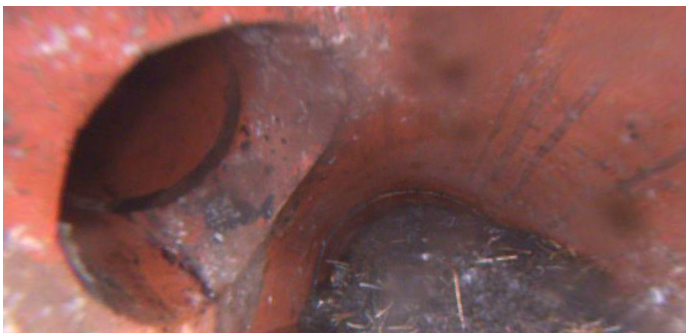
Code: **TF**
Description: **Tap Factory**

Distance (ft): **157.3**
Structural Grade: **0**
O&M Grade: **0**
Clock Start/From: **10**
Clock To:
1st Value: **4.000**
2nd Value:
Value Percent:
Continuous Index:
Within 8" of Joint:
Remarks:

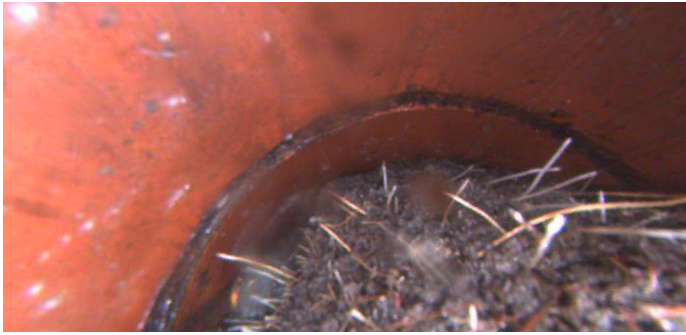
Code: **RBJ**
Description: **Roots Ball Joint**

Distance (ft): **158.7**
Structural Grade: **0**
O&M Grade: **4**
Clock Start/From: **12**
Clock To: **12**
1st Value:
2nd Value:
Value Percent: **90.000**
Continuous Index:
Within 8" of Joint: **YES**
Remarks:

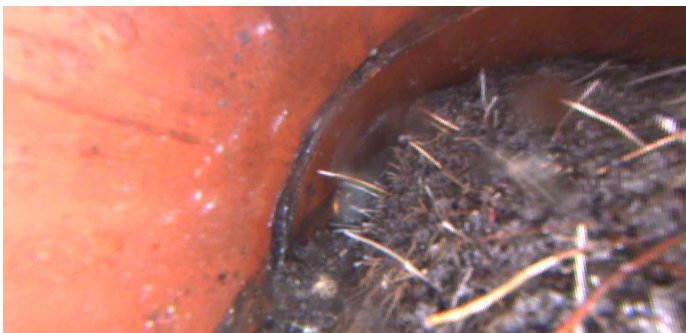
Code: **MSA**
Description: **Abandoned Survey**

Distance (ft): **158.7**
Structural Grade: **0**
O&M Grade: **0**
Clock Start/From:
Clock To:
1st Value:
2nd Value:
Value Percent:
Continuous Index:
Within 8" of Joint: **NO**
Remarks: **root ball infiltration**
