## Profile/Photo Observation Report

Street:	<b>ROCHE ST</b>	Flow Control:	<b>Not Controlled</b>
City:	<b>Hobart, IN</b>	Year Renewed:	
Location:	<b>Other</b>	Tape/Media #:	
Purpose:	<b>Not Known</b>	Dia/Height:	<b>10"</b>
Use:	<b>Sanitary</b>	Material:	<b>VCP</b>
Drain Area:	<b>NA</b>	Lining:	
Category:	<b>NA</b>		
Comment:

Location Details:		Direction of Survey:	<b>Downstream</b>
US MH:	<b>M-303-039</b>	DS MH:	<b>M-303-038</b>
		Total Length Surveyed (ft):	<b>8.7</b>

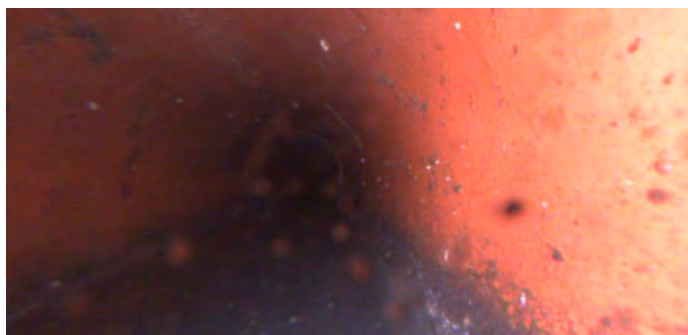
Code: **AMH**  
Description: **Manhole**

Distance (ft): **.0**  
Structural Grade: **0**  
O&M Grade: **0**  
Clock Start/From:  
Clock To:  
1st Value:  
2nd Value:  
Value Percent:  
Continuous Index:  
Within 8" of Joint: **NO**  
Remarks: **M-303-039**

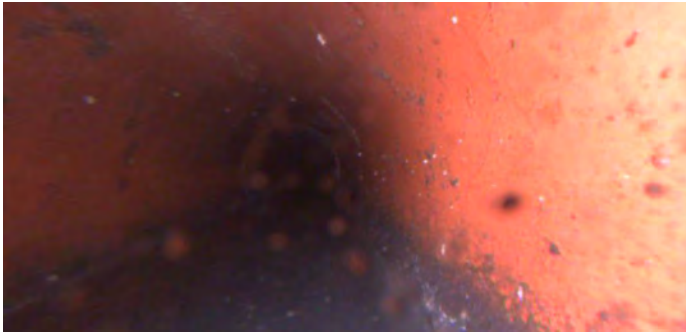
Code:	<b>MWL</b>
Description:	<b>Water Level</b>

Distance (ft):	<b>.0</b>
Structural Grade:	<b>0</b>
O&M Grade:	<b>0</b>
Clock Start/From:	
Clock To:	
1st Value:	
2nd Value:	
Value Percent:	<b>20.000</b>
Continuous Index:	
Within 8" of Joint:	<b>NO</b>
Remarks:

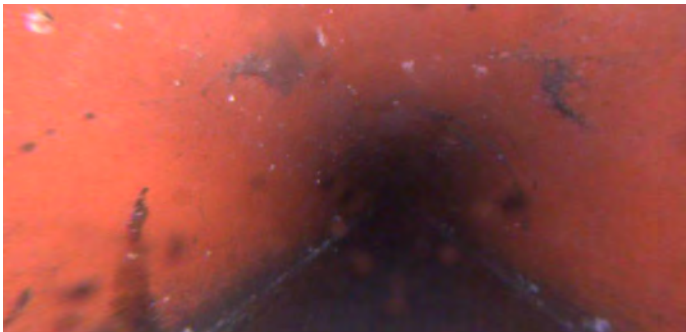
Code:	<b>MSA</b>
Description:	<b>Abandoned Survey</b>

Distance (ft):	<b>8.7</b>
Structural Grade:	<b>0</b>
O&M Grade:	<b>0</b>
Clock Start/From:	
Clock To:	
1st Value:	
2nd Value:	
Value Percent:	
Continuous Index:	
Within 8" of Joint:	<b>NO</b>
Remarks:	<b>DEBRIS UNDER WATER</b>
