Profile/Photo Observation Report

Street:	ROCHE ST	Flow Control:	Not Controlled
City:	Hobart, IN	Year Renewed:	
Location:	Other	Tape/Media #:	
Purpose:	Not Known	Dia/Height:	10"
Use:	Sanitary	Material:	VCP
Drain Area:	NA	Lining:	
Category:	NA		
Comment:

Location Details:		Direction of Survey:	Downstream
US MH:	M-303-039	DS MH:	M-303-038
		Total Length Surveyed (ft):	8.7

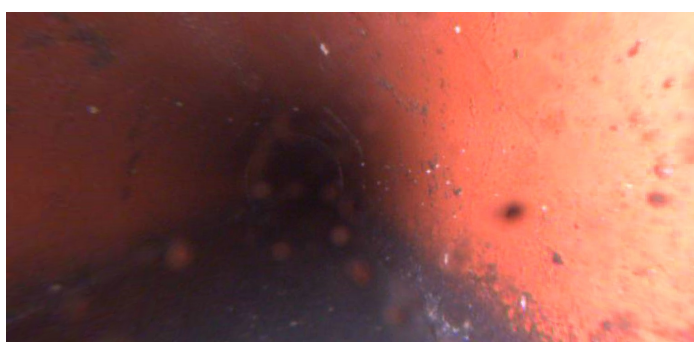
Code: **AMH**
Description: **Manhole**

Distance (ft): **.0**
Structural Grade: **0**
O&M Grade: **0**
Clock Start/From:
Clock To:
1st Value:
2nd Value:
Value Percent:
Continuous Index:
Within 8" of Joint: **NO**
Remarks: **M-303-039**

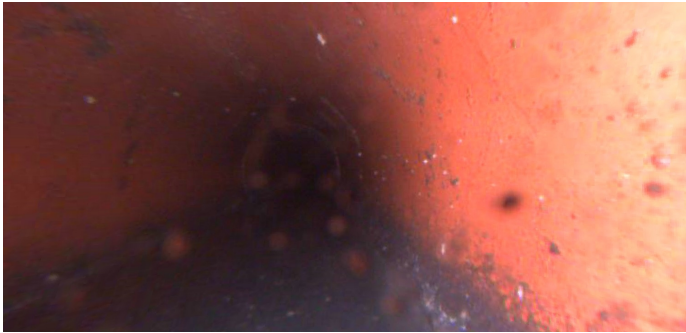
Code:	MWL
Description:	Water Level

Distance (ft):	.0
Structural Grade:	0
O&M Grade:	0
Clock Start/From:	
Clock To:	
1st Value:	
2nd Value:	
Value Percent:	20.000
Continuous Index:	
Within 8" of Joint:	NO
Remarks:

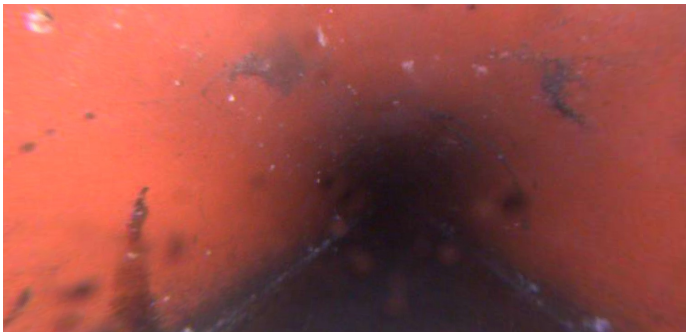
Code:	MSA
Description:	Abandoned Survey

Distance (ft):	8.7
Structural Grade:	0
O&M Grade:	0
Clock Start/From:	
Clock To:	
1st Value:	
2nd Value:	
Value Percent:	
Continuous Index:	
Within 8" of Joint:	NO
Remarks:	DEBRIS UNDER WATER
