Profile/Photo Observation Report

Date:	09/26/2018	Weather:		Coding:	PACP 6.0
Pipe Length (ft):	416.1	Owner:	NA	Pre Clean:	Not Known
P.O.#:		Surveyor:	Selasie Honu	PSR:	P-303-038-039
Customer:		Clean Date:	01/01/1900	Shape:	C

Street:	Roche St.	Flow Control:	Not Controlled
City:	Hobart, IN	Year Renewed:	
Location:	Light Highway	Tape/Media #:	
Purpose:	Routine Assessment	Dia/Height:	10"
Use:	Sanitary	Material:	VCP
Drain Area:	NA	Lining:	
Category:	NA		
Comment:			
Location Details:		Direction of Survey:	Upstream
US MH:	M-303-039	DS MH:	M-303-038
		Total Length Surveyed (ft):	196.5

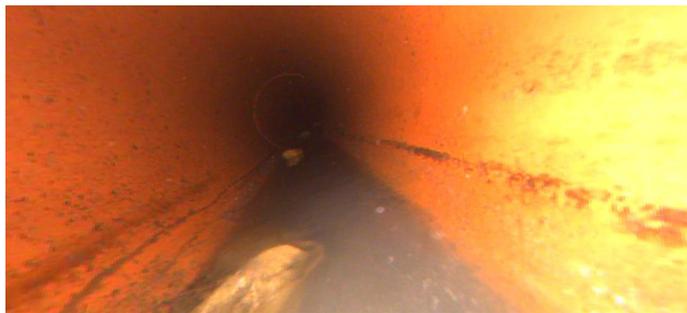
Code: **AMH**
 Description: **Manhole**
 Distance (ft): **.0**
 Structural Grade: **0**
 O&M Grade: **0**
 Clock Start/From:
 Clock To:
 1st Value:
 2nd Value:
 Value Percent:
 Continuous Index:
 Within 8" of Joint: **NO**
 Remarks: **M-303-038**

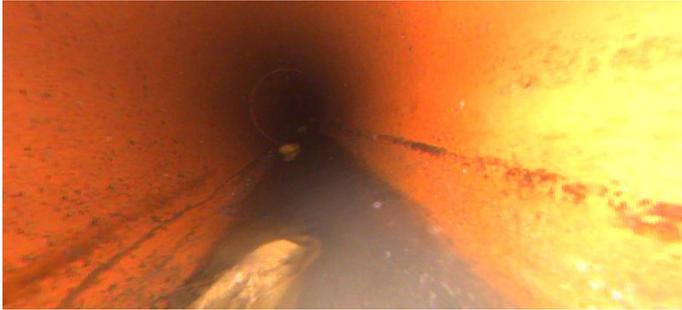
Code: **MWL**
Description: **Water Level**

Distance (ft): **.0**
Structural Grade: **0**
O&M Grade: **0**
Clock Start/From:
Clock To:
1st Value:
2nd Value:
Value Percent: **5.000**
Continuous Index:
Within 8" of Joint: **NO**
Remarks:

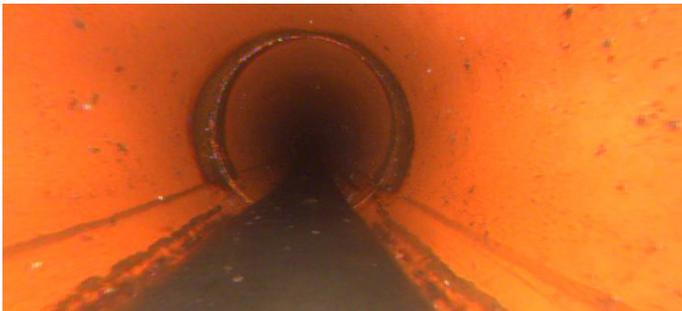
Code: **IS**
Description: **Infil Stain**

Distance (ft): **12.8**
Structural Grade: **0**
O&M Grade: **0**
Clock Start/From: **8**
Clock To: **4**
1st Value:
2nd Value:
Value Percent:
Continuous Index:
Within 8" of Joint: **YES**
Remarks:

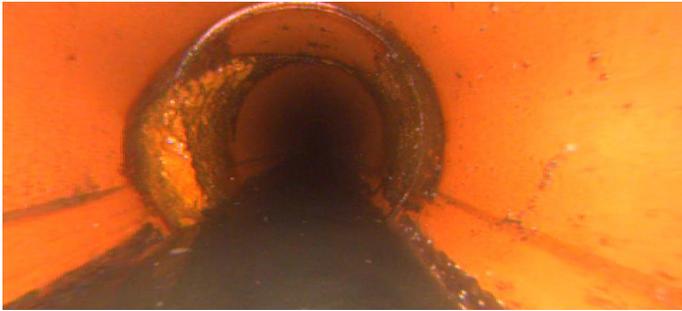
Code: **DAE**
Description: **Deposits Attached Encrustation**

Distance (ft): **18.2**
Structural Grade: **0**
O&M Grade: **4**
Clock Start/From: **8**
Clock To: **4**
1st Value:
2nd Value:
Value Percent: **30.000**
Continuous Index:
Within 8" of Joint: **YES**
Remarks:

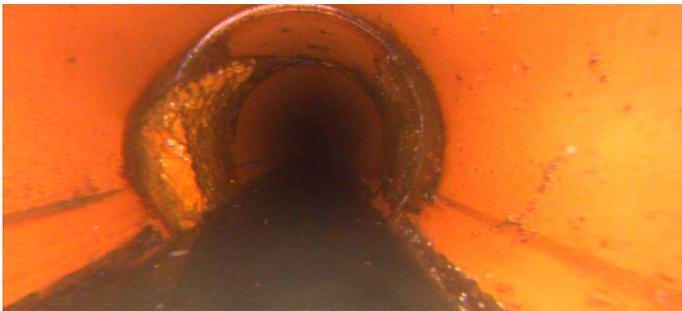
Code: **FC**
Description: **Fracture Circumferential**

Distance (ft): **18.2**
Structural Grade: **2**
O&M Grade: **0**
Clock Start/From: **8**
Clock To: **4**
1st Value:
2nd Value:
Value Percent:
Continuous Index:
Within 8" of Joint: **YES**
Remarks:

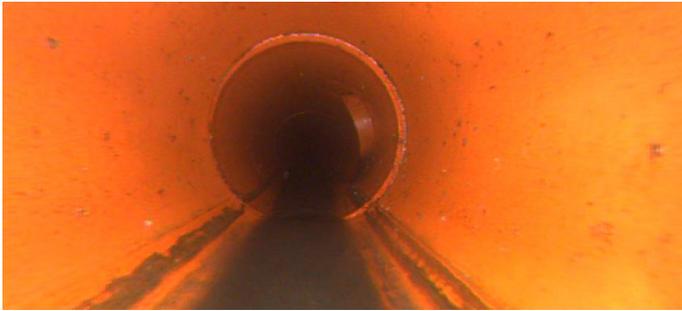
Code: **TF**
Description: **Tap Factory**

Distance (ft): **33.1**
Structural Grade: **0**
O&M Grade: **0**
Clock Start/From: **3**
Clock To:
1st Value: **4.000**
2nd Value:
Value Percent:
Continuous Index:
Within 8" of Joint:
Remarks:

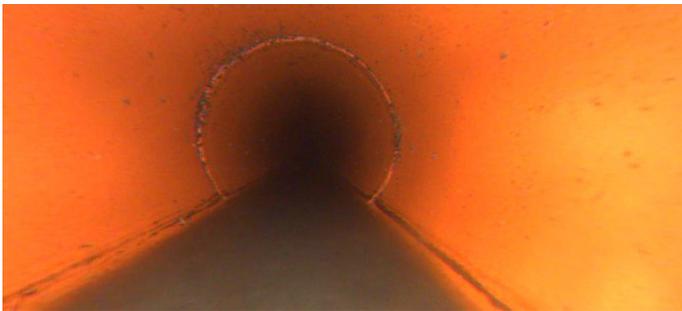
Code: **RFJ**
Description: **Roots Fine Joint**

Distance (ft): **40.1**
Structural Grade: **0**
O&M Grade: **1**
Clock Start/From: **8**
Clock To: **4**
1st Value:
2nd Value:
Value Percent:
Continuous Index:
Within 8" of Joint: **YES**
Remarks:

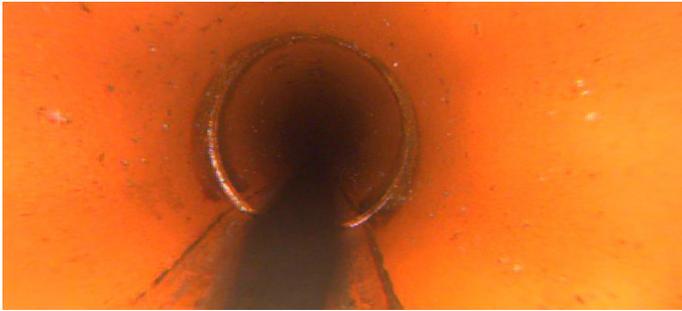
Code: **IS**
Description: **Infil Stain**

Distance (ft): **65.5**
Structural Grade: **0**
O&M Grade: **0**
Clock Start/From: **7**
Clock To: **5**
1st Value:
2nd Value:
Value Percent:
Continuous Index:
Within 8" of Joint: **YES**
Remarks:

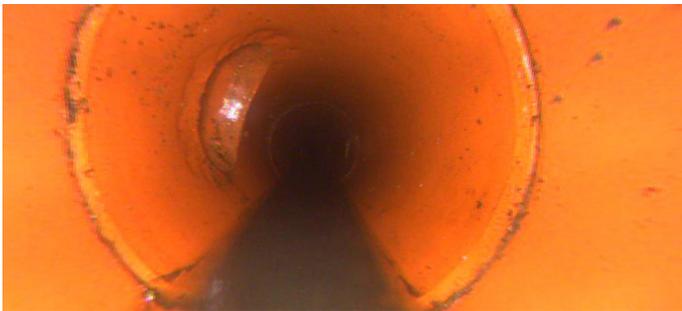
Code: **TF**
Description: **Tap Factory**

Distance (ft): **95.8**
Structural Grade: **0**
O&M Grade: **0**
Clock Start/From: **9**
Clock To:
1st Value: **4.000**
2nd Value:
Value Percent:
Continuous Index:
Within 8" of Joint:
Remarks:

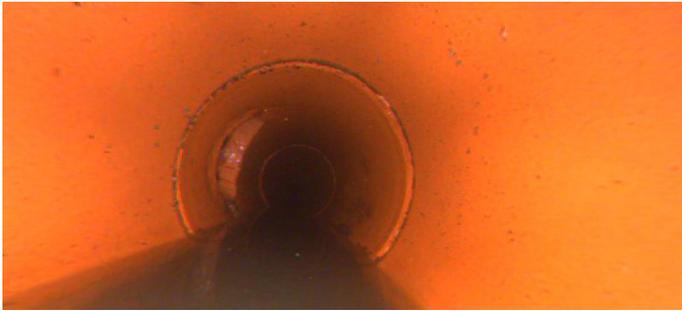
Code: **TF**
Description: **Tap Factory**

Distance (ft): **142.7**
Structural Grade: **0**
O&M Grade: **0**
Clock Start/From: **9**
Clock To:
1st Value: **4.000**
2nd Value:
Value Percent:
Continuous Index:
Within 8" of Joint:
Remarks:

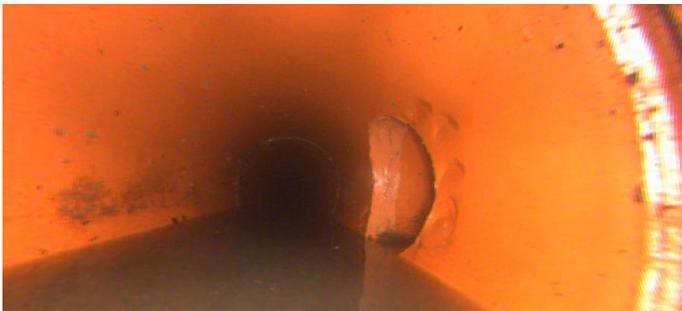
Code: **TF**
Description: **Tap Factory**

Distance (ft): **185.9**
Structural Grade: **0**
O&M Grade: **0**
Clock Start/From: **3**
Clock To:
1st Value: **4.000**
2nd Value:
Value Percent:
Continuous Index:
Within 8" of Joint:
Remarks:

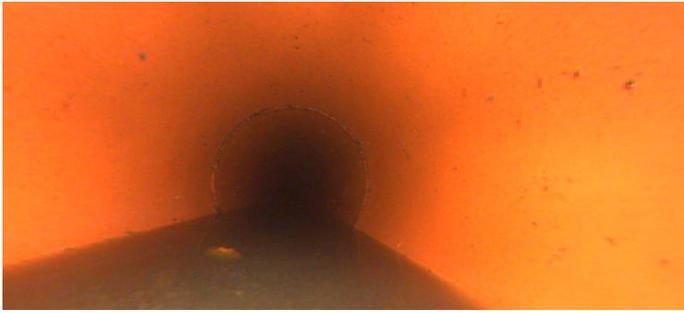
Code: **MSA**
Description: **Abandoned Survey**

Distance (ft): **196.5**
Structural Grade: **0**
O&M Grade: **0**
Clock Start/From:
Clock To:
1st Value:
2nd Value:
Value Percent:
Continuous Index:
Within 8" of Joint: **NO**
Remarks: **camera stopped**
