Profile/Photo Observation Report

Date:	09/26/2018	Weather:		Coding:	PACP 6.0
Pipe Length (ft):	416.1	Owner:	NA	Pre Clean:	Not Known
P.O.#:		Surveyor:	Justin Gonzales	PSR:	P-303-038-039
Customer:		Clean Date:	01/01/1900	Shape:	C

Street:	ROCHE ST	Flow Control:	Not Controlled
City:	Hobart, IN	Year Renewed:	
Location:	Light Highway	Tape/Media #:	
Purpose:	Routine Assessment	Dia/Height:	10"
Use:	Sanitary	Material:	VCP
Drain Area:	NA	Lining:	
Category:	NA		
Comment:

Location Details:		Direction of Survey:	Downstream
US MH:	M-303-039	DS MH:	M-303-038
		Total Length Surveyed (ft):	396.8

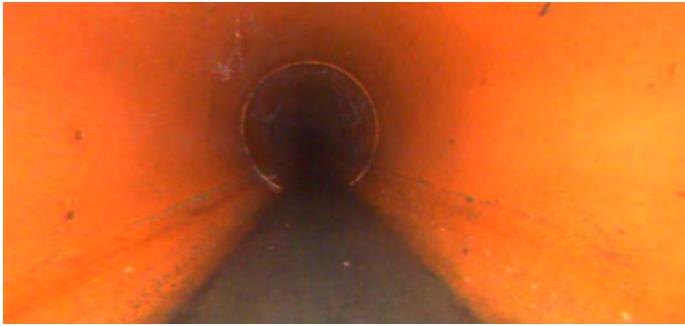
Code: **MWL**
Description: **Water Level**

Distance (ft): **.0**
Structural Grade: **0**
O&M Grade: **0**
Clock Start/From:
Clock To:
1st Value:
2nd Value:
Value Percent: **10.000**
Continuous Index:
Within 8" of Joint: **NO**
Remarks:

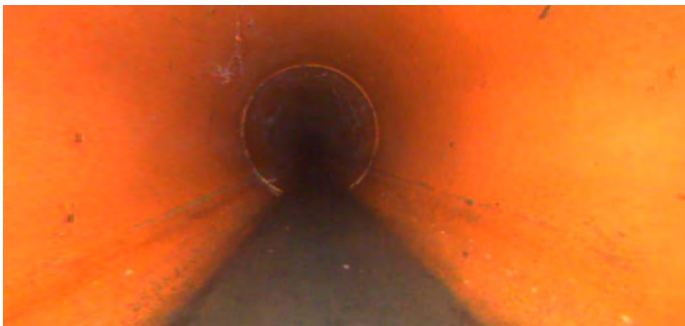
Code: **AMH**
Description: **Manhole**

Distance (ft): **.0**
Structural Grade: **0**
O&M Grade: **0**
Clock Start/From:
Clock To:
1st Value:
2nd Value:
Value Percent:
Continuous Index:
Within 8" of Joint: **NO**
Remarks: **M-303-039**

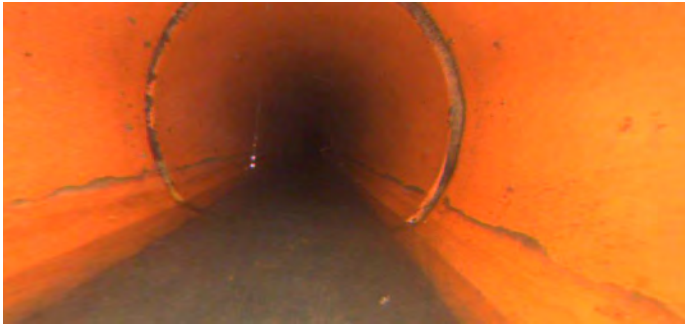
Code: **MWLS**
Description: **Water Level Sag**

Distance (ft): **12.0**
Structural Grade: **2**
O&M Grade: **3**
Clock Start/From:
Clock To:
1st Value:
2nd Value:
Value Percent: **10.000**
Continuous Index:
Within 8" of Joint: **NO**
Remarks:

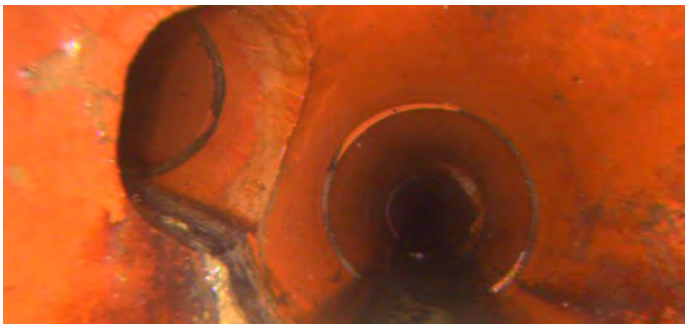
Code: **TF**
Description: **Tap Factory**

Distance (ft): **28.7**
Structural Grade: **0**
O&M Grade: **0**
Clock Start/From: **9**
Clock To:
1st Value: **4.000**
2nd Value:
Value Percent:
Continuous Index:
Within 8" of Joint:
Remarks:

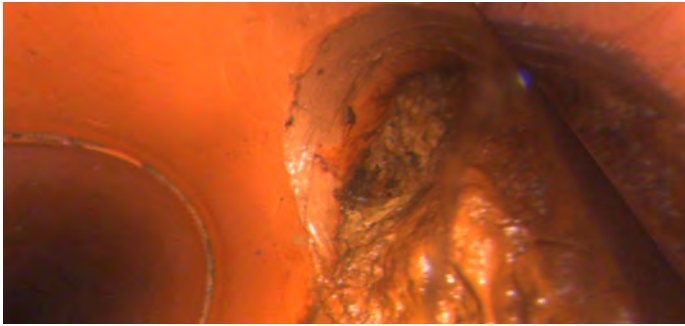
Code: **TFD**
Description: **Tap Factory Defective**

Distance (ft): **30.9**
Structural Grade: **0**
O&M Grade: **2**
Clock Start/From: **2**
Clock To:
1st Value: **4.000**
2nd Value:
Value Percent:
Continuous Index:
Within 8" of Joint:
Remarks: **DEPOSITS INSIDE TAP**

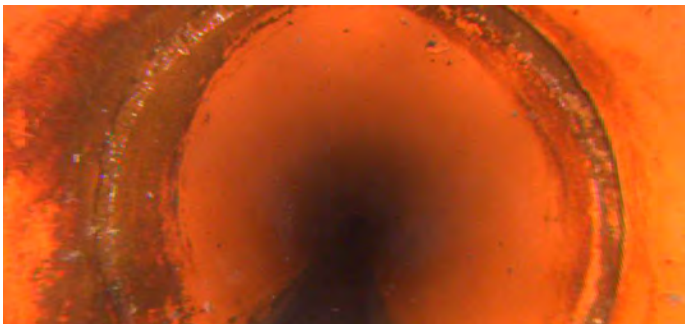
Code: **IS**
Description: **Infil Stain**

Distance (ft): **71.9**
Structural Grade: **0**
O&M Grade: **0**
Clock Start/From: **7**
Clock To: **3**
1st Value:
2nd Value:
Value Percent:
Continuous Index:
Within 8" of Joint: **YES**
Remarks:

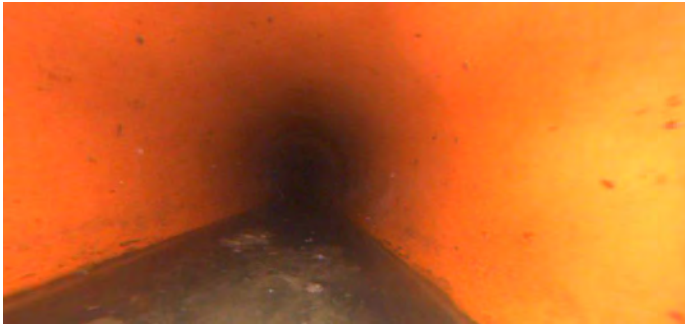
Code: **MWLS**
Description: **Water Level Sag**

Distance (ft): **78.6**
Structural Grade: **2**
O&M Grade: **3**
Clock Start/From:
Clock To:
1st Value:
2nd Value:
Value Percent: **10.000**
Continuous Index:
Within 8" of Joint: **NO**
Remarks:

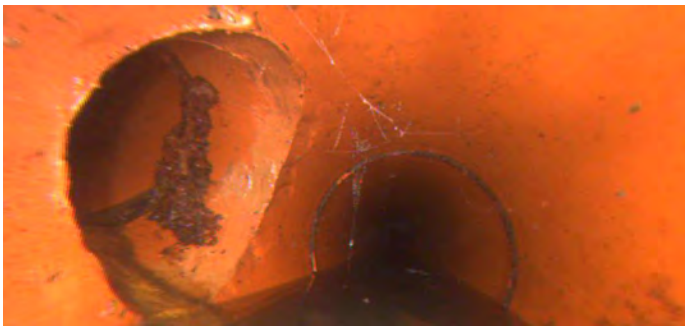
Code: **TF**
Description: **Tap Factory**

Distance (ft): **93.4**
Structural Grade: **0**
O&M Grade: **0**
Clock Start/From: **9**
Clock To:
1st Value: **4.000**
2nd Value:
Value Percent:
Continuous Index:
Within 8" of Joint:
Remarks:

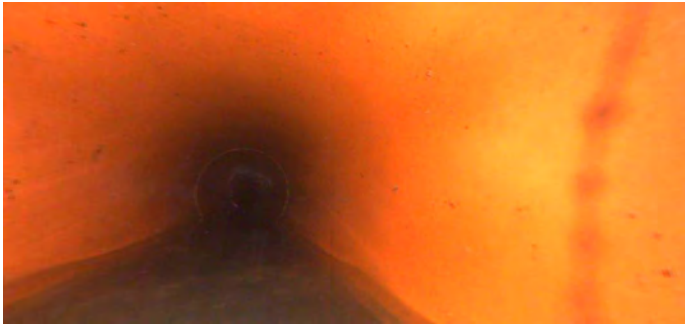
Code: **MWLS**
Description: **Water Level Sag**

Distance (ft): **97.0**
Structural Grade: **2**
O&M Grade: **3**
Clock Start/From:
Clock To:
1st Value:
2nd Value:
Value Percent: **10.000**
Continuous Index:
Within 8" of Joint: **NO**
Remarks:

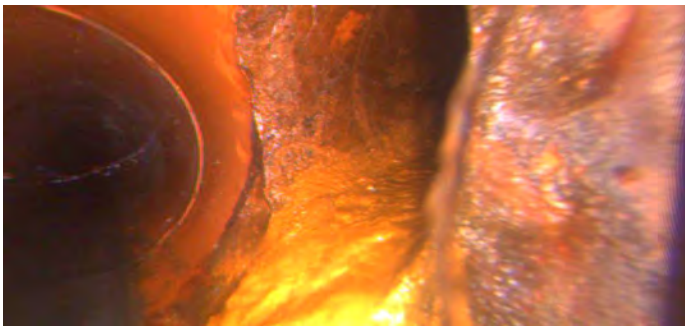
Code: **TF**
Description: **Tap Factory**

Distance (ft): **105.8**
Structural Grade: **0**
O&M Grade: **0**
Clock Start/From: **3**
Clock To:
1st Value: **4.000**
2nd Value:
Value Percent:
Continuous Index:
Within 8" of Joint:
Remarks:

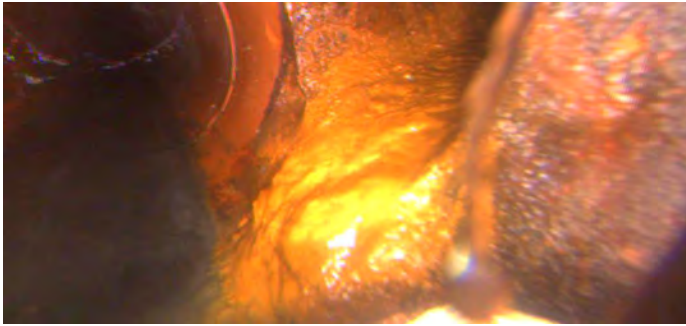
Code: **DAE**
Description: **Deposits Attached Encrustation**

Distance (ft): **105.8**
Structural Grade: **0**
O&M Grade: **2**
Clock Start/From: **5**
Clock To:
1st Value:
2nd Value:
Value Percent: **5.000**
Continuous Index:
Within 8" of Joint: **NO**
Remarks:

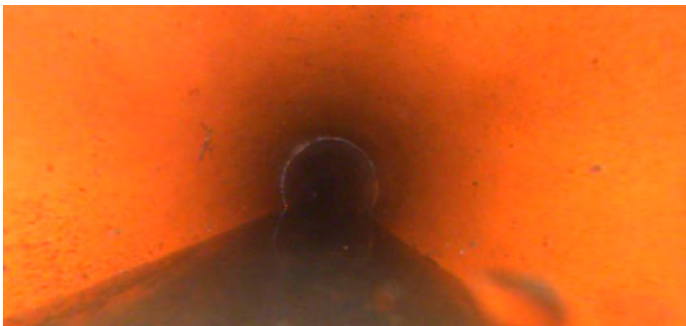
Code: **MWLS**
Description: **Water Level Sag**

Distance (ft): **129.7**
Structural Grade: **2**
O&M Grade: **3**
Clock Start/From:
Clock To:
1st Value:
2nd Value:
Value Percent: **10.000**
Continuous Index:
Within 8" of Joint: **NO**
Remarks:

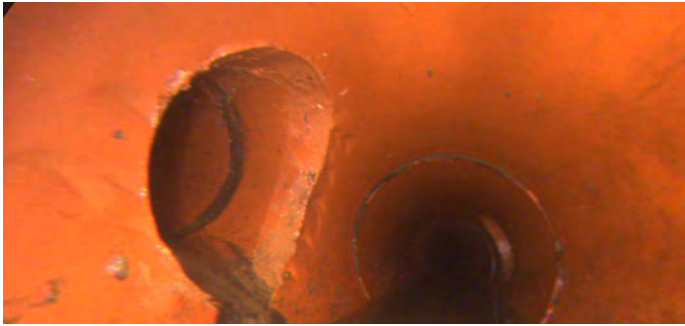
Code: **TF**
Description: **Tap Factory**

Distance (ft): **143.1**
Structural Grade: **0**
O&M Grade: **0**
Clock Start/From: **3**
Clock To:
1st Value: **4.000**
2nd Value:
Value Percent:
Continuous Index:
Within 8" of Joint:
Remarks:

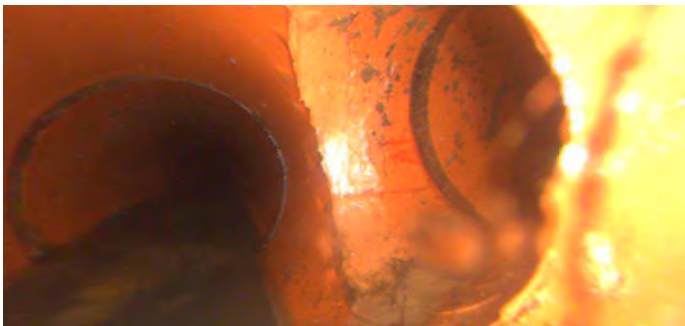
Code: **TF**
Description: **Tap Factory**

Distance (ft): **144.8**
Structural Grade: **0**
O&M Grade: **0**
Clock Start/From: **3**
Clock To:
1st Value: **4.000**
2nd Value:
Value Percent:
Continuous Index:
Within 8" of Joint:
Remarks:

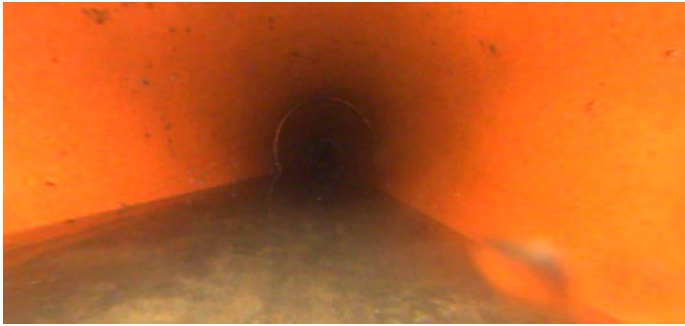
Code: **MWLS**
Description: **Water Level Sag**

Distance (ft): **183.9**
Structural Grade: **2**
O&M Grade: **3**
Clock Start/From:
Clock To:
1st Value:
2nd Value:
Value Percent: **10.000**
Continuous Index:
Within 8" of Joint: **NO**
Remarks:

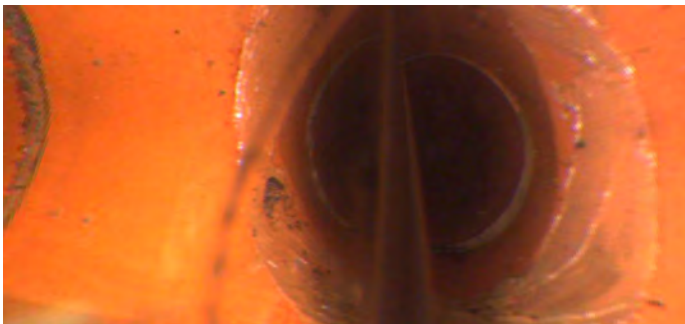
Code: **TF**
Description: **Tap Factory**

Distance (ft): **192.5**
Structural Grade: **0**
O&M Grade: **0**
Clock Start/From: **3**
Clock To:
1st Value: **4.000**
2nd Value:
Value Percent:
Continuous Index:
Within 8" of Joint:
Remarks:

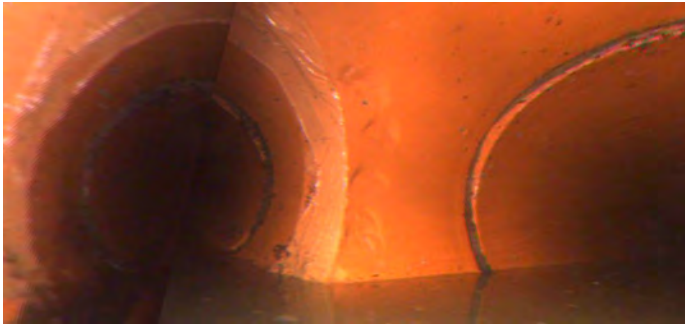
Code: **TFA**
Description: **Tap Factory Active**

Distance (ft): **219.3**
Structural Grade: **0**
O&M Grade: **0**
Clock Start/From: **9**
Clock To:
1st Value: **4.000**
2nd Value:
Value Percent:
Continuous Index:
Within 8" of Joint:
Remarks:

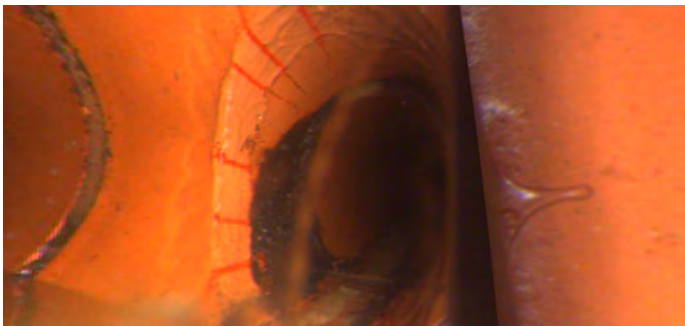
Code: **TF**
Description: **Tap Factory**

Distance (ft): **261.4**
Structural Grade: **0**
O&M Grade: **0**
Clock Start/From: **3**
Clock To:
1st Value: **4.000**
2nd Value:
Value Percent:
Continuous Index:
Within 8" of Joint:
Remarks:

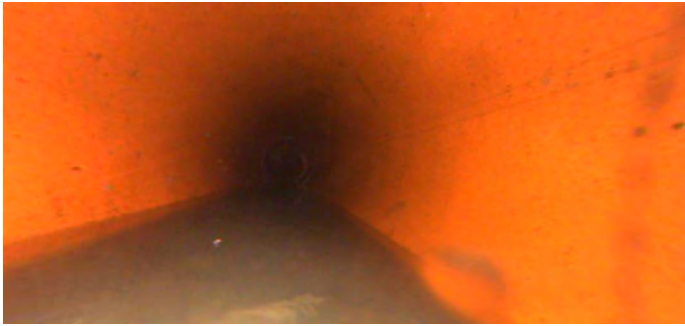
Code: **MWLS**
Description: **Water Level Sag**

Distance (ft): **302.7**
Structural Grade: **2**
O&M Grade: **3**
Clock Start/From:
Clock To:
1st Value:
2nd Value:
Value Percent: **10.000**
Continuous Index:
Within 8" of Joint: **NO**
Remarks:

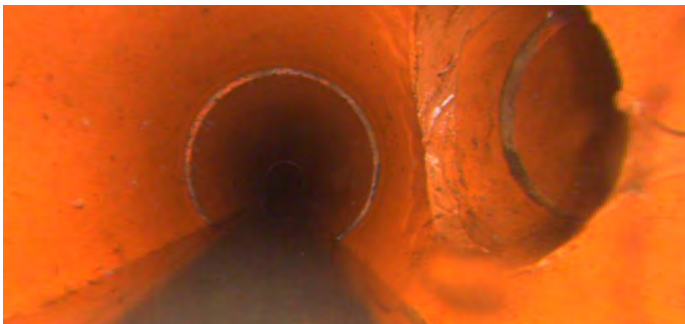
Code: **TF**
Description: **Tap Factory**

Distance (ft): **308.1**
Structural Grade: **0**
O&M Grade: **0**
Clock Start/From: **3**
Clock To:
1st Value: **4.000**
2nd Value:
Value Percent:
Continuous Index:
Within 8" of Joint:
Remarks:

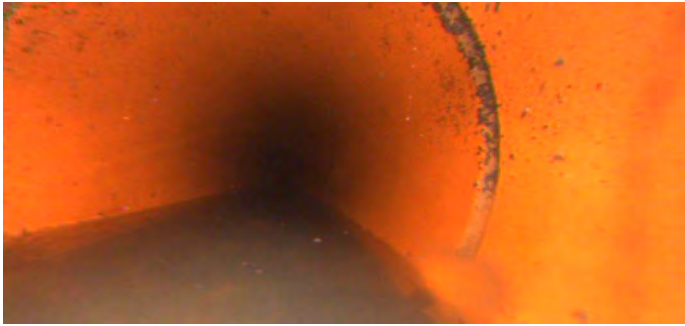
Code: **MWLS**
Description: **Water Level Sag**

Distance (ft): **323.9**
Structural Grade: **2**
O&M Grade: **3**
Clock Start/From:
Clock To:
1st Value:
2nd Value:
Value Percent: **10.000**
Continuous Index:
Within 8" of Joint: **NO**
Remarks:

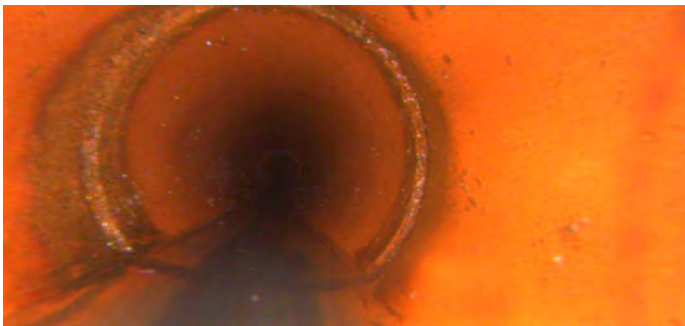
Code: **IS**
Description: **Infil Stain**

Distance (ft): **338.7**
Structural Grade: **0**
O&M Grade: **0**
Clock Start/From: **7**
Clock To: **5**
1st Value:
2nd Value:
Value Percent:
Continuous Index:
Within 8" of Joint: **YES**
Remarks:

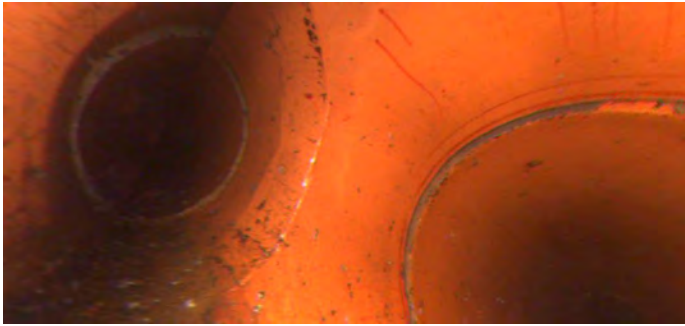
Code: **TF**
Description: **Tap Factory**

Distance (ft): **370.8**
Structural Grade: **0**
O&M Grade: **0**
Clock Start/From: **10**
Clock To:
1st Value: **4.000**
2nd Value:
Value Percent:
Continuous Index:
Within 8" of Joint:
Remarks:

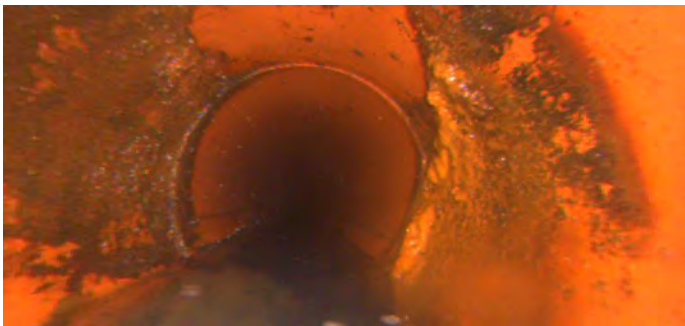
Code: **DAE**
Description: **Deposits Attached Encrustation**

Distance (ft): **385.9**
Structural Grade: **0**
O&M Grade: **2**
Clock Start/From: **7**
Clock To: **5**
1st Value:
2nd Value:
Value Percent: **5.000**
Continuous Index:
Within 8" of Joint: **YES**
Remarks:

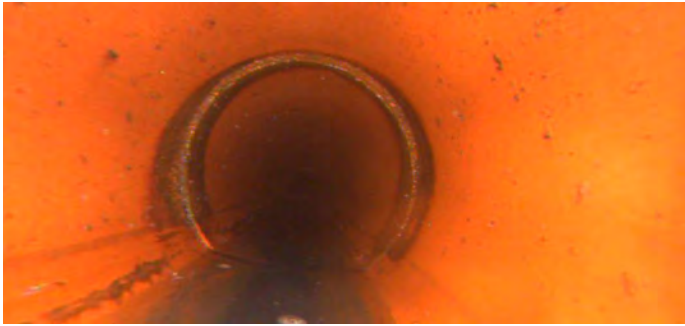
Code: **IS**
Description: **Infil Stain**

Distance (ft): **390.8**
Structural Grade: **0**
O&M Grade: **0**
Clock Start/From: **7**
Clock To: **5**
1st Value:
2nd Value:
Value Percent:
Continuous Index:
Within 8" of Joint: **YES**
Remarks:

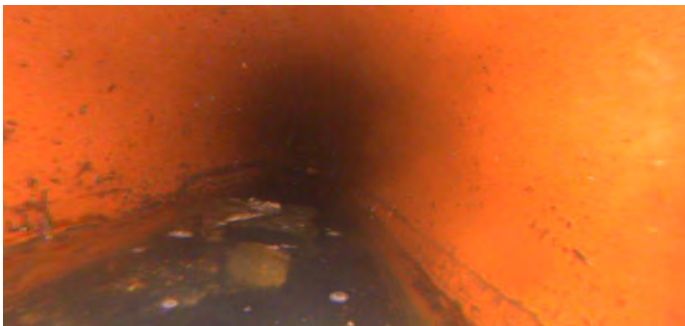
Code: **MSA**
Description: **Abandoned Survey**

Distance (ft): **396.8**
Structural Grade: **0**
O&M Grade: **0**
Clock Start/From:
Clock To:
1st Value:
2nd Value:
Value Percent:
Continuous Index:
Within 8" of Joint: **NO**
Remarks: **ROBOT HAS STOPPED**
