Profile/Photo Observation Report

Date:	09/26/2018	Weather:		Coding:	PACP 6.0
Pipe Length (ft):	416.1	Owner:	NA	Pre Clean:	Not Known
P.O.#:		Surveyor:	Justin Gonzales	PSR:	P-303-038-039
Customer:		Clean Date:	01/01/1900	Shape:	C

Street:	Roche St.	Flow Control:	Not Controlled
City:	Hobart, IN	Year Renewed:	
Location:	Light Highway	Tape/Media #:	
Purpose:	Routine Assessment	Dia/Height:	10"
Use:	Sanitary	Material:	VCP
Drain Area:	NA	Lining:	
Category:	NA		
Comment:

Location Details:		Direction of Survey:	Downstream
US MH:	M-303-039	DS MH:	M-303-038
		Total Length Surveyed (ft):	396.8

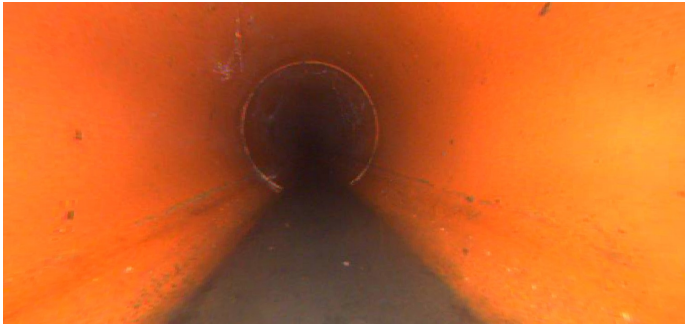
Code: **MWL**
Description: **Water Level**

Distance (ft): **.0**
Structural Grade: **0**
O&M Grade: **0**
Clock Start/From:
Clock To:
1st Value:
2nd Value:
Value Percent: **10.000**
Continuous Index:
Within 8" of Joint: **NO**
Remarks:

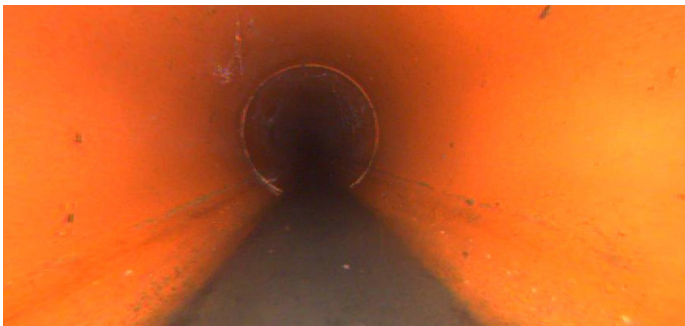
Code: **AMH**
Description: **Manhole**

Distance (ft): **.0**
Structural Grade: **0**
O&M Grade: **0**
Clock Start/From:
Clock To:
1st Value:
2nd Value:
Value Percent:
Continuous Index:
Within 8" of Joint: **NO**
Remarks: **M-303-039**

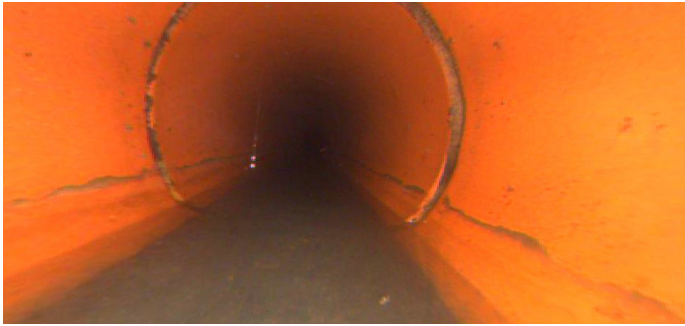
Code: **MWLS**
Description: **Water Level Sag**

Distance (ft): **12.0**
Structural Grade: **2**
O&M Grade: **3**
Clock Start/From:
Clock To:
1st Value:
2nd Value:
Value Percent: **10.000**
Continuous Index:
Within 8" of Joint: **NO**
Remarks:

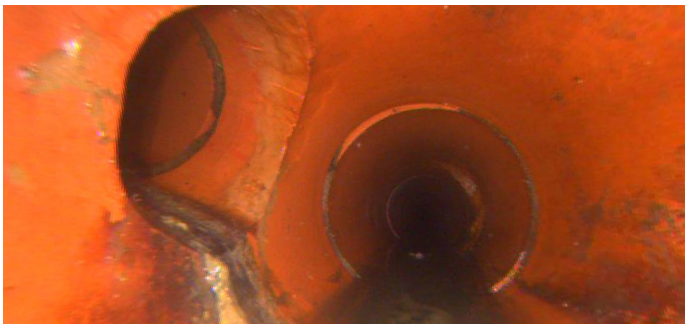
Code: **TF**
Description: **Tap Factory**

Distance (ft): **28.7**
Structural Grade: **0**
O&M Grade: **0**
Clock Start/From: **9**
Clock To:
1st Value: **4.000**
2nd Value:
Value Percent:
Continuous Index:
Within 8" of Joint:
Remarks:

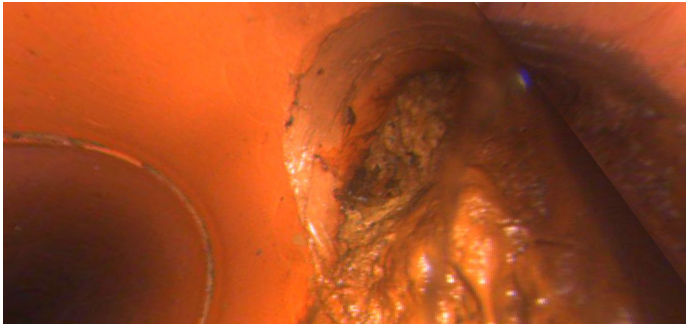
Code: **TFD**
Description: **Tap Factory Defective**

Distance (ft): **30.9**
Structural Grade: **0**
O&M Grade: **2**
Clock Start/From: **2**
Clock To:
1st Value: **4.000**
2nd Value:
Value Percent:
Continuous Index:
Within 8" of Joint:
Remarks: **DEPOSITS INSIDE TAP**

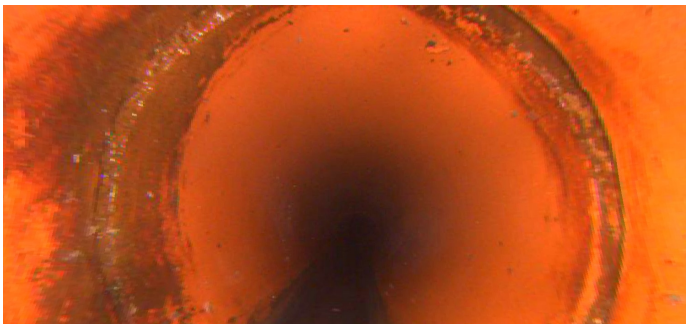
Code: **IS**
Description: **Infil Stain**

Distance (ft): **71.9**
Structural Grade: **0**
O&M Grade: **0**
Clock Start/From: **7**
Clock To: **3**
1st Value:
2nd Value:
Value Percent:
Continuous Index:
Within 8" of Joint: **YES**
Remarks:

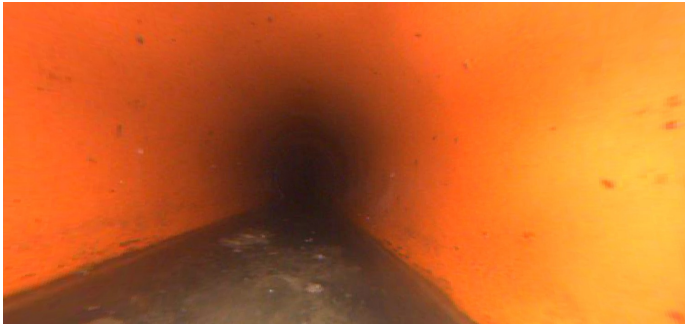
Code: **MWLS**
Description: **Water Level Sag**

Distance (ft): **78.6**
Structural Grade: **2**
O&M Grade: **3**
Clock Start/From:
Clock To:
1st Value:
2nd Value:
Value Percent: **10.000**
Continuous Index:
Within 8" of Joint: **NO**
Remarks:

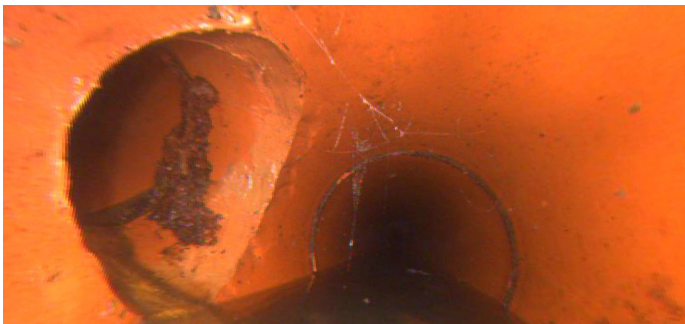
Code: **TF**
Description: **Tap Factory**

Distance (ft): **93.4**
Structural Grade: **0**
O&M Grade: **0**
Clock Start/From: **9**
Clock To:
1st Value: **4.000**
2nd Value:
Value Percent:
Continuous Index:
Within 8" of Joint:
Remarks:

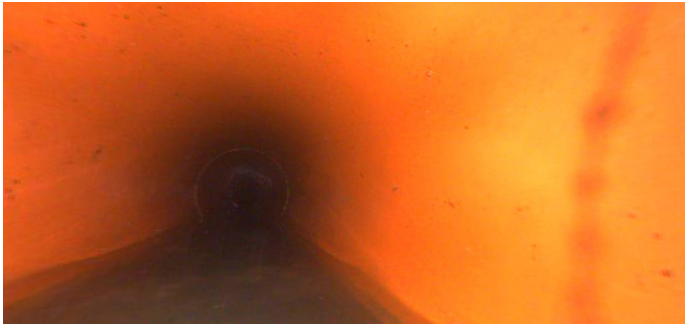
Code: **MWLS**
Description: **Water Level Sag**

Distance (ft): **97.0**
Structural Grade: **2**
O&M Grade: **3**
Clock Start/From:
Clock To:
1st Value:
2nd Value:
Value Percent: **10.000**
Continuous Index:
Within 8" of Joint: **NO**
Remarks:

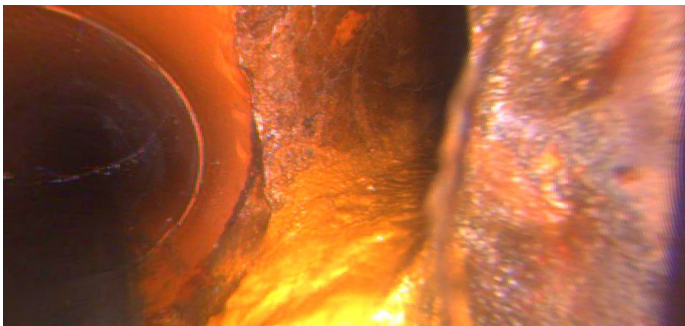
Code: **TF**
Description: **Tap Factory**

Distance (ft): **105.8**
Structural Grade: **0**
O&M Grade: **0**
Clock Start/From: **3**
Clock To:
1st Value: **4.000**
2nd Value:
Value Percent:
Continuous Index:
Within 8" of Joint:
Remarks:

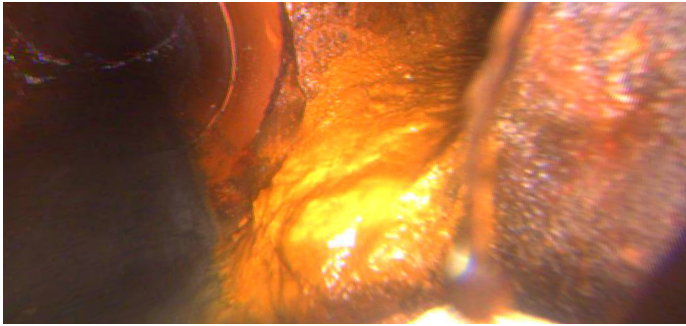
Code: **DAE**
Description: **Deposits Attached Encrustation**

Distance (ft): **105.8**
Structural Grade: **0**
O&M Grade: **2**
Clock Start/From: **5**
Clock To:
1st Value:
2nd Value:
Value Percent: **5.000**
Continuous Index:
Within 8" of Joint: **NO**
Remarks:

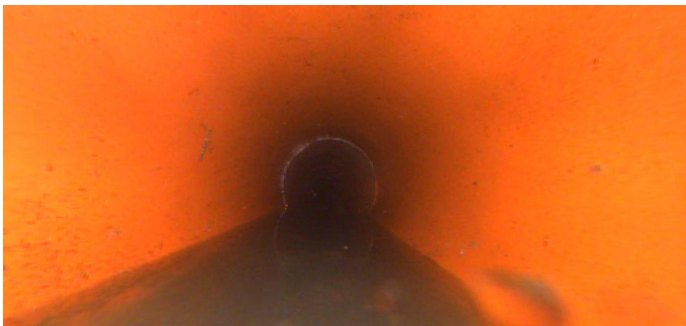
Code: **MWLS**
Description: **Water Level Sag**

Distance (ft): **129.7**
Structural Grade: **2**
O&M Grade: **3**
Clock Start/From:
Clock To:
1st Value:
2nd Value:
Value Percent: **10.000**
Continuous Index:
Within 8" of Joint: **NO**
Remarks:

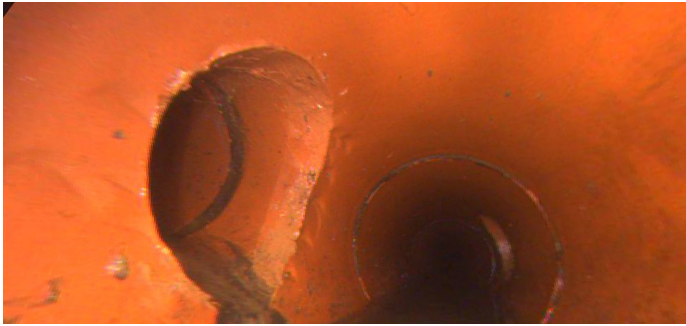
Code: **TF**
Description: **Tap Factory**

Distance (ft): **143.1**
Structural Grade: **0**
O&M Grade: **0**
Clock Start/From: **3**
Clock To:
1st Value: **4.000**
2nd Value:
Value Percent:
Continuous Index:
Within 8" of Joint:
Remarks:

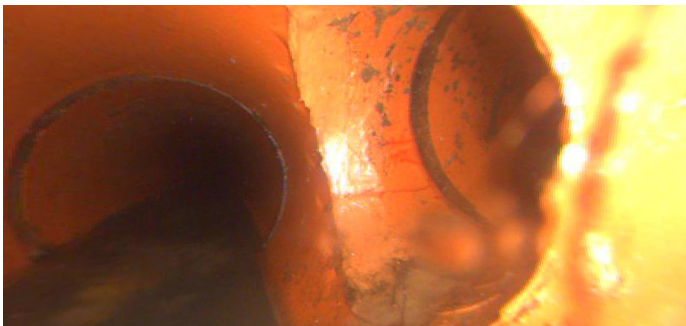
Code: **TF**
Description: **Tap Factory**

Distance (ft): **144.8**
Structural Grade: **0**
O&M Grade: **0**
Clock Start/From: **3**
Clock To:
1st Value: **4.000**
2nd Value:
Value Percent:
Continuous Index:
Within 8" of Joint:
Remarks:

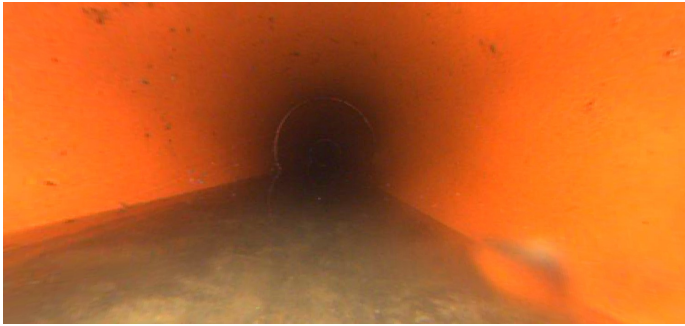
Code: **MWLS**
Description: **Water Level Sag**

Distance (ft): **183.9**
Structural Grade: **2**
O&M Grade: **3**
Clock Start/From:
Clock To:
1st Value:
2nd Value:
Value Percent: **10.000**
Continuous Index:
Within 8" of Joint: **NO**
Remarks:

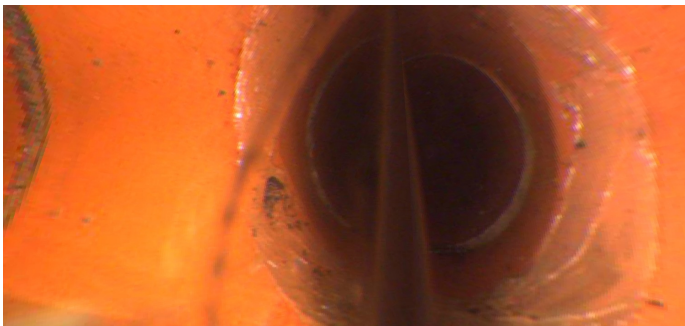
Code: **TF**
Description: **Tap Factory**

Distance (ft): **192.5**
Structural Grade: **0**
O&M Grade: **0**
Clock Start/From: **3**
Clock To:
1st Value: **4.000**
2nd Value:
Value Percent:
Continuous Index:
Within 8" of Joint:
Remarks:

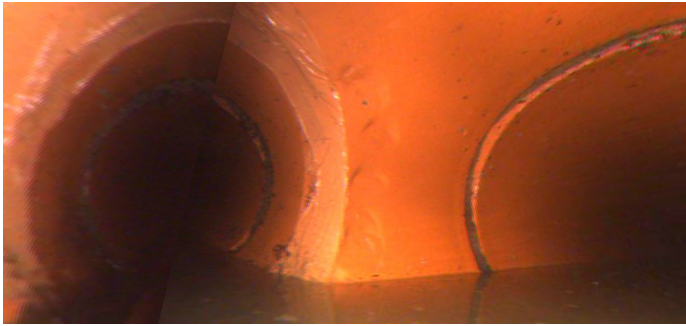
Code: **TFA**
Description: **Tap Factory Active**

Distance (ft): **219.3**
Structural Grade: **0**
O&M Grade: **0**
Clock Start/From: **9**
Clock To:
1st Value: **4.000**
2nd Value:
Value Percent:
Continuous Index:
Within 8" of Joint:
Remarks:

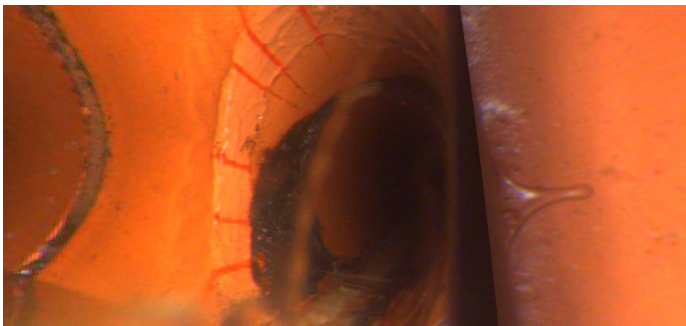
Code: **TF**
Description: **Tap Factory**

Distance (ft): **261.4**
Structural Grade: **0**
O&M Grade: **0**
Clock Start/From: **3**
Clock To:
1st Value: **4.000**
2nd Value:
Value Percent:
Continuous Index:
Within 8" of Joint:
Remarks:

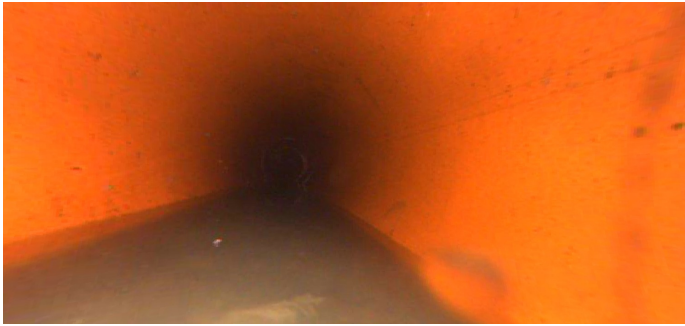
Code: **MWLS**
Description: **Water Level Sag**

Distance (ft): **302.7**
Structural Grade: **2**
O&M Grade: **3**
Clock Start/From:
Clock To:
1st Value:
2nd Value:
Value Percent: **10.000**
Continuous Index:
Within 8" of Joint: **NO**
Remarks:

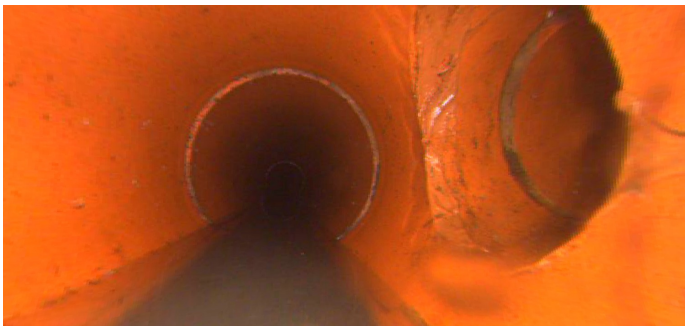
Code: **TF**
Description: **Tap Factory**

Distance (ft): **308.1**
Structural Grade: **0**
O&M Grade: **0**
Clock Start/From: **3**
Clock To:
1st Value: **4.000**
2nd Value:
Value Percent:
Continuous Index:
Within 8" of Joint:
Remarks:

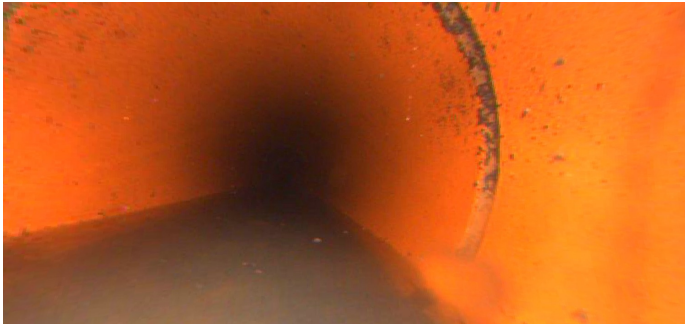
Code: **MWLS**
Description: **Water Level Sag**

Distance (ft): **323.9**
Structural Grade: **2**
O&M Grade: **3**
Clock Start/From:
Clock To:
1st Value:
2nd Value:
Value Percent: **10.000**
Continuous Index:
Within 8" of Joint: **NO**
Remarks:

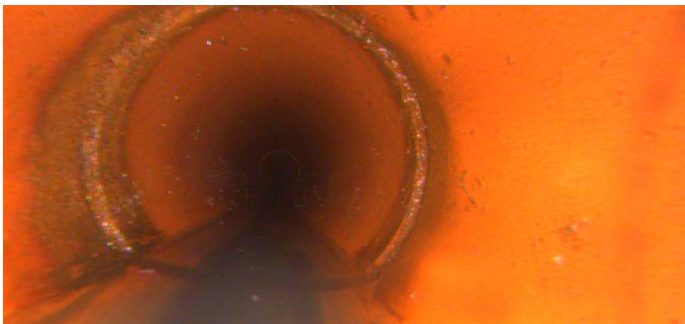
Code: **IS**
Description: **Infil Stain**

Distance (ft): **338.7**
Structural Grade: **0**
O&M Grade: **0**
Clock Start/From: **7**
Clock To: **5**
1st Value:
2nd Value:
Value Percent:
Continuous Index:
Within 8" of Joint: **YES**
Remarks:

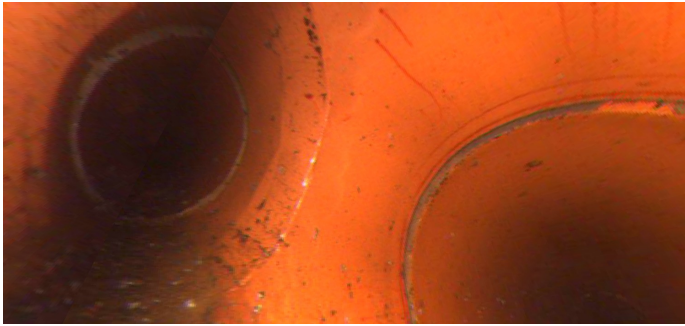
Code: **TF**
Description: **Tap Factory**

Distance (ft): **370.8**
Structural Grade: **0**
O&M Grade: **0**
Clock Start/From: **10**
Clock To:
1st Value: **4.000**
2nd Value:
Value Percent:
Continuous Index:
Within 8" of Joint:
Remarks:

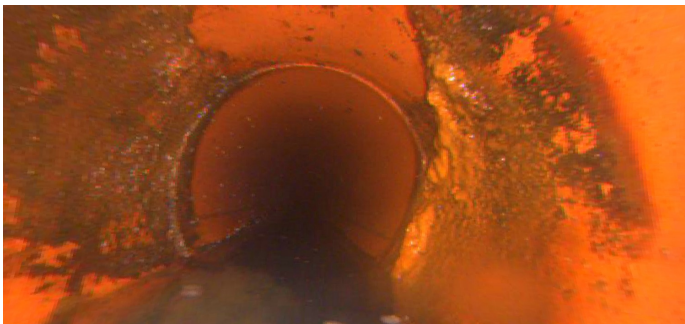
Code: **DAE**
Description: **Deposits Attached Encrustation**

Distance (ft): **385.9**
Structural Grade: **0**
O&M Grade: **2**
Clock Start/From: **7**
Clock To: **5**
1st Value:
2nd Value:
Value Percent: **5.000**
Continuous Index:
Within 8" of Joint: **YES**
Remarks:

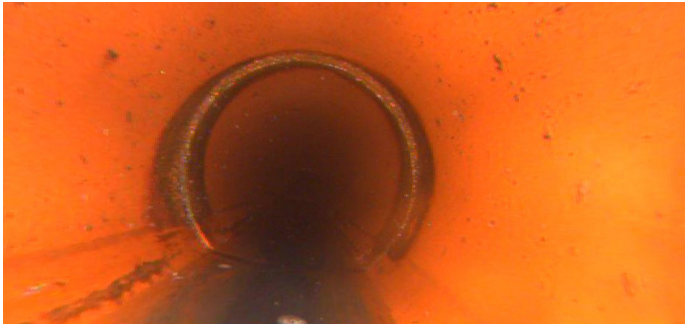
Code: **IS**
Description: **Infil Stain**

Distance (ft): **390.8**
Structural Grade: **0**
O&M Grade: **0**
Clock Start/From: **7**
Clock To: **5**
1st Value:
2nd Value:
Value Percent:
Continuous Index:
Within 8" of Joint: **YES**
Remarks:

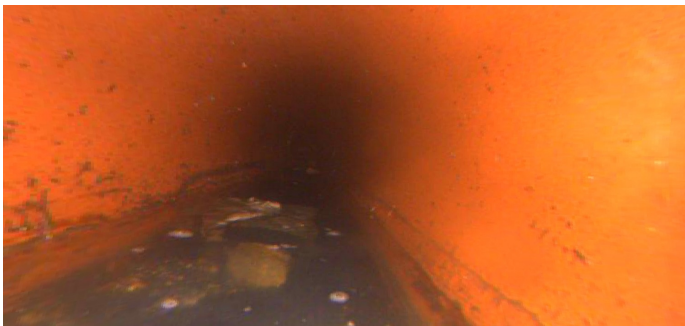
Code: **MSA**
Description: **Abandoned Survey**

Distance (ft): **396.8**
Structural Grade: **0**
O&M Grade: **0**
Clock Start/From:
Clock To:
1st Value:
2nd Value:
Value Percent:
Continuous Index:
Within 8" of Joint: **NO**
Remarks: **ROBOT HAS STOPPED**
