## Profile/Photo Observation Report

Street:	<b>ROCHE ST &amp; W 38TH AVE</b>	Flow Control:	<b>Not Controlled</b>
City:	<b>Hobart, IN</b>	Year Renewed:	
Location:	<b>Other</b>	Tape/Media #:	
Purpose:	<b>Not Known</b>	Dia/Height:	<b>10"</b>
Use:	<b>Sanitary</b>	Material:	<b>VCP</b>
Drain Area:	<b>NA</b>	Lining:	
Category:	<b>NA</b>		
Comment:

Location Details:		Direction of Survey:	<b>Upstream</b>
US MH:	<b>M-303-040</b>	DS MH:	<b>M-303-039</b>
		Total Length Surveyed (ft):	<b>60.0</b>

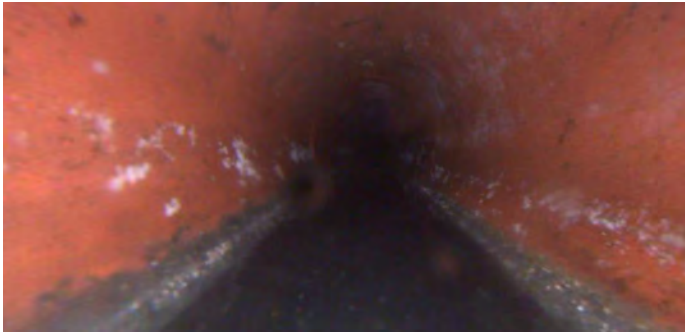
Code:	<b>MWL</b>
Description:	<b>Water Level</b>

Distance (ft):	<b>.0</b>
Structural Grade:	<b>0</b>
O&M Grade:	<b>0</b>
Clock Start/From:	
Clock To:	
1st Value:	
2nd Value:	
Value Percent:	<b>20.000</b>
Continuous Index:	
Within 8" of Joint:	<b>NO</b>
Remarks:

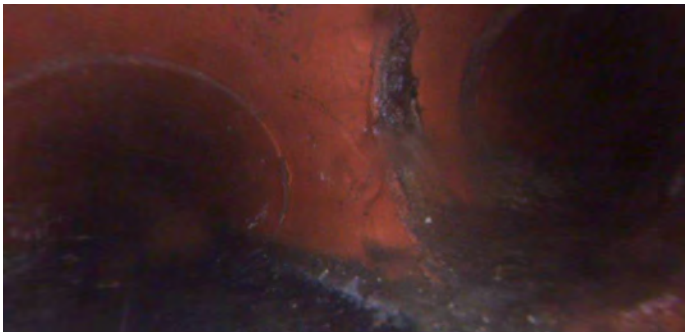
Code:	<b>TF</b>
Description:	<b>Tap Factory</b>

Distance (ft):	<b>30.4</b>
Structural Grade:	<b>0</b>
O&M Grade:	<b>0</b>
Clock Start/From:	<b>9</b>
Clock To:	
1st Value:	<b>4.000</b>
2nd Value:	
Value Percent:	
Continuous Index:	
Within 8" of Joint:	
Remarks:

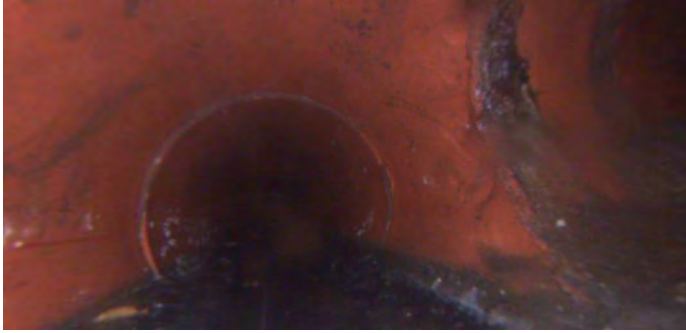
Code: **MGO**  
Description: **General Observation**

Distance (ft): **30.4**  
Structural Grade: **0**  
O&M Grade: **0**  
Clock Start/From:  
Clock To:  
1st Value:  
2nd Value:  
Value Percent:  
Continuous Index:  
Within 8" of Joint: **NO**  
Remarks: **REAR CAMERA**
