## Profile/Photo Observation Report

Street:	<b>ROCHE ST</b>	Flow Control:	<b>Not Controlled</b>
City:	<b>Hobart, IN</b>	Year Renewed:	
Location:	<b>Other</b>	Tape/Media #:	
Purpose:	<b>Not Known</b>	Dia/Height:	<b>10"</b>
Use:	<b>Sanitary</b>	Material:	<b>VCP</b>
Drain Area:	<b>NA</b>	Lining:	
Category:	<b>NA</b>		
Comment:

Location Details:		Direction of Survey:	<b>Upstream</b>
US MH:	<b>M-303-040</b>	DS MH:	<b>M-303-039</b>
		Total Length Surveyed (ft):	<b>60.0</b>

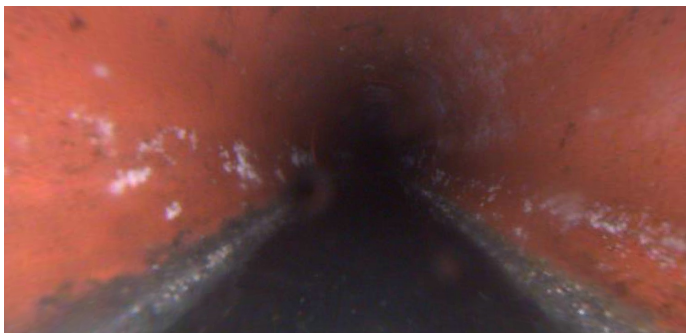
Code: **AMH**  
Description: **Manhole**

Distance (ft): **.0**  
Structural Grade: **0**  
O&M Grade: **0**  
Clock Start/From:  
Clock To:  
1st Value:  
2nd Value:  
Value Percent:  
Continuous Index:  
Within 8" of Joint: **NO**  
Remarks: **M-303-039**

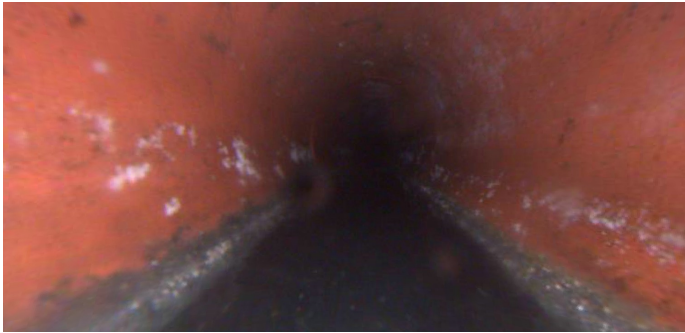
Code:	<b>MWL</b>
Description:	<b>Water Level</b>

Distance (ft):	<b>.0</b>
Structural Grade:	<b>0</b>
O&M Grade:	<b>0</b>
Clock Start/From:	
Clock To:	
1st Value:	
2nd Value:	
Value Percent:	<b>20.000</b>
Continuous Index:	
Within 8" of Joint:	<b>NO</b>
Remarks:

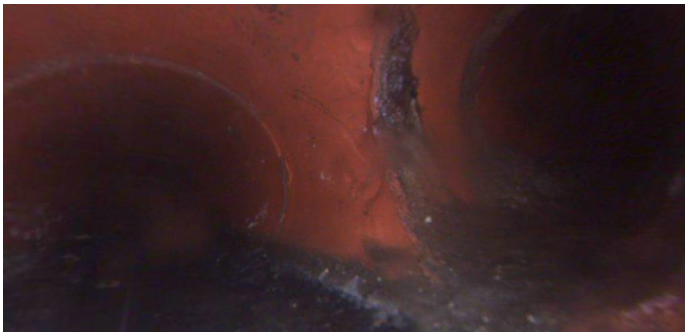
Code:	<b>TF</b>
Description:	<b>Tap Factory</b>

Distance (ft):	<b>30.4</b>
Structural Grade:	<b>0</b>
O&M Grade:	<b>0</b>
Clock Start/From:	<b>9</b>
Clock To:	
1st Value:	<b>4.000</b>
2nd Value:	
Value Percent:	
Continuous Index:	
Within 8" of Joint:	
Remarks:

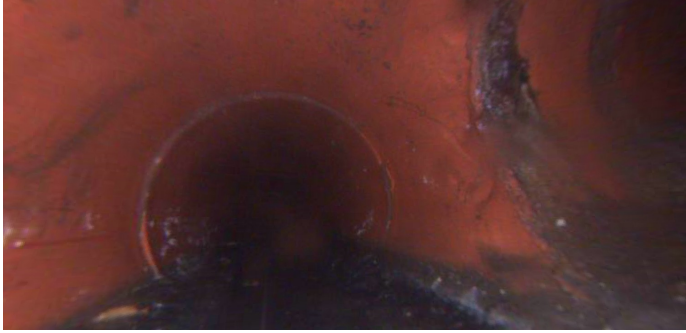
Code: **MGO**  
Description: **General Observation**

Distance (ft): **30.4**  
Structural Grade: **0**  
O&M Grade: **0**  
Clock Start/From:  
Clock To:  
1st Value:  
2nd Value:  
Value Percent:  
Continuous Index:  
Within 8" of Joint: **NO**  
Remarks: **REAR CAMERA**
