Profile/Photo Observation Report

Date:	03/29/2018	Weather:		Coding:	PACP 6.0
Pipe Length (ft):	338.8	Owner:	NA	Pre Clean:	Not Known
P.O.#:		Surveyor:	Jen Costello	PSR:	P-303-041-043
Customer:		Clean Date:	01/01/1900	Shape:	C

Street:	ROCHE ST	Flow Control:	Not Controlled
City:	Hobart, IN	Year Renewed:	
Location:	Other	Tape/Media #:	
Purpose:	Not Known	Dia/Height:	12"
Use:	Sanitary	Material:	VCP
Drain Area:	NA	Lining:	
Category:	NA		
Comment:

Location Details:		Direction of Survey:	Upstream
US MH:	M-303-043	DS MH:	M-303-041
		Total Length Surveyed (ft):	130.9

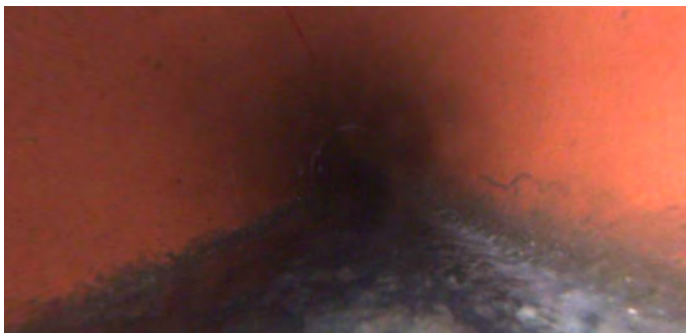
Code: **AMH**
Description: **Manhole**

Distance (ft): **.0**
Structural Grade: **0**
O&M Grade: **0**
Clock Start/From:
Clock To:
1st Value:
2nd Value:
Value Percent:
Continuous Index:
Within 8" of Joint: **NO**
Remarks: **M-303-041**

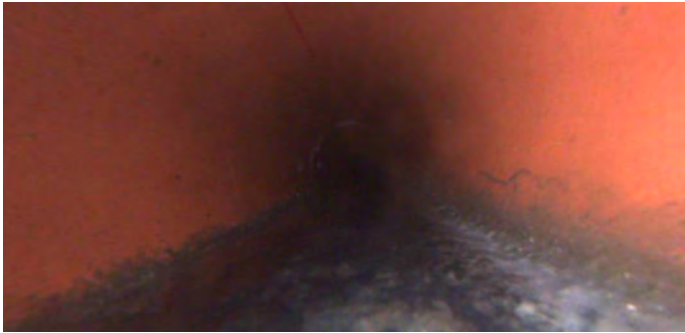
Code:	MWL
Description:	Water Level

Distance (ft):	.0
Structural Grade:	0
O&M Grade:	0
Clock Start/From:	
Clock To:	
1st Value:	
2nd Value:	
Value Percent:	10.000
Continuous Index:	
Within 8" of Joint:	NO
Remarks:

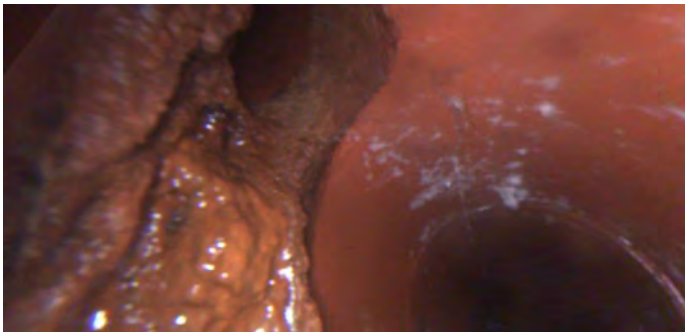
Code:	TFD
Description:	Tap Factory Defective

Distance (ft):	25.0
Structural Grade:	0
O&M Grade:	2
Clock Start/From:	10
Clock To:	
1st Value:	4.000
2nd Value:	
Value Percent:	
Continuous Index:	
Within 8" of Joint:	NO
Remarks:	DAE

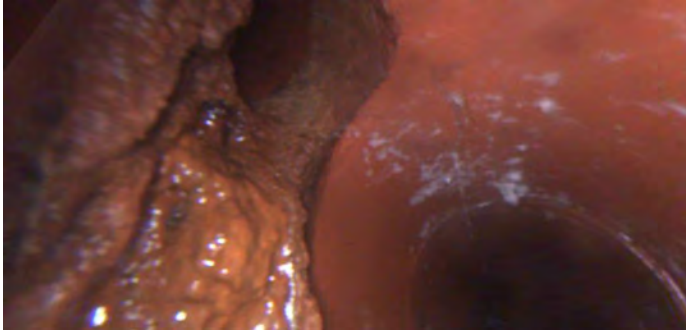
Code: **DAE**
Description: **Deposits Attached Encrustation**

Distance (ft): **25.0**
Structural Grade: **0**
O&M Grade: **3**
Clock Start/From: **7**
Clock To: **10**
1st Value:
2nd Value:
Value Percent: **15.000**
Continuous Index:
Within 8" of Joint: **NO**
Remarks:

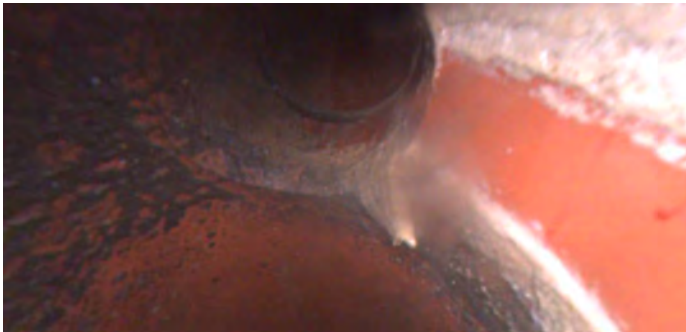
Code: **TF**
Description: **Tap Factory**

Distance (ft): **67.2**
Structural Grade: **0**
O&M Grade: **0**
Clock Start/From: **12**
Clock To:
1st Value: **4.000**
2nd Value:
Value Percent:
Continuous Index:
Within 8" of Joint:
Remarks:

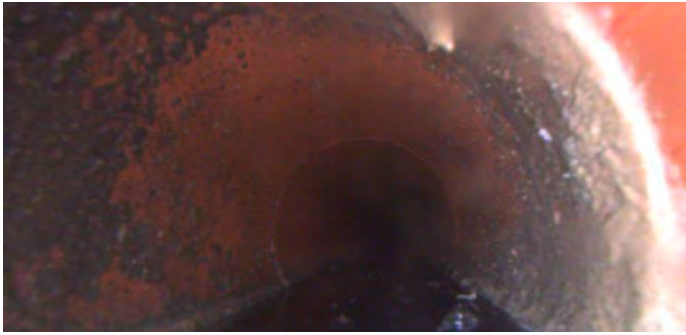
Code: **DAGS**
Description: **Deposits Attached Grease**

Distance (ft): **67.2**
Structural Grade: **0**
O&M Grade: **2**
Clock Start/From: **8**
Clock To: **4**
1st Value:
2nd Value:
Value Percent: **5.000**
Continuous Index:
Within 8" of Joint: **NO**
Remarks:

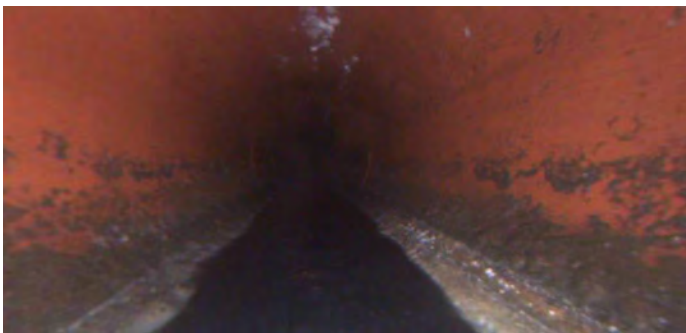
Code: **DAGS**
Description: **Deposits Attached Grease**

Distance (ft): **76.4**
Structural Grade: **0**
O&M Grade: **2**
Clock Start/From: **7**
Clock To: **5**
1st Value:
2nd Value:
Value Percent: **5.000**
Continuous Index: **S01**
Within 8" of Joint: **NO**
Remarks:

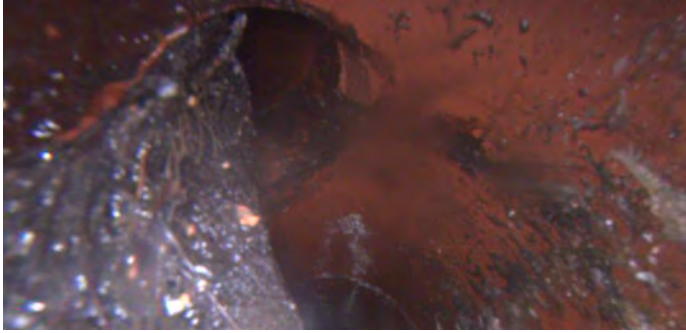
Code: **TFD**
Description: **Tap Factory Defective**

Distance (ft): **84.0**
Structural Grade: **0**
O&M Grade: **2**
Clock Start/From: **1**
Clock To:
1st Value: **4.000**
2nd Value:
Value Percent:
Continuous Index:
Within 8" of Joint:
Remarks: **ROOTS**

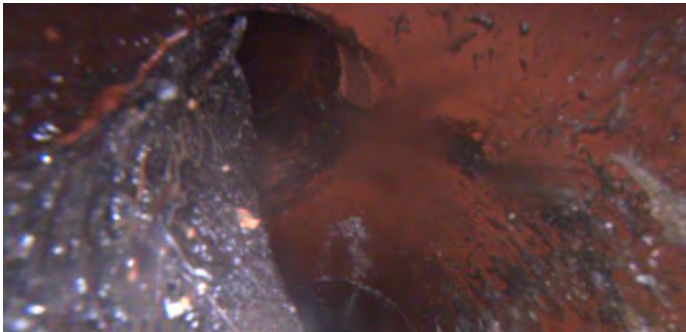
Code: **RML**
Description: **Roots Medium Lateral**

Distance (ft): **84.0**
Structural Grade: **0**
O&M Grade: **3**
Clock Start/From: **6**
Clock To: **12**
1st Value:
2nd Value:
Value Percent: **40.000**
Continuous Index:
Within 8" of Joint: **NO**
Remarks:

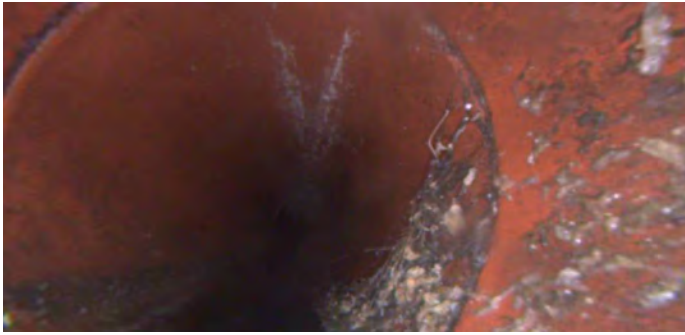
Code: **RMJ**
Description: **Roots Medium Joint**

Distance (ft): **85.3**
Structural Grade: **0**
O&M Grade: **3**
Clock Start/From: **8**
Clock To: **4**
1st Value:
2nd Value:
Value Percent: **5.000**
Continuous Index:
Within 8" of Joint: **YES**
Remarks:

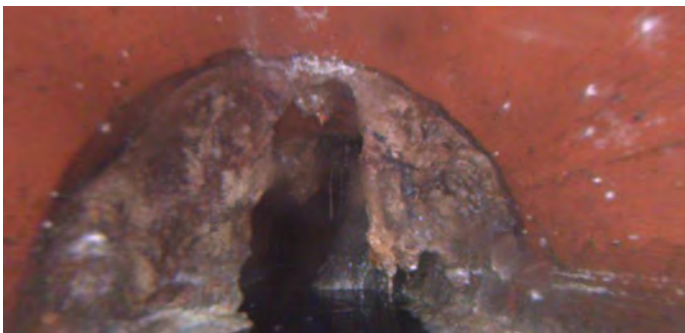
Code: **DAGS**
Description: **Deposits Attached Grease**

Distance (ft): **110.1**
Structural Grade: **0**
O&M Grade: **5**
Clock Start/From: **8**
Clock To: **4**
1st Value:
2nd Value:
Value Percent: **70.000**
Continuous Index:
Within 8" of Joint: **YES**
Remarks:

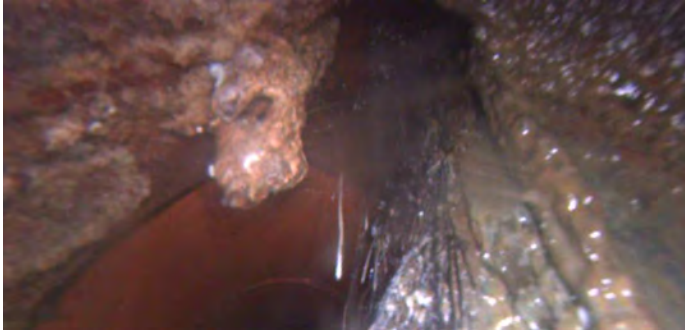
Code: **TFD**
Description: **Tap Factory Defective**

Distance (ft): **111.3**
Structural Grade: **0**
O&M Grade: **2**
Clock Start/From: **1**
Clock To:
1st Value: **4.000**
2nd Value:
Value Percent:
Continuous Index:
Within 8" of Joint:
Remarks: **RML**

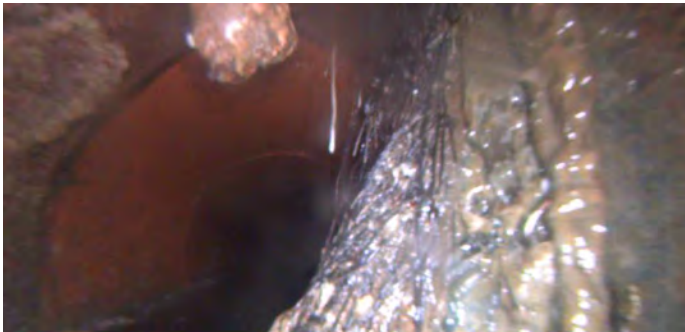
Code: **RML**
Description: **Roots Medium Lateral**

Distance (ft): **111.3**
Structural Grade: **0**
O&M Grade: **3**
Clock Start/From: **12**
Clock To: **4**
1st Value:
2nd Value:
Value Percent: **40.000**
Continuous Index:
Within 8" of Joint: **NO**
Remarks:

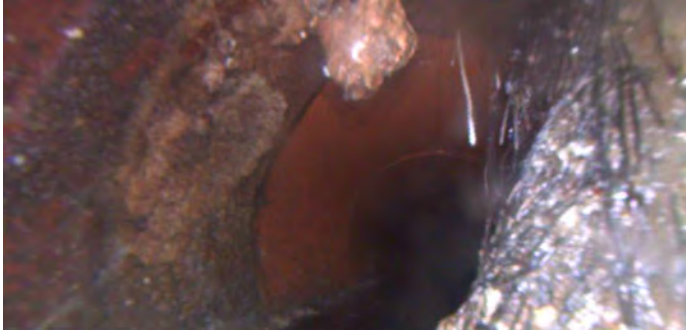
Code: **DAGS**
Description: **Deposits Attached Grease**

Distance (ft): **111.3**
Structural Grade: **0**
O&M Grade: **2**
Clock Start/From: **7**
Clock To: **12**
1st Value:
2nd Value:
Value Percent: **10.000**
Continuous Index:
Within 8" of Joint: **NO**
Remarks:

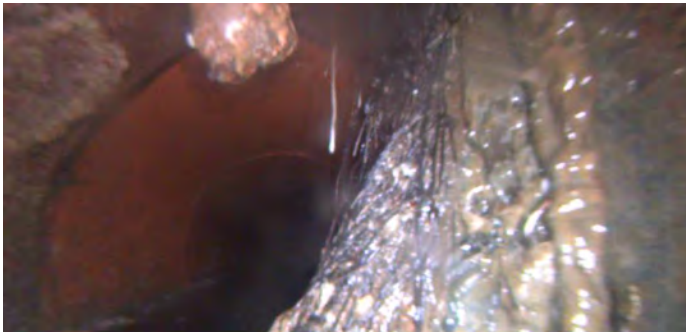
Code: **DAGS**
Description: **Deposits Attached Grease**

Distance (ft): **111.3**
Structural Grade: **0**
O&M Grade: **2**
Clock Start/From: **7**
Clock To: **5**
1st Value:
2nd Value:
Value Percent: **5.000**
Continuous Index: **F01**
Within 8" of Joint: **NO**
Remarks:
