Profile/Photo Observation Report

Street:	ROCHE ST	Flow Control:	Not Controlled
City:	Hobart, IN	Year Renewed:	
Location:	Other	Tape/Media #:	
Purpose:	Not Known	Dia/Height:	12"
Use:	Sanitary	Material:	VCP
Drain Area:	NA	Lining:	
Category:	NA		
Comment:

Location Details:		Direction of Survey:	Upstream
US MH:	M-303-043	DS MH:	M-303-041
		Total Length Surveyed (ft):	130.9

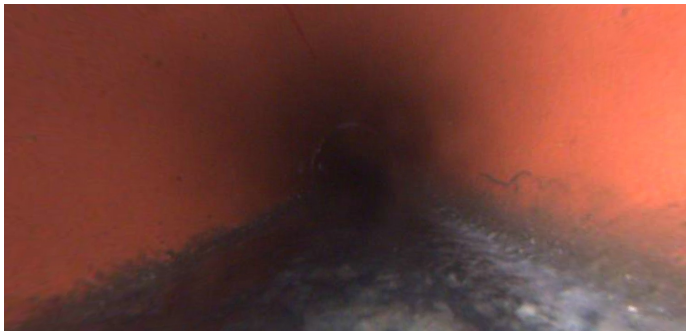
Code: **AMH**
Description: **Manhole**

Distance (ft): **.0**
Structural Grade: **0**
O&M Grade: **0**
Clock Start/From:
Clock To:
1st Value:
2nd Value:
Value Percent:
Continuous Index:
Within 8" of Joint: **NO**
Remarks: **M-303-041**

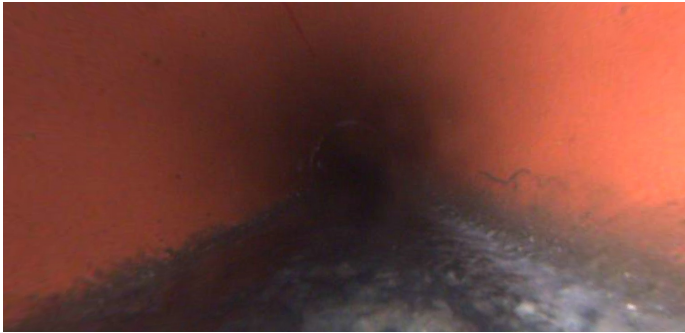
Code:	MWL
Description:	Water Level

Distance (ft):	.0
Structural Grade:	0
O&M Grade:	0
Clock Start/From:	
Clock To:	
1st Value:	
2nd Value:	
Value Percent:	10.000
Continuous Index:	
Within 8" of Joint:	NO
Remarks:

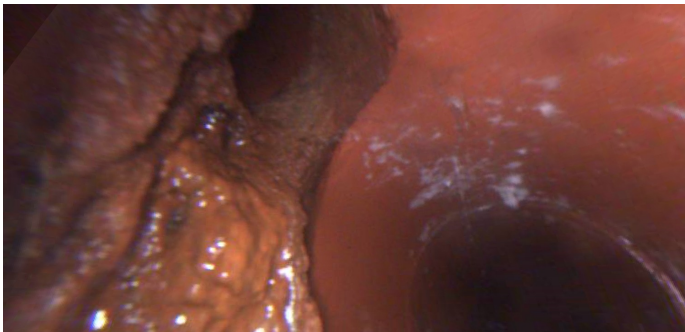
Code:	TFD
Description:	Tap Factory Defective

Distance (ft):	25.0
Structural Grade:	0
O&M Grade:	2
Clock Start/From:	10
Clock To:	
1st Value:	4.000
2nd Value:	
Value Percent:	
Continuous Index:	
Within 8" of Joint:	NO
Remarks:	DAE

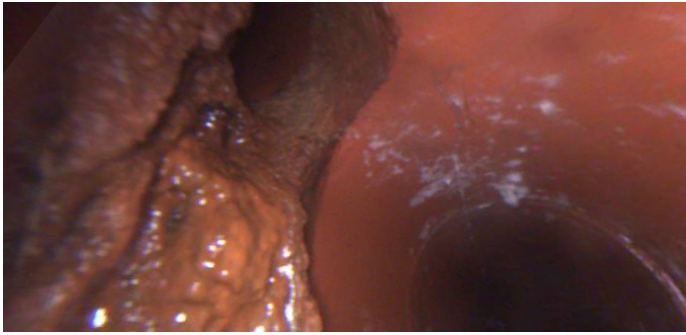
Code: **DAE**
Description: **Deposits Attached Encrustation**

Distance (ft): **25.0**
Structural Grade: **0**
O&M Grade: **3**
Clock Start/From: **7**
Clock To: **10**
1st Value:
2nd Value:
Value Percent: **15.000**
Continuous Index:
Within 8" of Joint: **NO**
Remarks:

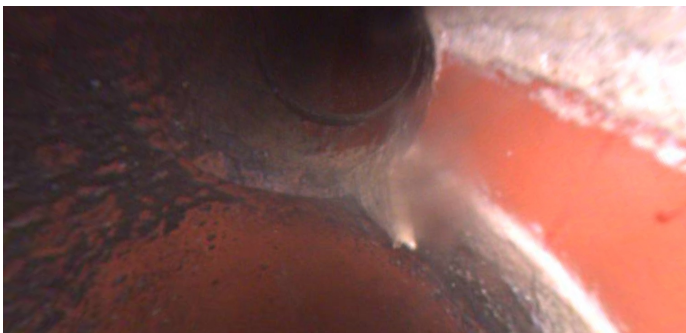
Code: **TF**
Description: **Tap Factory**

Distance (ft): **67.2**
Structural Grade: **0**
O&M Grade: **0**
Clock Start/From: **12**
Clock To:
1st Value: **4.000**
2nd Value:
Value Percent:
Continuous Index:
Within 8" of Joint:
Remarks:

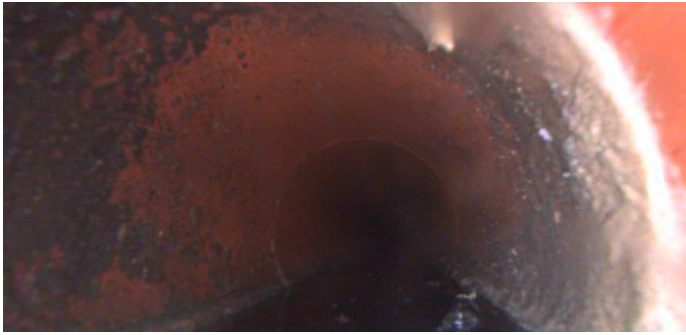
Code: **DAGS**
Description: **Deposits Attached Grease**

Distance (ft): **67.2**
Structural Grade: **0**
O&M Grade: **2**
Clock Start/From: **8**
Clock To: **4**
1st Value:
2nd Value:
Value Percent: **5.000**
Continuous Index:
Within 8" of Joint: **NO**
Remarks:

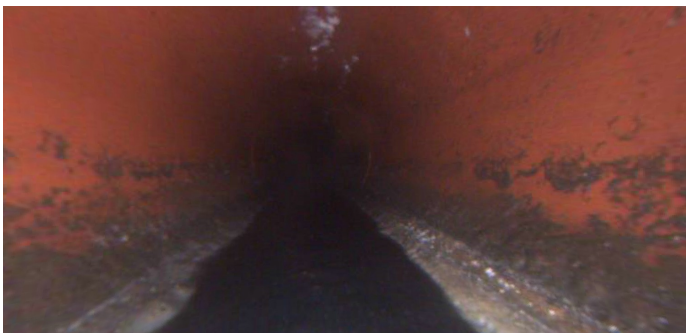
Code: **DAGS**
Description: **Deposits Attached Grease**

Distance (ft): **76.4**
Structural Grade: **0**
O&M Grade: **2**
Clock Start/From: **7**
Clock To: **5**
1st Value:
2nd Value:
Value Percent: **5.000**
Continuous Index: **S01**
Within 8" of Joint: **NO**
Remarks:

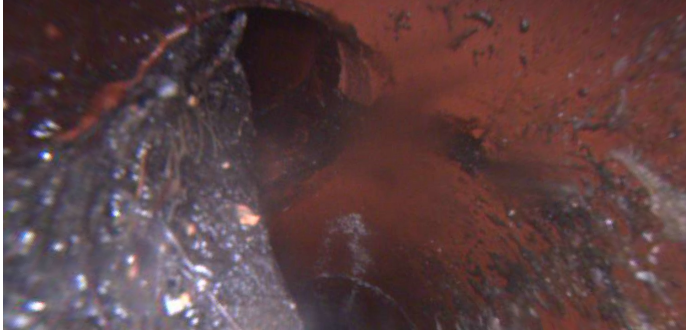
Code: **TFD**
Description: **Tap Factory Defective**

Distance (ft): **84.0**
Structural Grade: **0**
O&M Grade: **2**
Clock Start/From: **1**
Clock To:
1st Value: **4.000**
2nd Value:
Value Percent:
Continuous Index:
Within 8" of Joint:
Remarks: **ROOTS**

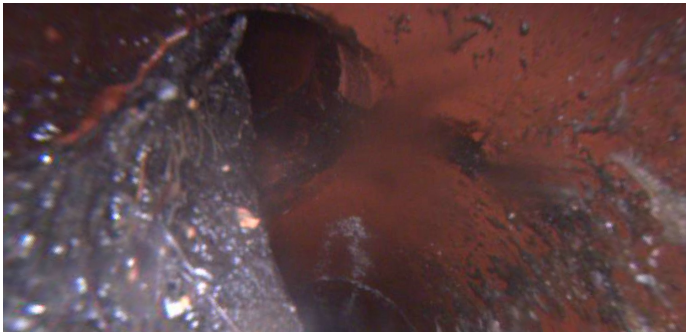
Code: **RML**
Description: **Roots Medium Lateral**

Distance (ft): **84.0**
Structural Grade: **0**
O&M Grade: **3**
Clock Start/From: **6**
Clock To: **12**
1st Value:
2nd Value:
Value Percent: **40.000**
Continuous Index:
Within 8" of Joint: **NO**
Remarks:

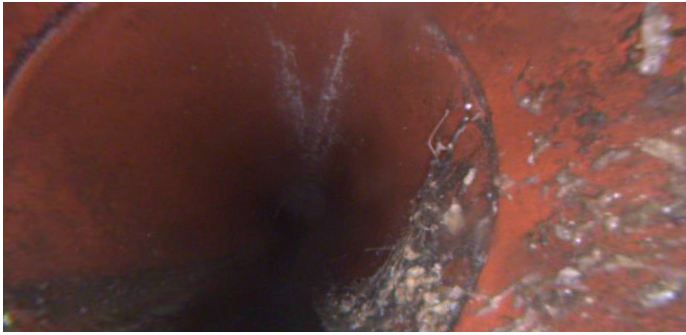
Code: **RMJ**
Description: **Roots Medium Joint**

Distance (ft): **85.3**
Structural Grade: **0**
O&M Grade: **3**
Clock Start/From: **8**
Clock To: **4**
1st Value:
2nd Value:
Value Percent: **5.000**
Continuous Index:
Within 8" of Joint: **YES**
Remarks:

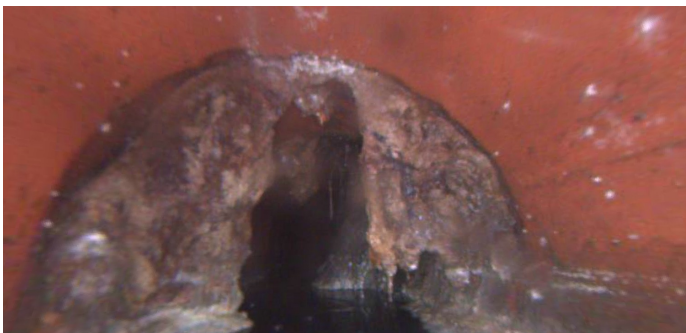
Code: **DAGS**
Description: **Deposits Attached Grease**

Distance (ft): **110.1**
Structural Grade: **0**
O&M Grade: **5**
Clock Start/From: **8**
Clock To: **4**
1st Value:
2nd Value:
Value Percent: **70.000**
Continuous Index:
Within 8" of Joint: **YES**
Remarks:

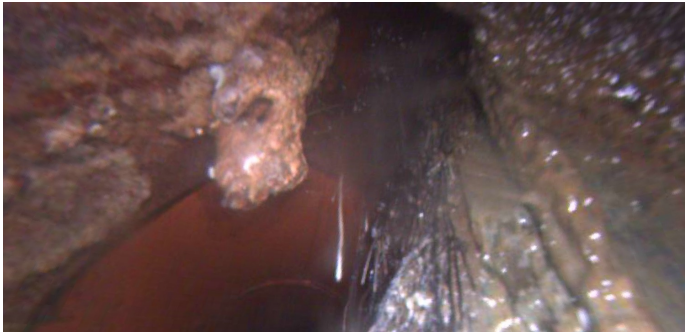
Code: **TFD**
Description: **Tap Factory Defective**

Distance (ft): **111.3**
Structural Grade: **0**
O&M Grade: **2**
Clock Start/From: **1**
Clock To:
1st Value: **4.000**
2nd Value:
Value Percent:
Continuous Index:
Within 8" of Joint:
Remarks: **RML**

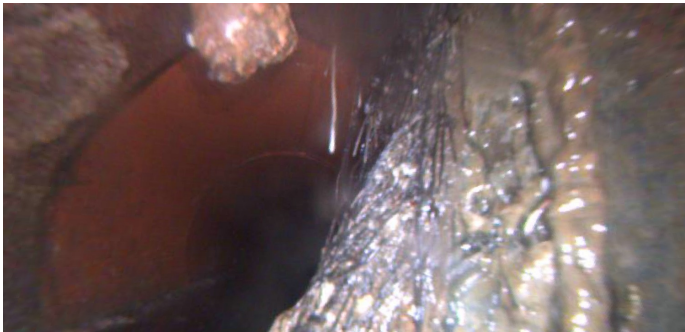
Code: **RML**
Description: **Roots Medium Lateral**

Distance (ft): **111.3**
Structural Grade: **0**
O&M Grade: **3**
Clock Start/From: **12**
Clock To: **4**
1st Value:
2nd Value:
Value Percent: **40.000**
Continuous Index:
Within 8" of Joint: **NO**
Remarks:

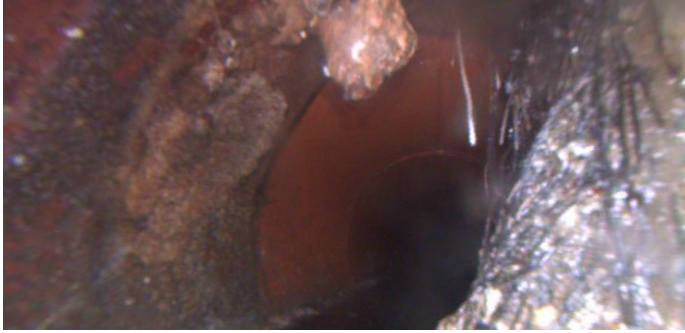
Code: **DAGS**
Description: **Deposits Attached Grease**

Distance (ft): **111.3**
Structural Grade: **0**
O&M Grade: **2**
Clock Start/From: **7**
Clock To: **12**
1st Value:
2nd Value:
Value Percent: **10.000**
Continuous Index:
Within 8" of Joint: **NO**
Remarks:

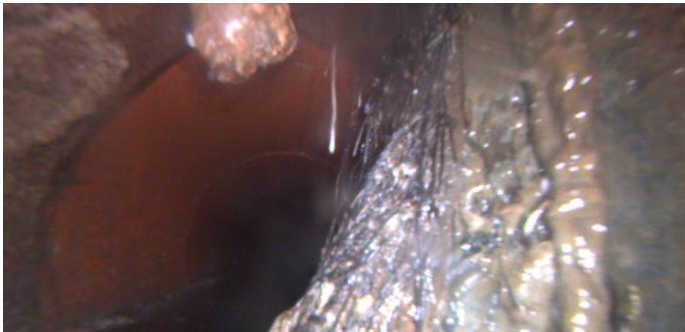
Code: **DAGS**
Description: **Deposits Attached Grease**

Distance (ft): **111.3**
Structural Grade: **0**
O&M Grade: **2**
Clock Start/From: **7**
Clock To: **5**
1st Value:
2nd Value:
Value Percent: **5.000**
Continuous Index: **F01**
Within 8" of Joint: **NO**
Remarks:
