Profile/Photo Observation Report

Date:	10/15/2021	Weather:		Coding:	PACP 6.0
Pipe Length (ft):		Owner:	Hobart, IN	Pre Clean:	Not Known
P.O.#:	804_1	Surveyor:	M. Pielacha	PSR:	P-303-043-044
Customer:	Hobart, IN	Clean Date:		Shape:	C

Street:	Brown Street	Flow Control:	
City:	Hobart, IN	Year Renewed:	
Location:	Light Highway	Tape/Media #:	804
Purpose:	Routine Assessment	Dia/Height:	12"
Use:	Sanitary	Material:	VCP
Drain Area:		Lining:	
Category:	NA		
Comment:

Location Details:		Direction of Survey:	Upstream
US MH:	M-303-44	DS MH:	M-303-43
		Total Length Surveyed (ft):	335.3

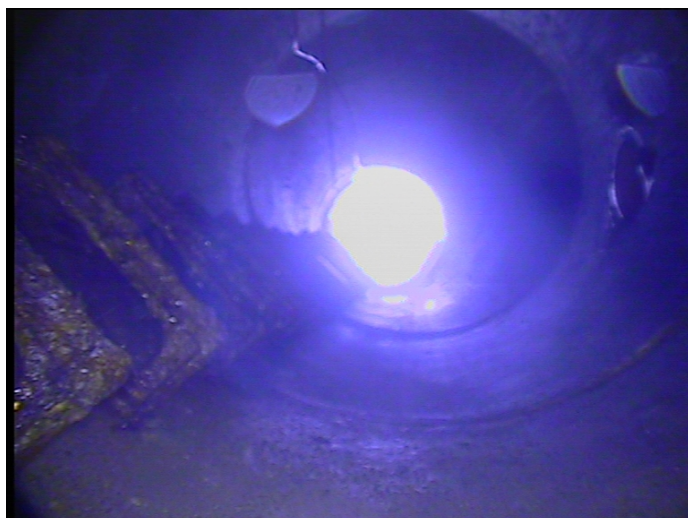
Code: **AMH**
 Description: **Manhole**

Distance (ft): **.0**
 Structural Grade: **0**
 O&M Grade: **0**
 Clock Start/From:
 Clock To:
 1st Value:
 2nd Value:
 Value Percent:
 Continuous Index:
 Within 8" of Joint: **NO**
 Remarks: **M-303-43**

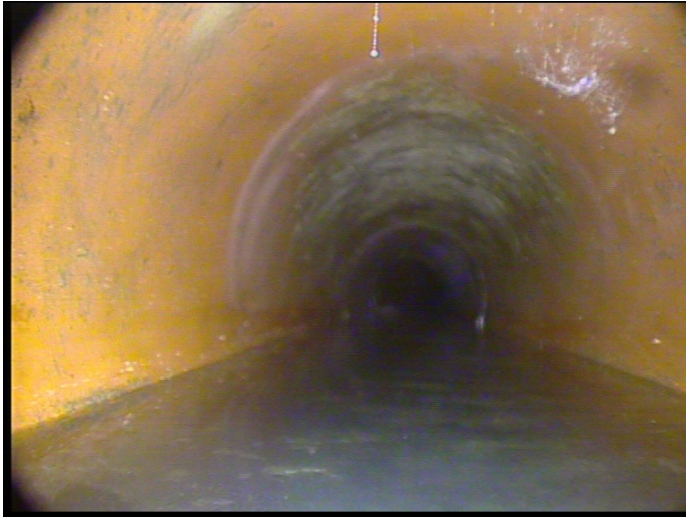
Code: **MWL**
Description: **Water Level**

Distance (ft): **.0**
Structural Grade: **0**
O&M Grade: **0**
Clock Start/From:
Clock To:
1st Value:
2nd Value:
Value Percent: **5.000**
Continuous Index:
Within 8" of Joint: **NO**
Remarks:

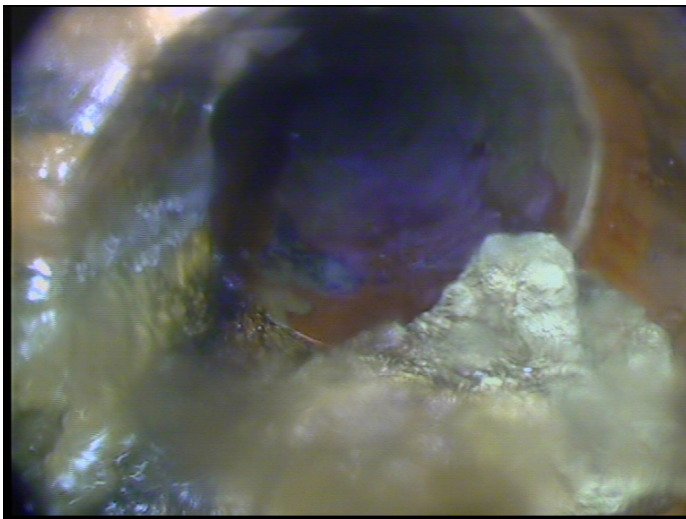
Code: **TFA**
Description: **Tap Factory Active**

Distance (ft): **77.4**
Structural Grade: **0**
O&M Grade: **0**
Clock Start/From: **10**
Clock To:
1st Value: **4.000**
2nd Value:
Value Percent:
Continuous Index:
Within 8" of Joint: **NO**
Remarks:

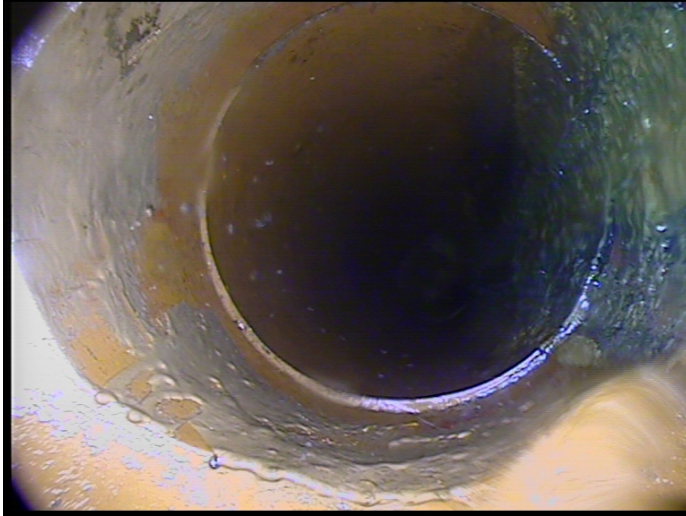
Code: **TF**
Description: **Tap Factory**

Distance (ft): **104.7**
Structural Grade: **0**
O&M Grade: **0**
Clock Start/From: **2**
Clock To:
1st Value: **4.000**
2nd Value:
Value Percent:
Continuous Index:
Within 8" of Joint: **NO**
Remarks:

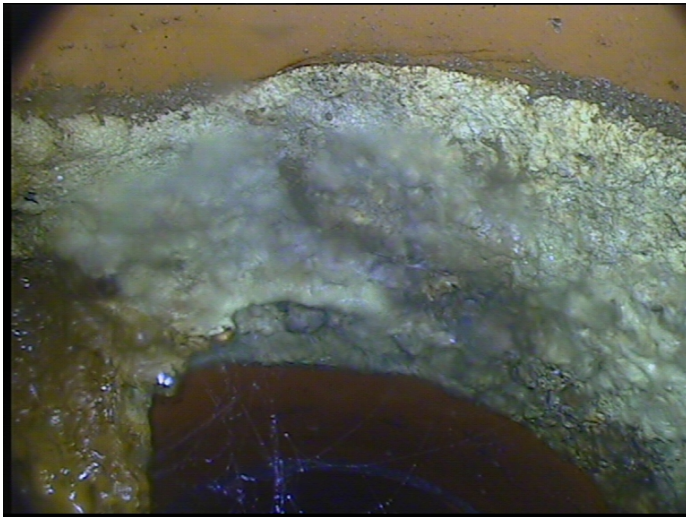
Code: **DAE**
Description: **Deposits Attached Encrustation**

Distance (ft): **146.0**
Structural Grade: **0**
O&M Grade: **2**
Clock Start/From: **8**
Clock To: **4**
1st Value:
2nd Value:
Value Percent: **5.000**
Continuous Index:
Within 8" of Joint: **YES**
Remarks:

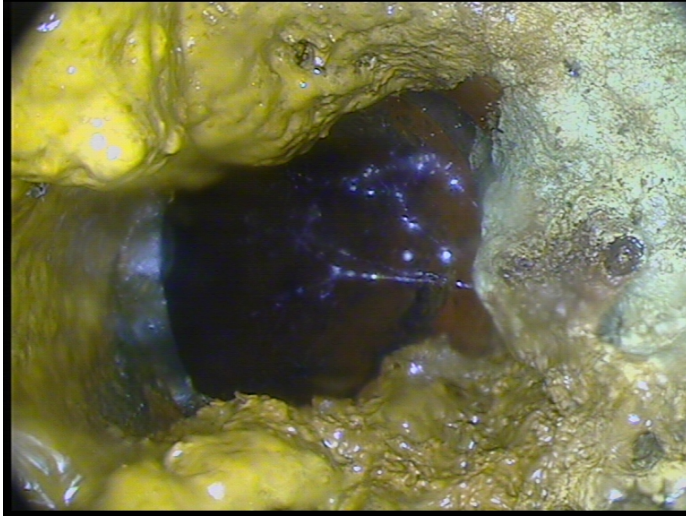
Code:	TFA
Description:	Tap Factory Active
Distance (ft):	146.8
Structural Grade:	0
O&M Grade:	0
Clock Start/From:	10
Clock To:	
1st Value:	4.000
2nd Value:	
Value Percent:	
Continuous Index:	
Within 8" of Joint:	NO
Remarks:

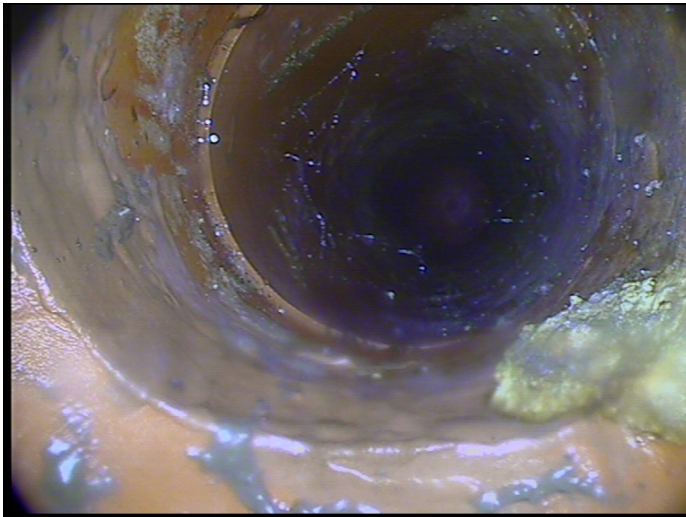
Code:	TF
Description:	Tap Factory
Distance (ft):	179.4
Structural Grade:	0
O&M Grade:	0
Clock Start/From:	2
Clock To:	
1st Value:	4.000
2nd Value:	
Value Percent:	
Continuous Index:	
Within 8" of Joint:	NO
Remarks:

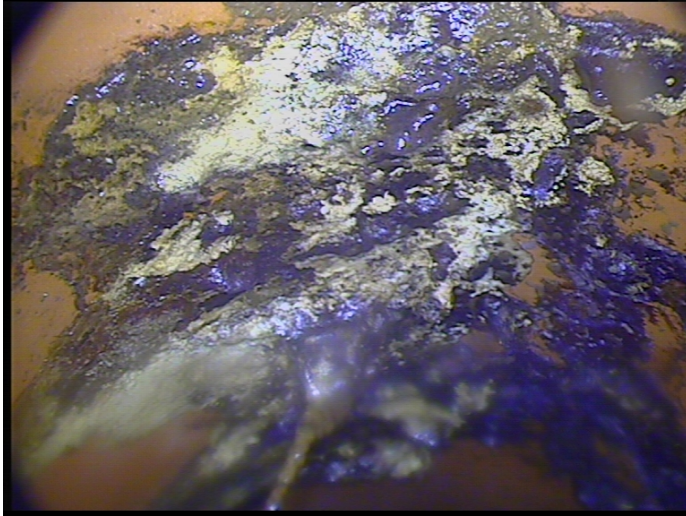
Code:	DAGS
Description:	Deposits Attached Grease
Distance (ft):	190.8
Structural Grade:	0
O&M Grade:	2
Clock Start/From:	9
Clock To:	12
1st Value:	
2nd Value:	
Value Percent:	5.000
Continuous Index:	
Within 8" of Joint:	NO
Remarks:

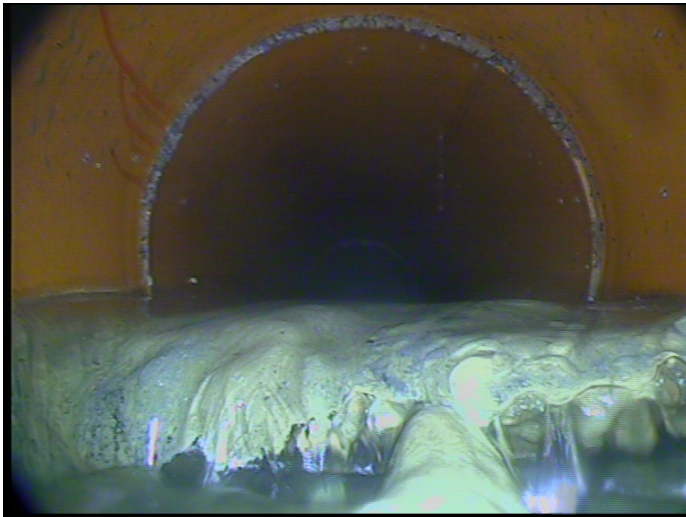
Code:	OBZ
Description:	Obstacle Other
Distance (ft):	238.4
Structural Grade:	0
O&M Grade:	3
Clock Start/From:	4
Clock To:	8
1st Value:	
2nd Value:	
Value Percent:	15.000
Continuous Index:	
Within 8" of Joint:	NO
Remarks:	Debris

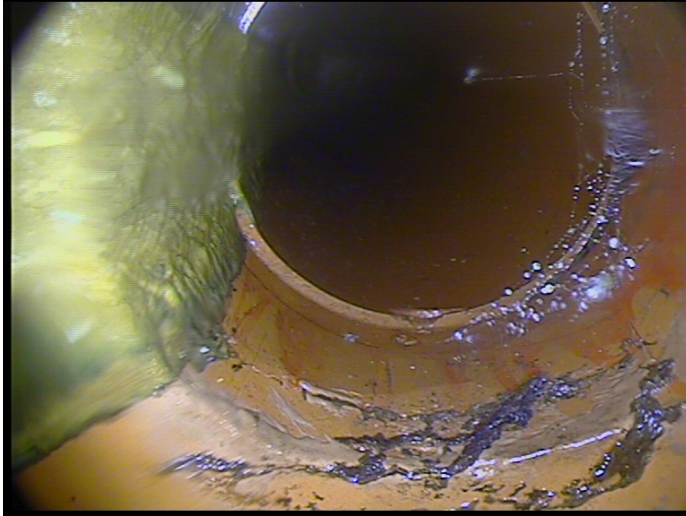
Code: **TF**
Description: **Tap Factory**

Distance (ft): **251.5**
Structural Grade: **0**
O&M Grade: **0**
Clock Start/From: **11**
Clock To:
1st Value: **4.000**
2nd Value:
Value Percent:
Continuous Index:
Within 8" of Joint: **NO**
Remarks:

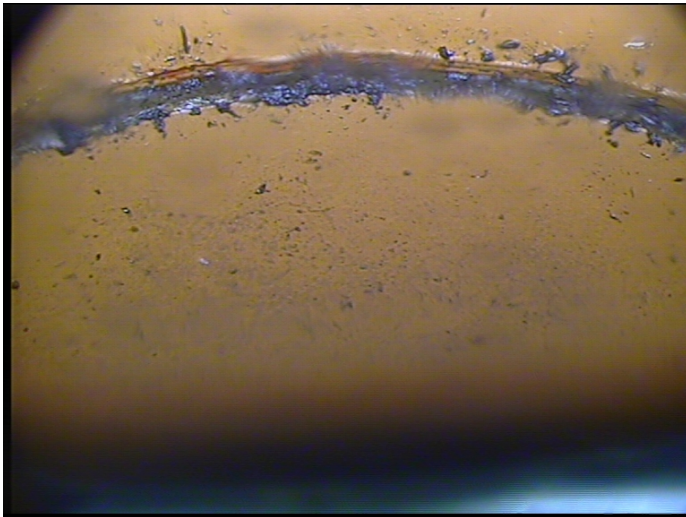
Code: **MWL**
Description: **Water Level**

Distance (ft): **257.4**
Structural Grade: **0**
O&M Grade: **0**
Clock Start/From:
Clock To:
1st Value:
2nd Value:
Value Percent: **50.000**
Continuous Index:
Within 8" of Joint: **NO**
Remarks:

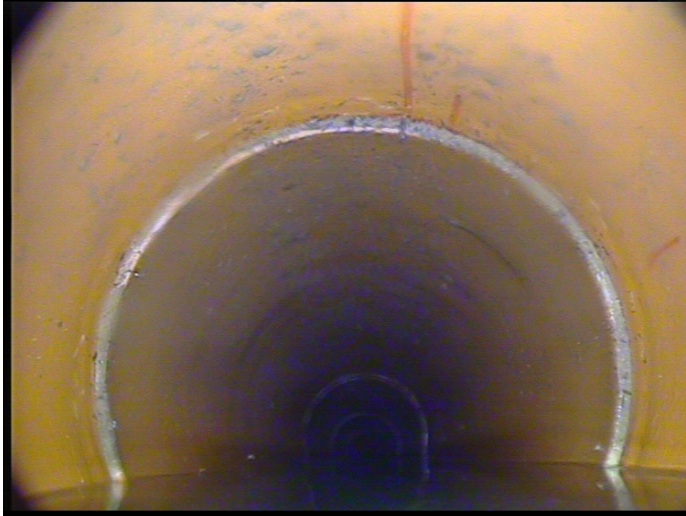
Code: **MWL**
Description: **Water Level**

Distance (ft): **280.0**
Structural Grade: **0**
O&M Grade: **0**
Clock Start/From:
Clock To:
1st Value:
2nd Value:
Value Percent: **20.000**
Continuous Index:
Within 8" of Joint: **NO**
Remarks:

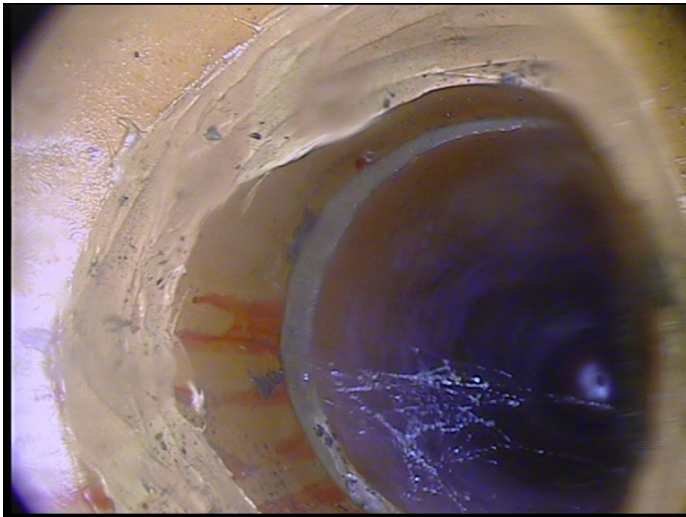
Code: **TF**
Description: **Tap Factory**

Distance (ft): **298.1**
Structural Grade: **0**
O&M Grade: **0**
Clock Start/From: **3**
Clock To:
1st Value: **4.000**
2nd Value:
Value Percent:
Continuous Index:
Within 8" of Joint: **NO**
Remarks:

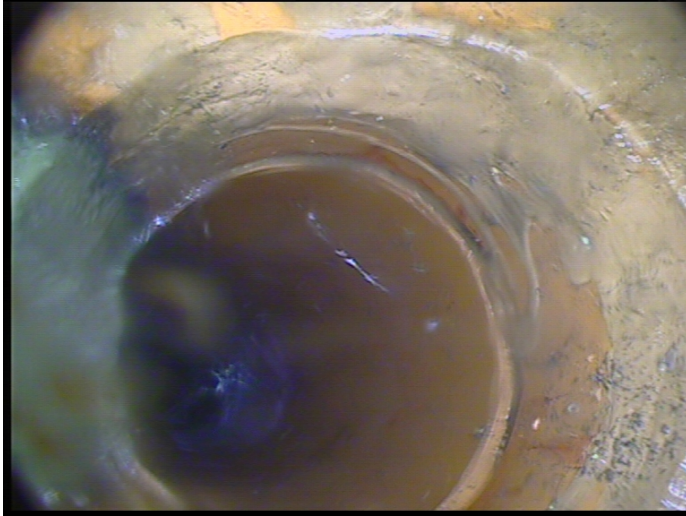
Code:	TFA
Description:	Tap Factory Active
Distance (ft):	315.2
Structural Grade:	0
O&M Grade:	0
Clock Start/From:	10
Clock To:	
1st Value:	4.000
2nd Value:	
Value Percent:	
Continuous Index:	
Within 8" of Joint:	NO
Remarks:

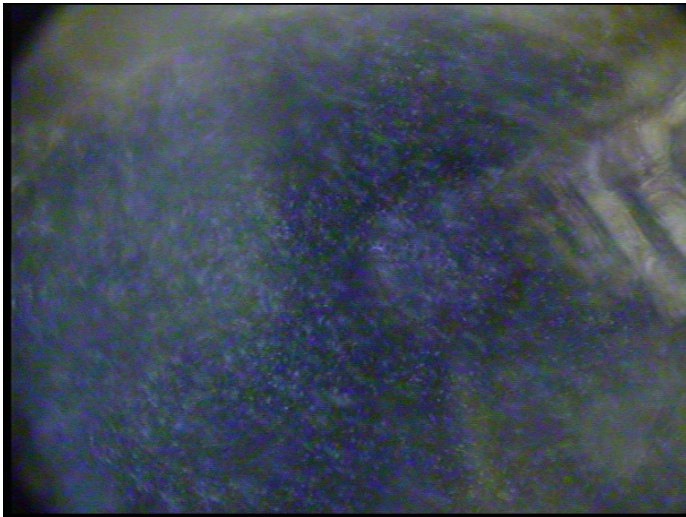
Code:	AMH
Description:	Manhole
Distance (ft):	335.3
Structural Grade:	0
O&M Grade:	0
Clock Start/From:	
Clock To:	
1st Value:	
2nd Value:	
Value Percent:	
Continuous Index:	
Within 8" of Joint:	NO
Remarks:	M-303-44
