## Profile/Photo Observation Report

Street:	<b>BROWN ST</b>	Flow Control:	<b>Not Controlled</b>
City:	<b>Hobart, IN</b>	Year Renewed:	
Location:	<b>Light Highway</b>	Tape/Media #:	
Purpose:	<b>Routine Assessment</b>	Dia/Height:	<b>10"</b>
Use:	<b>Sanitary</b>	Material:	<b>VCP</b>
Drain Area:	<b>NA</b>	Lining:	
Category:	<b>NA</b>		
Comment:

Location Details:		Direction of Survey:	<b>Upstream</b>
US MH:	<b>M-303-044</b>	DS MH:	<b>M-303-045</b>
		Total Length Surveyed (ft):	<b>4.9</b>

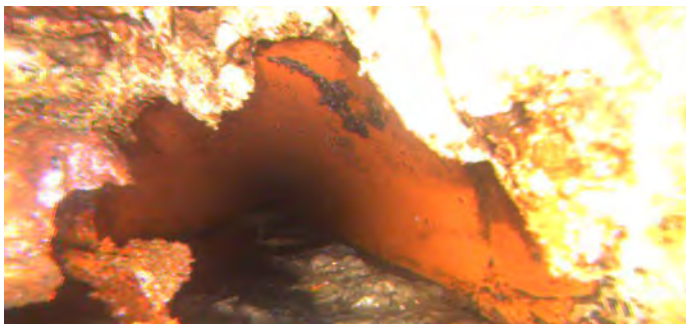
Code: **AMH**  
Description: **Manhole**

Distance (ft): **.0**  
Structural Grade: **0**  
O&M Grade: **0**  
Clock Start/From:  
Clock To:  
1st Value:  
2nd Value:  
Value Percent:  
Continuous Index:  
Within 8" of Joint: **NO**  
Remarks: **M-303-045**

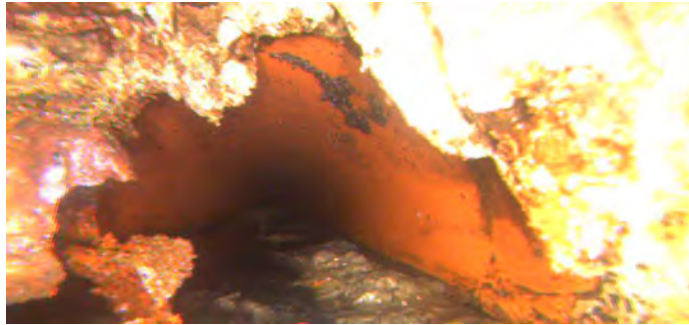
Code: **MWL**  
Description: **Water Level**

Distance (ft): **.0**  
Structural Grade: **0**  
O&M Grade: **0**  
Clock Start/From:  
Clock To:  
1st Value:  
2nd Value:  
Value Percent: **5.000**  
Continuous Index:  
Within 8" of Joint: **NO**  
Remarks:

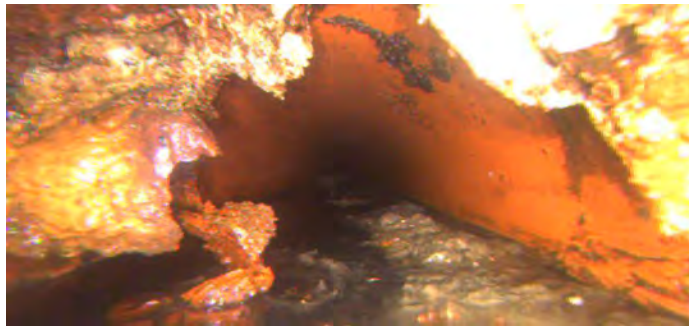
Code: **DAGS**  
Description: **Deposits Attached Grease**

Distance (ft): **.0**  
Structural Grade: **0**  
O&M Grade: **5**  
Clock Start/From: **8**  
Clock To: **3**  
1st Value:  
2nd Value:  
Value Percent: **40.000**  
Continuous Index:  
Within 8" of Joint: **NO**  
Remarks:

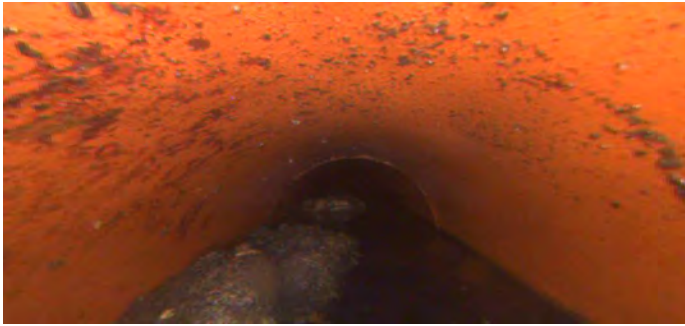
Code: **DSZ**  
Description: **Deposits Settled Other**

Distance (ft): **4.9**  
Structural Grade: **0**  
O&M Grade: **3**  
Clock Start/From: **6**  
Clock To: **8**  
1st Value:  
2nd Value:  
Value Percent: **20.000**  
Continuous Index:  
Within 8" of Joint: **NO**  
Remarks: **mixed material**

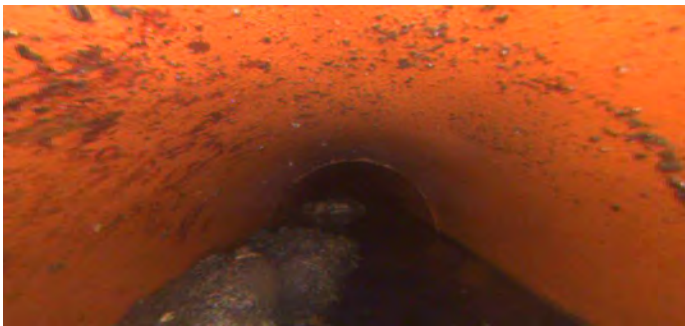
Code: **MSA**  
Description: **Abandoned Survey**

Distance (ft): **4.9**  
Structural Grade: **0**  
O&M Grade: **0**  
Clock Start/From:  
Clock To:  
1st Value:  
2nd Value:  
Value Percent:  
Continuous Index:  
Within 8" of Joint: **NO**  
Remarks: **mixed material blocking camera passage**
