Profile/Photo Observation Report

Street:	Kenwood St	Flow Control:	Not Controlled
City:	Hobart, IN	Year Renewed:	
Location:	Light Highway	Tape/Media #:	
Purpose:	Routine Assessment	Dia/Height:	10"
Use:	Sanitary	Material:	VCP
Drain Area:	NA	Lining:	
Category:	NA		
Comment:

Location Details:		Direction of Survey:	Upstream
US MH:	M-303-044	DS MH:	M-303-045
		Total Length Surveyed (ft):	4.9

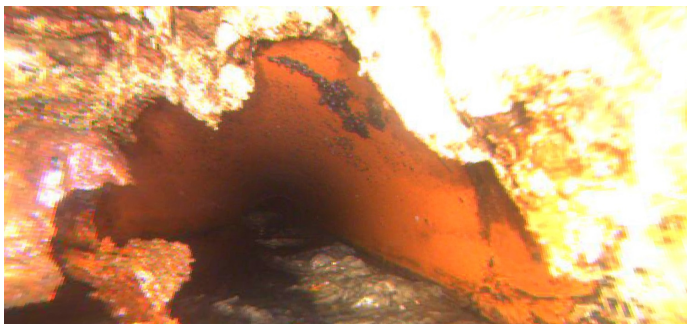
Code: **AMH**
 Description: **Manhole**

Distance (ft): **.0**
 Structural Grade: **0**
 O&M Grade: **0**
 Clock Start/From:
 Clock To:
 1st Value:
 2nd Value:
 Value Percent:
 Continuous Index:
 Within 8" of Joint: **NO**
 Remarks: **M-303-045**

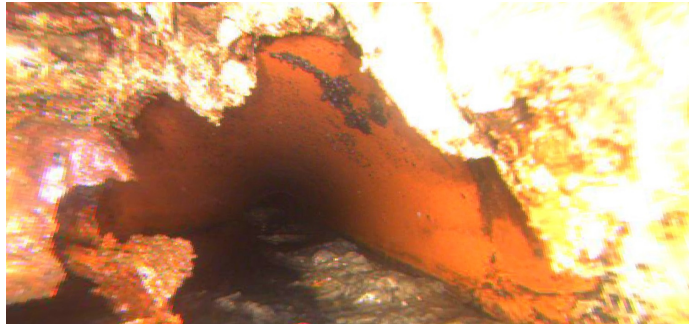
Code: **MWL**
Description: **Water Level**

Distance (ft): **.0**
Structural Grade: **0**
O&M Grade: **0**
Clock Start/From:
Clock To:
1st Value:
2nd Value:
Value Percent: **5.000**
Continuous Index:
Within 8" of Joint: **NO**
Remarks:

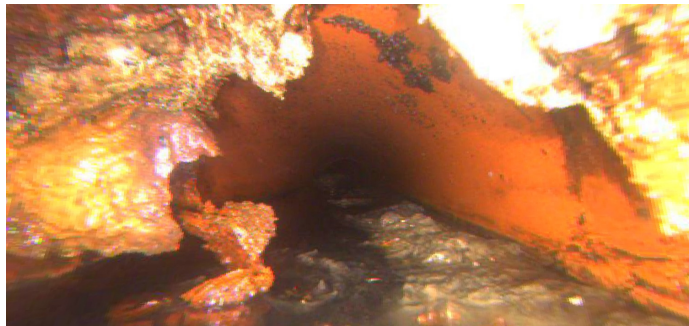
Code: **DAGS**
Description: **Deposits Attached Grease**

Distance (ft): **.0**
Structural Grade: **0**
O&M Grade: **5**
Clock Start/From: **8**
Clock To: **3**
1st Value:
2nd Value:
Value Percent: **40.000**
Continuous Index:
Within 8" of Joint: **NO**
Remarks:

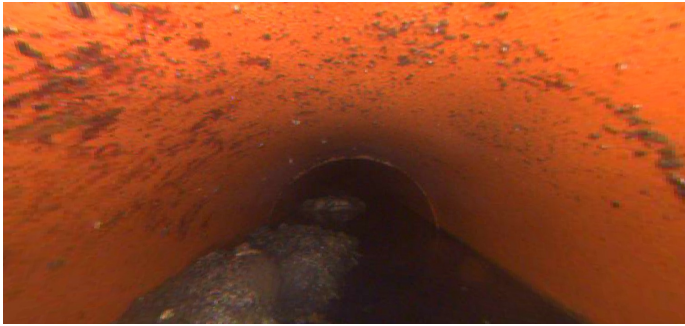
Code: **DSZ**
Description: **Deposits Settled Other**

Distance (ft): **4.9**
Structural Grade: **0**
O&M Grade: **3**
Clock Start/From: **6**
Clock To: **8**
1st Value:
2nd Value:
Value Percent: **20.000**
Continuous Index:
Within 8" of Joint: **NO**
Remarks: **mixed material**

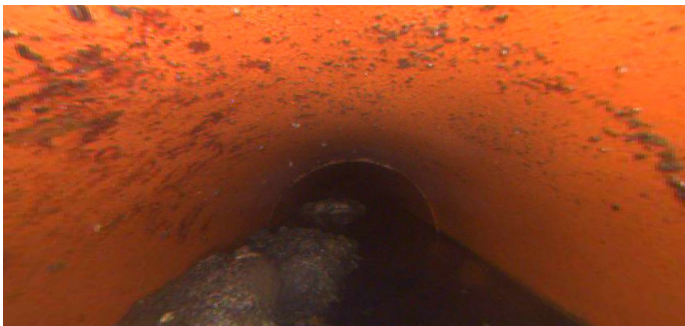
Code: **MSA**
Description: **Abandoned Survey**

Distance (ft): **4.9**
Structural Grade: **0**
O&M Grade: **0**
Clock Start/From:
Clock To:
1st Value:
2nd Value:
Value Percent:
Continuous Index:
Within 8" of Joint: **NO**
Remarks: **mixed material blocking camera passage**
