Profile/Photo Observation Report

Date:	09/26/2018	Weather:		Coding:	PACP 6.0
Pipe Length (ft):	329.7	Owner:	NA	Pre Clean:	Not Known
P.O.#:		Surveyor:	Justin Gonzales	PSR:	P-303-045.2-045.1
Customer:		Clean Date:	01/01/1900	Shape:	C

Street:	BROWN ST	Flow Control:	Not Controlled
City:	Hobart, IN	Year Renewed:	
Location:	Light Highway	Tape/Media #:	
Purpose:	Routine Assessment	Dia/Height:	10"
Use:	Sanitary	Material:	VCP
Drain Area:	NA	Lining:	
Category:	NA		
Comment:

Location Details:		Direction of Survey:	Upstream
US MH:	M-303-045.1	DS MH:	M-303-045.2
		Total Length Surveyed (ft):	271.5

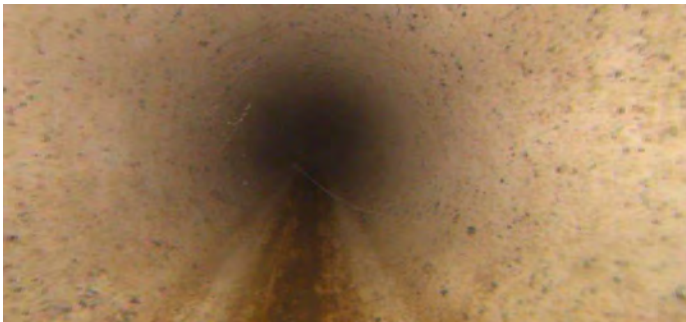
Code:	AMH
Description:	Manhole
Distance (ft):	.0
Structural Grade:	0
O&M Grade:	0
Clock Start/From:	
Clock To:	
1st Value:	
2nd Value:	
Value Percent:	
Continuous Index:	
Within 8" of Joint:	NO
Remarks:	M-303-045.2

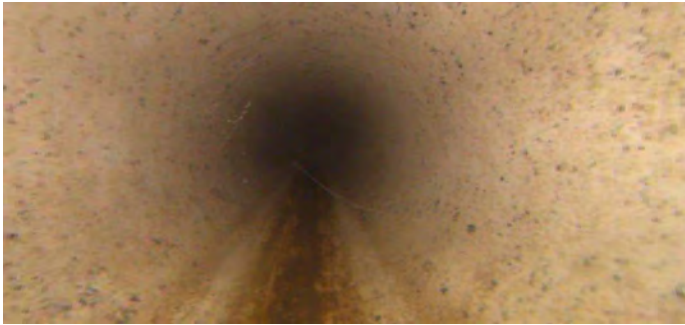
Code:	MWL
Description:	Water Level

Distance (ft):	.0
Structural Grade:	0
O&M Grade:	0
Clock Start/From:	
Clock To:	
1st Value:	
2nd Value:	
Value Percent:	5.000
Continuous Index:	
Within 8" of Joint:	NO
Remarks:

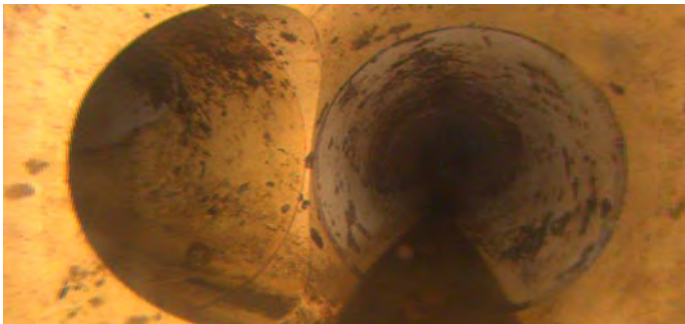
Code:	TF
Description:	Tap Factory

Distance (ft):	96.6
Structural Grade:	0
O&M Grade:	0
Clock Start/From:	9
Clock To:	
1st Value:	6.000
2nd Value:	
Value Percent:	
Continuous Index:	
Within 8" of Joint:	
Remarks:

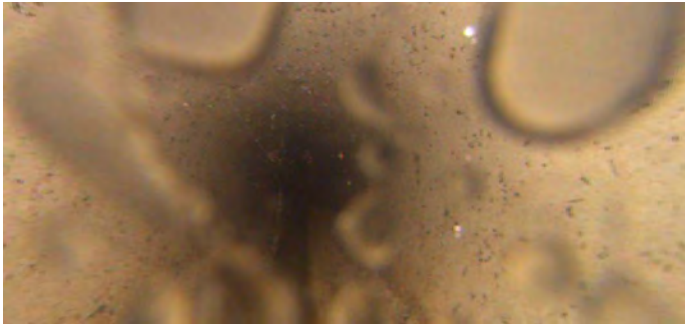
Code: **MGO**
Description: **General Observation**

Distance (ft): **104.5**
Structural Grade: **0**
O&M Grade: **0**
Clock Start/From:
Clock To:
1st Value:
2nd Value:
Value Percent:
Continuous Index:
Within 8" of Joint: **NO**
Remarks: **WATER DROPLETS FROM SPIDER WEBS**

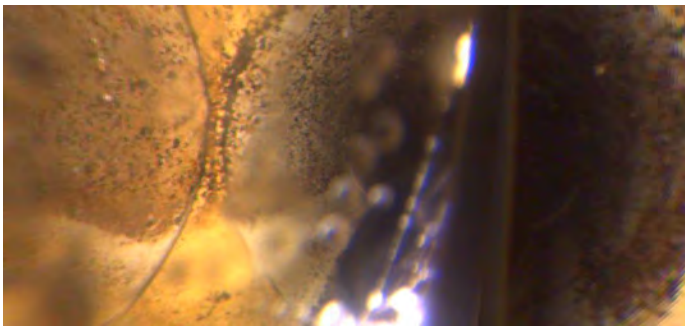
Code: **TF**
Description: **Tap Factory**

Distance (ft): **111.2**
Structural Grade: **0**
O&M Grade: **0**
Clock Start/From: **3**
Clock To:
1st Value: **6.000**
2nd Value:
Value Percent:
Continuous Index:
Within 8" of Joint:
Remarks:

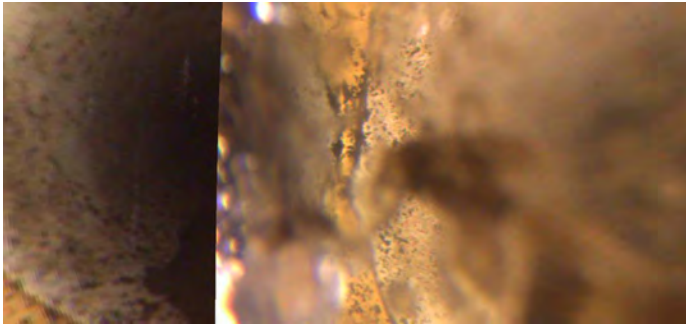
Code: **TF**
Description: **Tap Factory**

Distance (ft): **179.1**
Structural Grade: **0**
O&M Grade: **0**
Clock Start/From: **9**
Clock To:
1st Value: **6.000**
2nd Value:
Value Percent:
Continuous Index:
Within 8" of Joint:
Remarks:

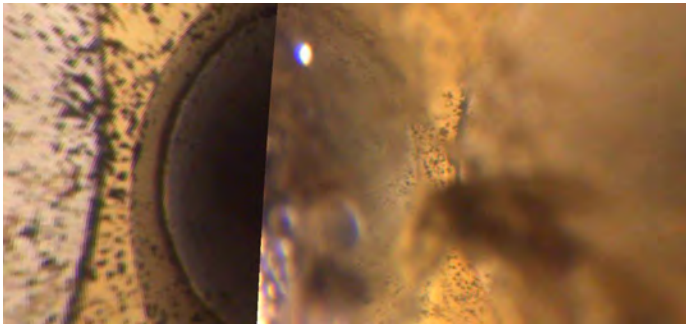
Code: **TF**
Description: **Tap Factory**

Distance (ft): **225.0**
Structural Grade: **0**
O&M Grade: **0**
Clock Start/From: **9**
Clock To:
1st Value: **6.000**
2nd Value:
Value Percent:
Continuous Index:
Within 8" of Joint:
Remarks:

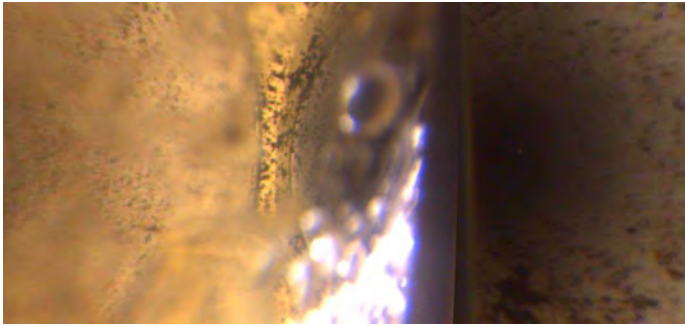
Code: **TF**
Description: **Tap Factory**

Distance (ft): **231.0**
Structural Grade: **0**
O&M Grade: **0**
Clock Start/From: **3**
Clock To:
1st Value: **6.000**
2nd Value:
Value Percent:
Continuous Index:
Within 8" of Joint:
Remarks:

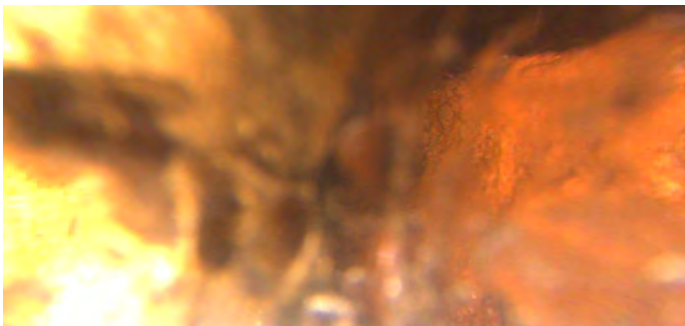
Code: **AMH**
Description: **Manhole**

Distance (ft): **271.5**
Structural Grade: **0**
O&M Grade: **0**
Clock Start/From:
Clock To:
1st Value:
2nd Value:
Value Percent:
Continuous Index:
Within 8" of Joint: **NO**
Remarks: **M-303-045.1**
