Profile/Photo Observation Report

Date:	09/26/2018	Weather:		Coding:	PACP 6.0
Pipe Length (ft):	329.7	Owner:	NA	Pre Clean:	Not Known
P.O.#:		Surveyor:	Justin Gonzales	PSR:	P-303-045.2-045.1
Customer:		Clean Date:	01/01/1900	Shape:	C

Street:	Brown St.	Flow Control:	Not Controlled
City:	Hobart, IN	Year Renewed:	
Location:	Light Highway	Tape/Media #:	
Purpose:	Routine Assessment	Dia/Height:	10"
Use:	Sanitary	Material:	VCP
Drain Area:	NA	Lining:	
Category:	NA		
Comment:			
Location Details:		Direction of Survey:	Upstream
US MH:	M-303-045.1	DS MH:	M-303-045.2
		Total Length Surveyed (ft):	271.5

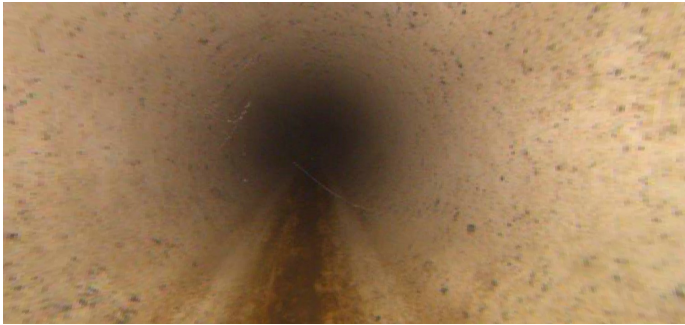
Code:	MWL
Description:	Water Level

Distance (ft):	.0
Structural Grade:	0
O&M Grade:	0
Clock Start/From:	
Clock To:	
1st Value:	
2nd Value:	
Value Percent:	5.000
Continuous Index:	
Within 8" of Joint:	NO
Remarks:

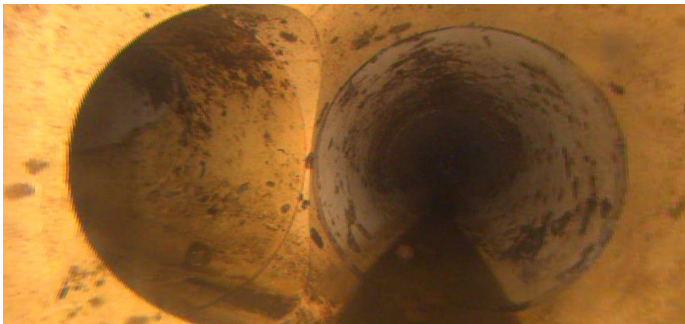
Code:	TF
Description:	Tap Factory

Distance (ft):	96.6
Structural Grade:	0
O&M Grade:	0
Clock Start/From:	9
Clock To:	
1st Value:	6.000
2nd Value:	
Value Percent:	
Continuous Index:	
Within 8" of Joint:	
Remarks:

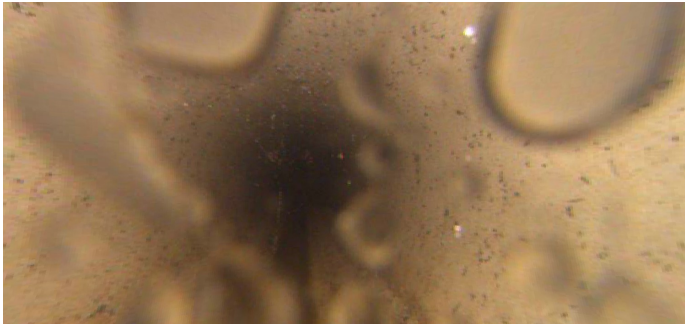
Code: **MGO**
Description: **General Observation**

Distance (ft): **104.5**
Structural Grade: **0**
O&M Grade: **0**
Clock Start/From:
Clock To:
1st Value:
2nd Value:
Value Percent:
Continuous Index:
Within 8" of Joint: **NO**
Remarks: **WATER DROPLETS FROM SPIDER WEBS**

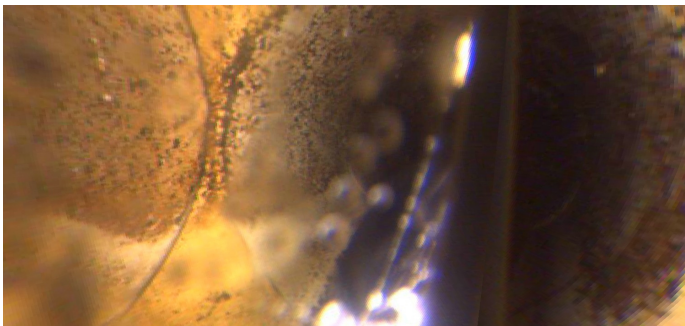
Code: **TF**
Description: **Tap Factory**

Distance (ft): **111.2**
Structural Grade: **0**
O&M Grade: **0**
Clock Start/From: **3**
Clock To:
1st Value: **6.000**
2nd Value:
Value Percent:
Continuous Index:
Within 8" of Joint:
Remarks:

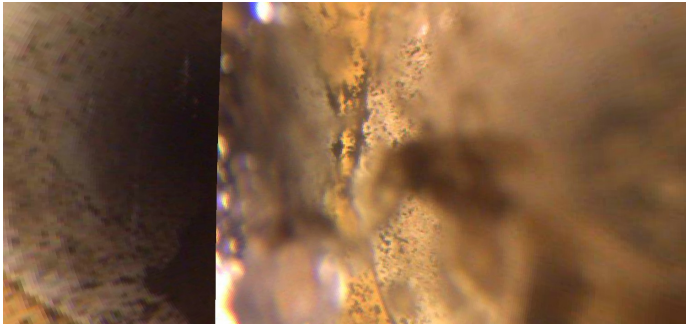
Code: **TF**
Description: **Tap Factory**

Distance (ft): **179.1**
Structural Grade: **0**
O&M Grade: **0**
Clock Start/From: **9**
Clock To:
1st Value: **6.000**
2nd Value:
Value Percent:
Continuous Index:
Within 8" of Joint:
Remarks:

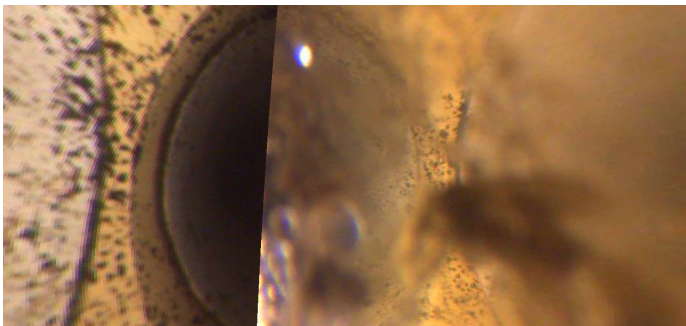
Code: **TF**
Description: **Tap Factory**

Distance (ft): **225.0**
Structural Grade: **0**
O&M Grade: **0**
Clock Start/From: **9**
Clock To:
1st Value: **6.000**
2nd Value:
Value Percent:
Continuous Index:
Within 8" of Joint:
Remarks:

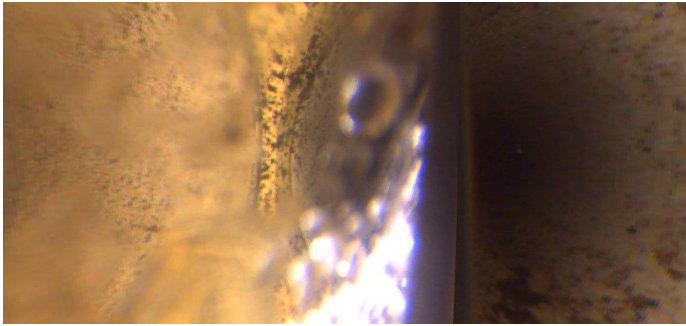
Code: **TF**
Description: **Tap Factory**

Distance (ft): **231.0**
Structural Grade: **0**
O&M Grade: **0**
Clock Start/From: **3**
Clock To:
1st Value: **6.000**
2nd Value:
Value Percent:
Continuous Index:
Within 8" of Joint:
Remarks:

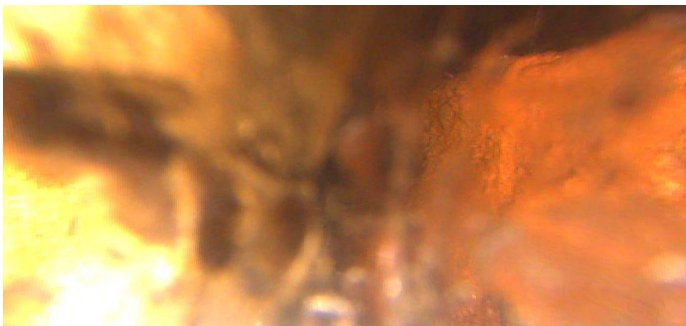
Code: **AMH**
Description: **Manhole**

Distance (ft): **271.5**
Structural Grade: **0**
O&M Grade: **0**
Clock Start/From:
Clock To:
1st Value:
2nd Value:
Value Percent:
Continuous Index:
Within 8" of Joint: **NO**
Remarks: **M-303-045.1**
