Profile/Photo Observation Report

Date:	09/26/2018	Weather:		Coding:	PACP 6.0
Pipe Length (ft):	329.7	Owner:	NA	Pre Clean:	Not Known
P.O.#:		Surveyor:	Justin Gonzales	PSR:	P-303-045.2-045.1
Customer:		Clean Date:	01/01/1900	Shape:	C

Street:	Brown St.	Flow Control:	Not Controlled
City:	Hobart, IN	Year Renewed:	
Location:	Light Highway	Tape/Media #:	
Purpose:	Routine Assessment	Dia/Height:	10"
Use:	Sanitary	Material:	VCP
Drain Area:	NA	Lining:	
Category:	NA		
Comment:

Location Details:		Direction of Survey:	Upstream
US MH:	M-303-045.1	DS MH:	M-303-045.2
		Total Length Surveyed (ft):	269.5

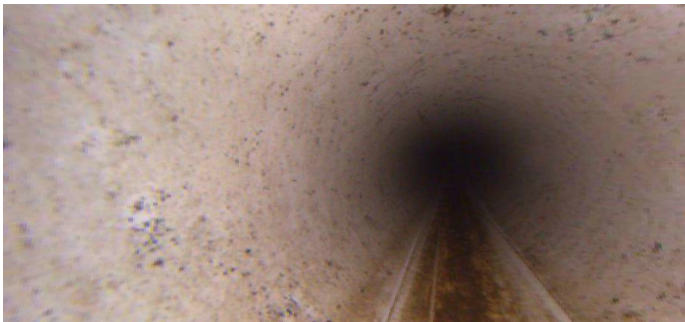
Code: **AMH**
Description: **Manhole**

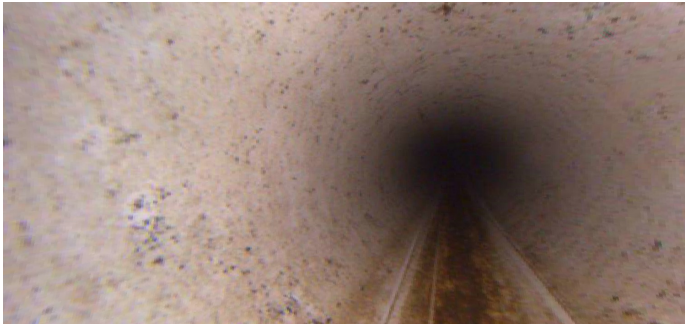
Code:	MWL
Description:	Water Level

Distance (ft):	.0
Structural Grade:	0
O&M Grade:	0
Clock Start/From:	
Clock To:	
1st Value:	
2nd Value:	
Value Percent:	5.000
Continuous Index:	
Within 8" of Joint:	NO
Remarks:

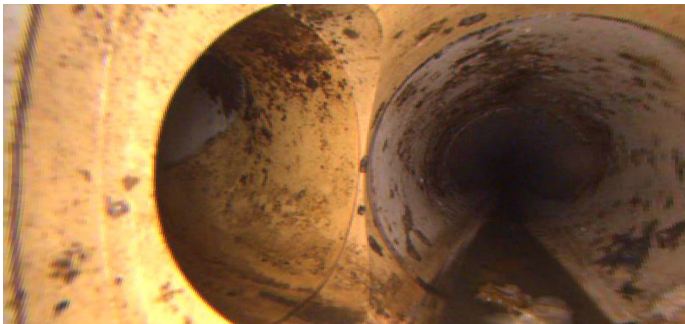
Code:	TF
Description:	Tap Factory

Distance (ft):	96.3
Structural Grade:	0
O&M Grade:	0
Clock Start/From:	9
Clock To:	
1st Value:	6.000
2nd Value:	
Value Percent:	
Continuous Index:	
Within 8" of Joint:	
Remarks:

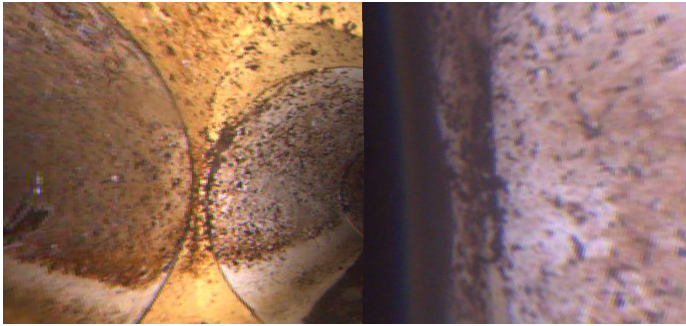
Code: **TF**
Description: **Tap Factory**

Distance (ft): **110.7**
Structural Grade: **0**
O&M Grade: **0**
Clock Start/From: **3**
Clock To:
1st Value: **6.000**
2nd Value:
Value Percent:
Continuous Index:
Within 8" of Joint:
Remarks:

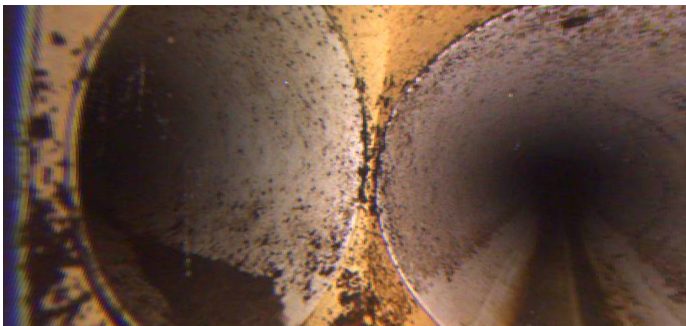
Code: **TF**
Description: **Tap Factory**

Distance (ft): **177.6**
Structural Grade: **0**
O&M Grade: **0**
Clock Start/From: **9**
Clock To:
1st Value: **6.000**
2nd Value:
Value Percent:
Continuous Index:
Within 8" of Joint:
Remarks:

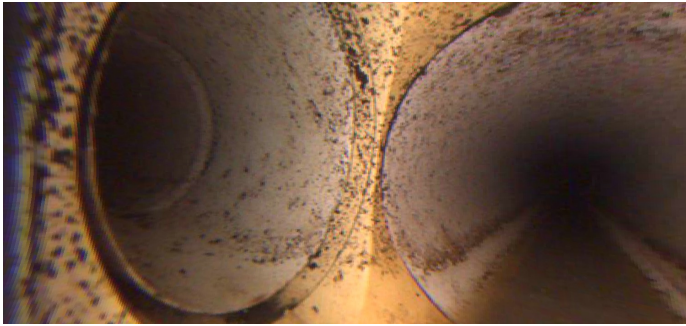
Code: **TF**
Description: **Tap Factory**

Distance (ft): **223.1**
Structural Grade: **0**
O&M Grade: **0**
Clock Start/From: **9**
Clock To:
1st Value: **6.000**
2nd Value:
Value Percent:
Continuous Index:
Within 8" of Joint:
Remarks:

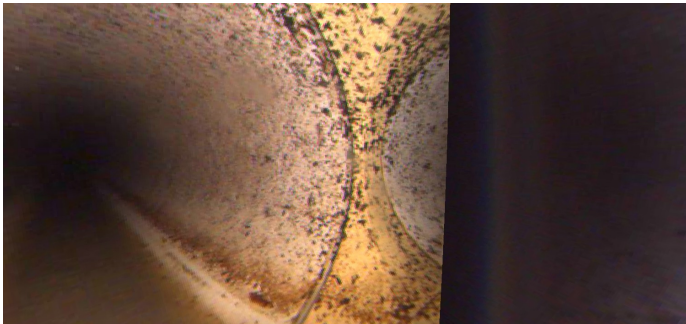
Code: **TF**
Description: **Tap Factory**

Distance (ft): **229.1**
Structural Grade: **0**
O&M Grade: **0**
Clock Start/From: **3**
Clock To:
1st Value: **4.000**
2nd Value:
Value Percent:
Continuous Index:
Within 8" of Joint:
Remarks:

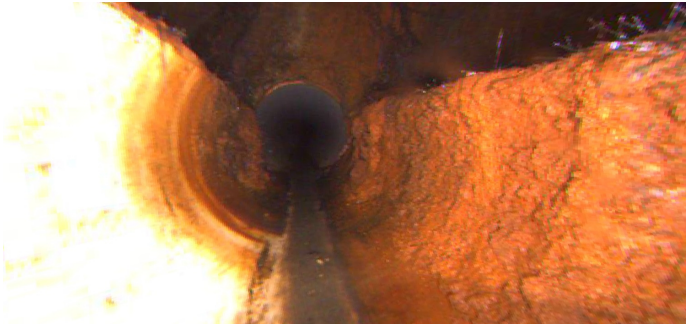
Code: **AMH**
Description: **Manhole**

Distance (ft): **269.5**
Structural Grade: **0**
O&M Grade: **0**
Clock Start/From:
Clock To:
1st Value:
2nd Value:
Value Percent:
Continuous Index:
Within 8" of Joint: **NO**
Remarks: **M-303-045.1**
