Profile/Photo Observation Report

Date:	10/15/2021	Weather:		Coding:	PACP 6.0
Pipe Length (ft):		Owner:	Hobart, IN	Pre Clean:	Not Known
P.O.#:	803_1	Surveyor:	M. Pielacha	PSR:	P-303-044-046
Customer:	Hobart, IN	Clean Date:		Shape:	C

Street:	Brown Street	Flow Control:	
City:	Hobart, IN	Year Renewed:	
Location:	Light Highway	Tape/Media #:	803
Purpose:	Routine Assessment	Dia/Height:	12"
Use:	Sanitary	Material:	VCP
Drain Area:		Lining:	
Category:	NA		
Comment:

Location Details:		Direction of Survey:	Downstream
US MH:	M-303-46	DS MH:	M-303-44
		Total Length Surveyed (ft):	248.8

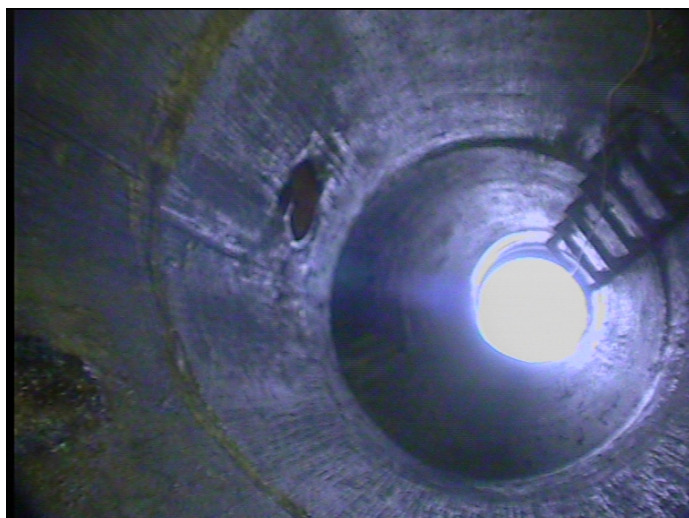
Code: **AMH**
 Description: **Manhole**

Distance (ft): **.0**
 Structural Grade: **0**
 O&M Grade: **0**
 Clock Start/From:
 Clock To:
 1st Value:
 2nd Value:
 Value Percent:
 Continuous Index:
 Within 8" of Joint: **NO**
 Remarks: **M-303-46**

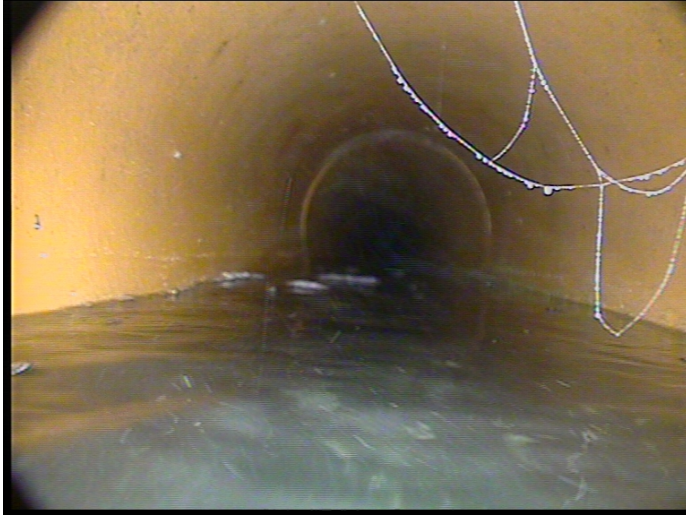
Code:	MWL
Description:	Water Level
Distance (ft):	.0
Structural Grade:	0
O&M Grade:	0
Clock Start/From:	
Clock To:	
1st Value:	
2nd Value:	
Value Percent:	15.000
Continuous Index:	
Within 8" of Joint:	NO
Remarks:

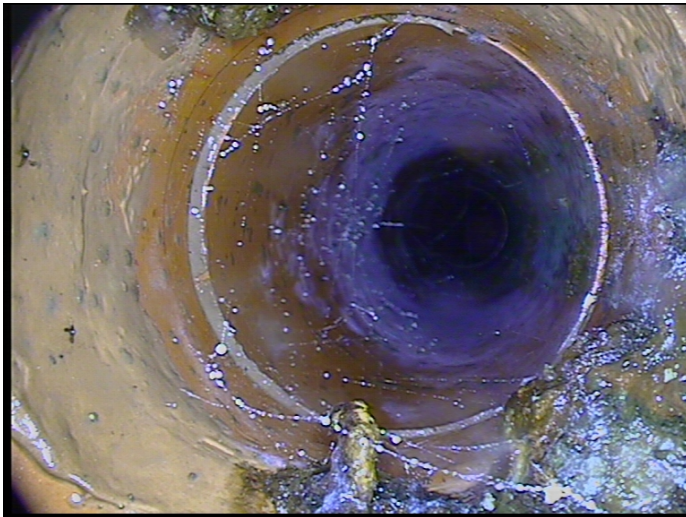
Code:	TF
Description:	Tap Factory
Distance (ft):	45.2
Structural Grade:	0
O&M Grade:	0
Clock Start/From:	2
Clock To:	
1st Value:	4.000
2nd Value:	
Value Percent:	
Continuous Index:	
Within 8" of Joint:	NO
Remarks:

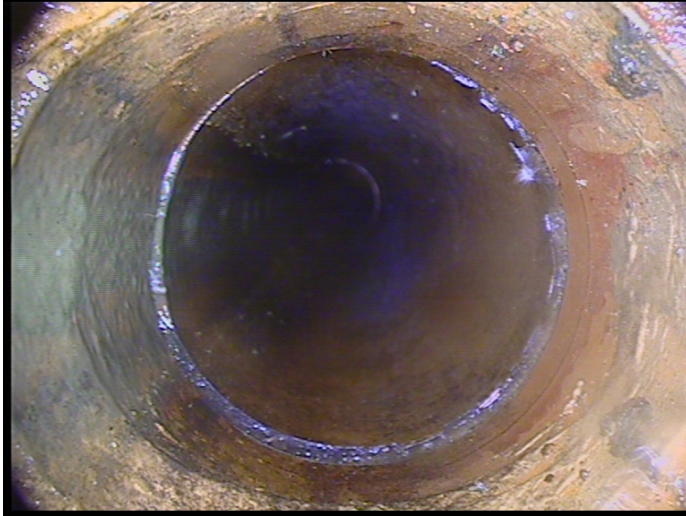
Code:	TFA
Description:	Tap Factory Active
Distance (ft):	87.3
Structural Grade:	0
O&M Grade:	0
Clock Start/From:	10
Clock To:	
1st Value:	4.000
2nd Value:	
Value Percent:	
Continuous Index:	
Within 8" of Joint:	NO
Remarks:

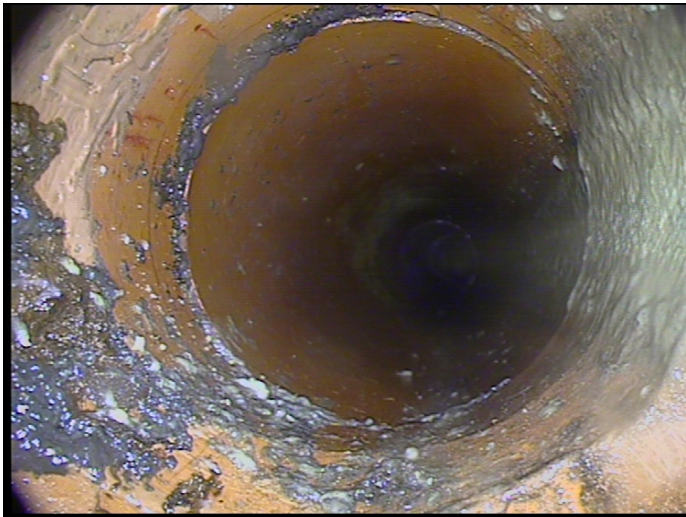
Code:	TF
Description:	Tap Factory
Distance (ft):	94.1
Structural Grade:	0
O&M Grade:	0
Clock Start/From:	2
Clock To:	
1st Value:	4.000
2nd Value:	
Value Percent:	
Continuous Index:	
Within 8" of Joint:	NO
Remarks:

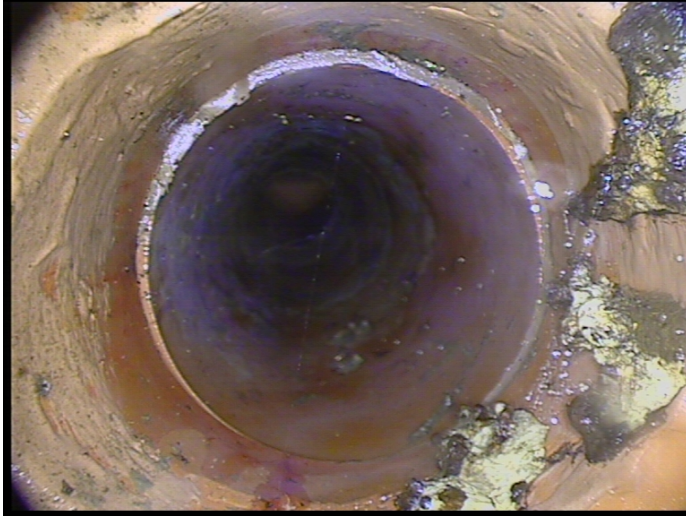
Code: **TF**
Description: **Tap Factory**

Distance (ft): **126.1**
Structural Grade: **0**
O&M Grade: **0**
Clock Start/From: **10**
Clock To:
1st Value: **4.000**
2nd Value:
Value Percent:
Continuous Index:
Within 8" of Joint: **NO**
Remarks:

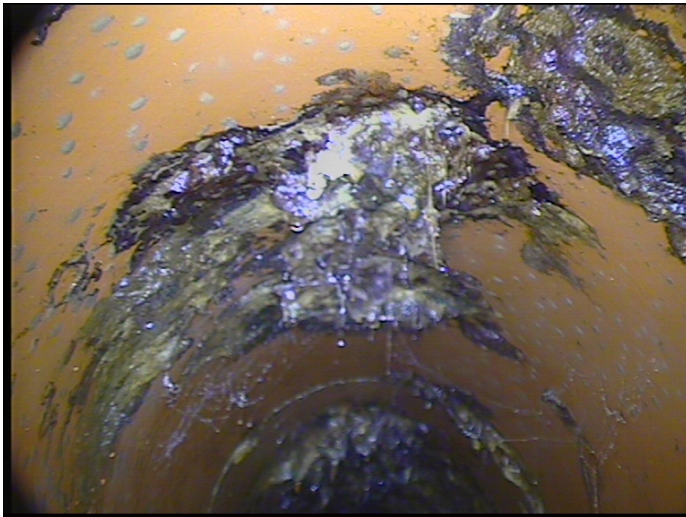
Code: **DAGS**
Description: **Deposits Attached Grease**

Distance (ft): **170.3**
Structural Grade: **0**
O&M Grade: **2**
Clock Start/From: **9**
Clock To: **3**
1st Value:
2nd Value:
Value Percent: **5.000**
Continuous Index: **S01**
Within 8" of Joint: **YES**
Remarks:

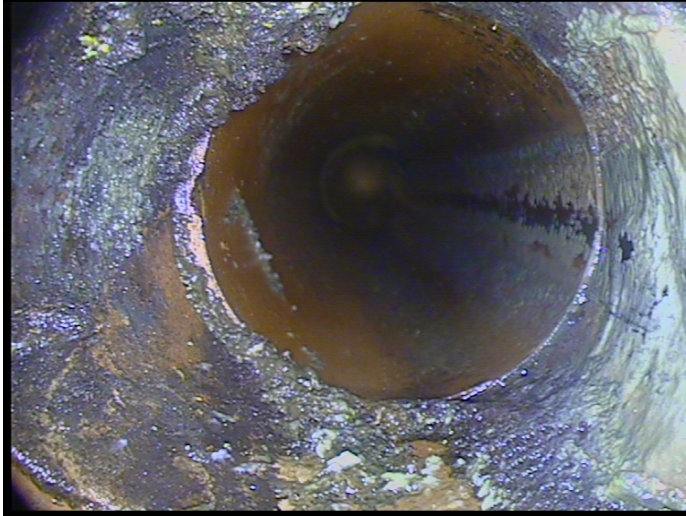
Code: **TF**
Description: **Tap Factory**

Distance (ft): **198.8**
Structural Grade: **0**
O&M Grade: **0**
Clock Start/From: **2**
Clock To:
1st Value: **4.000**
2nd Value:
Value Percent:
Continuous Index:
Within 8" of Joint: **NO**
Remarks:

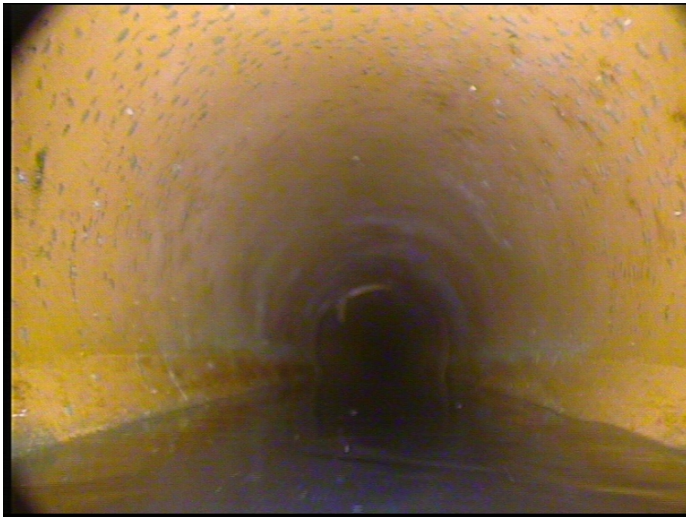
Code: **DAGS**
Description: **Deposits Attached Grease**

Distance (ft): **199.5**
Structural Grade: **0**
O&M Grade: **2**
Clock Start/From: **9**
Clock To: **3**
1st Value:
2nd Value:
Value Percent: **5.000**
Continuous Index: **F01**
Within 8" of Joint: **NO**
Remarks:

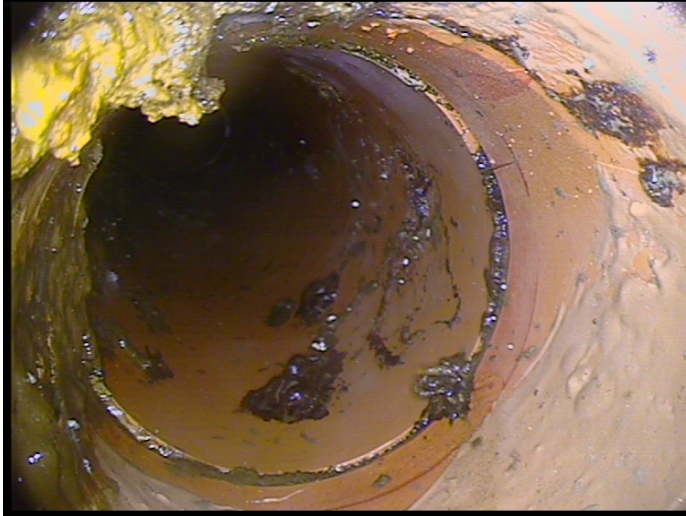
Code: **TF**
Description: **Tap Factory**

Distance (ft): **205.8**
Structural Grade: **0**
O&M Grade: **0**
Clock Start/From: **10**
Clock To:
1st Value: **4.000**
2nd Value:
Value Percent:
Continuous Index:
Within 8" of Joint: **NO**
Remarks:

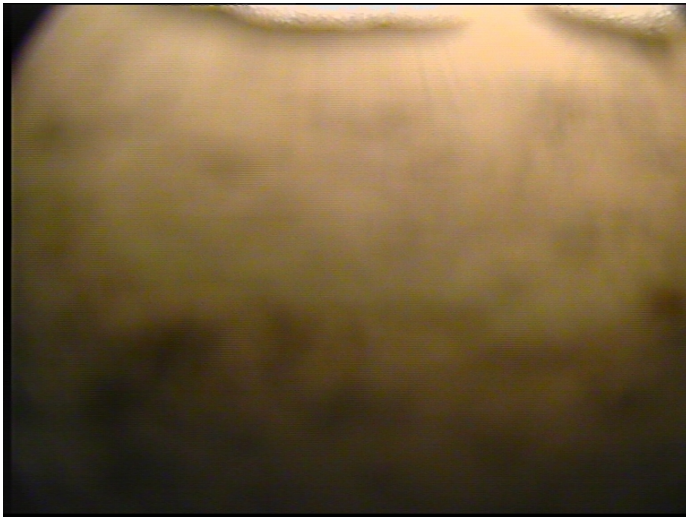
Code: **MWL**
Description: **Water Level**

Distance (ft): **246.2**
Structural Grade: **0**
O&M Grade: **0**
Clock Start/From:
Clock To:
1st Value:
2nd Value:
Value Percent: **40.000**
Continuous Index:
Within 8" of Joint: **NO**
Remarks:

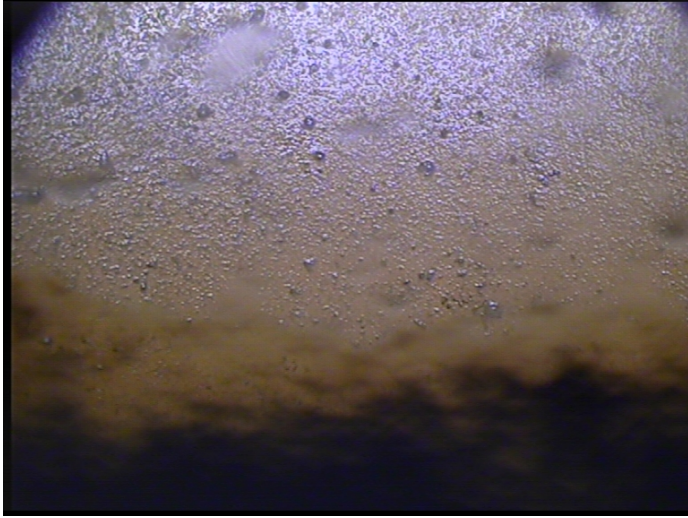
Code:	MSA
Description:	Abandoned Survey
Distance (ft):	248.7
Structural Grade:	0
O&M Grade:	0
Clock Start/From:	
Clock To:	
1st Value:	
2nd Value:	
Value Percent:	
Continuous Index:	
Within 8" of Joint:	NO
Remarks:	deep sediment
