Profile/Photo Observation Report

Profile/Photo Observation Report							
Date: Pipe Length (ft) P.O.#:	YES502259	Weather: Owner: Surveyor:	City of Hobart S. Bucklin	Coding: Pre Clean: PSR:	PACP 7.0 Heavy Cleaning P-303-047-LS004		
Customer:	City of Hobart	Clean Date:	10/25/2024	Shape:	С		
Street:	West 37th Avenu	West 37th Avenue		Not Controlled	I		
City:	Hobart, IN		Year Renewed:				
Location:	Easement/Right	of Way	Tape/Media #:				
Purpose:	Sewer System Ev	aluation Survey (SS	Dia/Height:	12"			
Use:	Sanitary Sewage	Pipe	Material:	VCP			
Drain Area:			Lining:	None			
Category:	NA						
Comment:							
Location Detail	s:		Direction of Survey	: Downstream			
US MH:	M-303-047	DS MH:	LS004	Total Length Surveyed (ft): 59.8		
O&M Index:	2.25	O&M Quick:	4122	O&M Rating:	9.00		
Structural Index:	3.00	Structural Qui	ick: 4121	Structural Rating:	6.00		
Overall Index:	2.50	Overall Quick:	4222	Overall Rating:	15.00

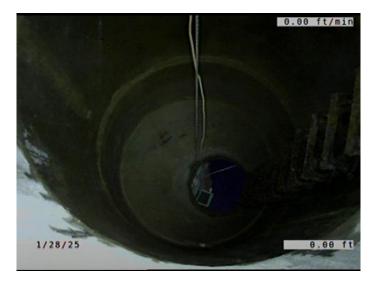
Code:	AMH
Description:	Manhole
Distance (ft):	.0
Structural Grade	: 0
O&M Grade:	0
Clock Start/From	:
Clock To:	
1st Value:	
2nd Value:	
Value Percent:	
Continuous Index	x:
Within 8" of Join	t: NO
Remarks:	M-303-047

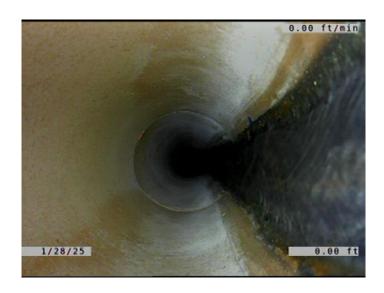
Code: MWL

Description: Miscellaneous Water Level

Distance (ft): .0
Structural Grade: 0
O&M Grade: 0

Value Percent: 5

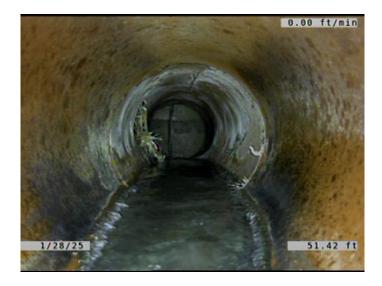
Code: LD

Description: Line Down

Distance (ft): 38.4
Structural Grade: 0

O&M Grade: 2

Value Percent: 15.000

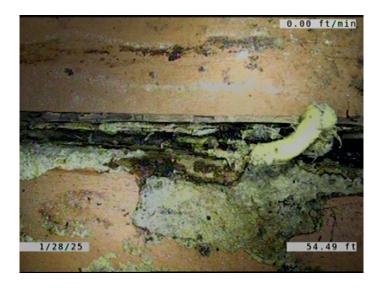
Code: RFJ

Description: Roots Fine Joint

Distance (ft): 54.5
Structural Grade: 0
O&M Grade: 1
Clock Start/From: 7
Clock To: 5
1st Value:
2nd Value:
Value Percent:

Within 8" of Joint: YES

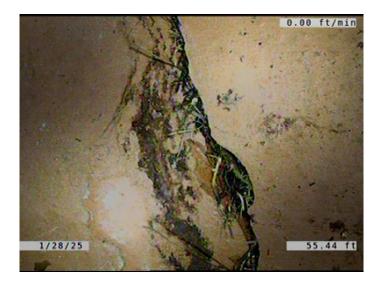
Code: B
Description: Broken

Distance (ft): 54.5
Structural Grade: 4

O&M Grade: 0
Clock Start/From: 7
Clock To: 5
