Profile/Photo Observation Report

Date:	03/28/2018	Weather:		Coding:	PACP 6.0
Pipe Length (ft):	221.6	Owner:	NA	Pre Clean:	Not Known
P.O.#:		Surveyor:	Selasie Honu	PSR:	P-303-049-048
Customer:		Clean Date:	01/01/1900	Shape:	C

Street:	W 37TH AVE	Flow Control:	Not Controlled
City:	Hobart, IN	Year Renewed:	
Location:	Other	Tape/Media #:	
Purpose:	Not Known	Dia/Height:	10"
Use:	Sanitary	Material:	VCP
Drain Area:	NA	Lining:	
Category:	NA		
Comment:

Location Details:		Direction of Survey:	Downstream
US MH:	M-303-049	DS MH:	M-303-048
		Total Length Surveyed (ft):	223.9

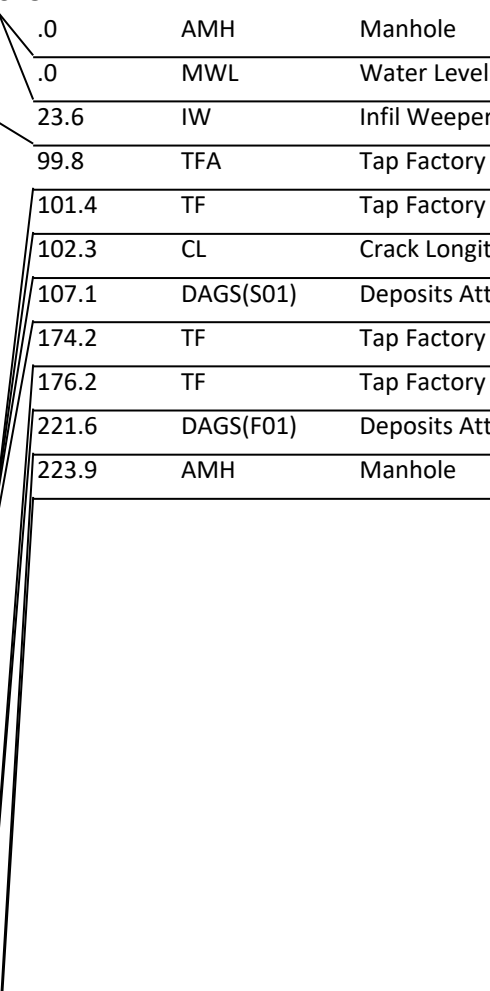
.0	AMH	Manhole	10	NA
.0	MWL	Water Level	21	NA
23.6	IW	Infil Weeper	80	M 2
99.8	TFA	Tap Factory Active	245	NA
101.4	TF	Tap Factory	261	NA
102.3	CL	Crack Longitudinal	275	S 2
107.1	DAGS(S01)	Deposits Attached Grease	296	M 2
174.2	TF	Tap Factory	444	NA
176.2	TF	Tap Factory	463	NA
221.6	DAGS(F01)	Deposits Attached Grease	567	M 2
223.9	AMH	Manhole	583	NA

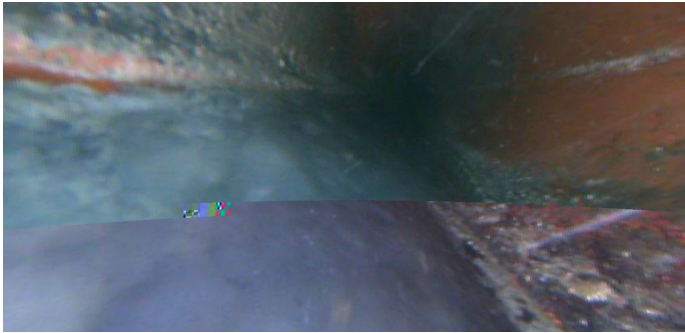
Code:	MWL
Description:	Water Level

Distance (ft):	.0
Structural Grade:	0
O&M Grade:	0
Clock Start/From:	
Clock To:	
1st Value:	
2nd Value:	
Value Percent:	5.000
Continuous Index:	
Within 8" of Joint:	NO
Remarks:

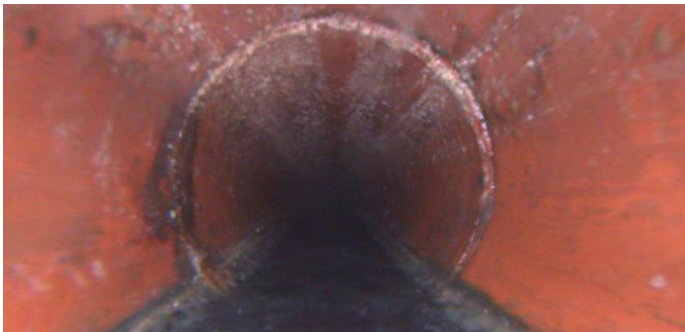
Code:	IW
Description:	Infil Weeper

Distance (ft):	23.6
Structural Grade:	0
O&M Grade:	2
Clock Start/From:	8
Clock To:	4
1st Value:	
2nd Value:	
Value Percent:	
Continuous Index:	
Within 8" of Joint:	YES
Remarks:

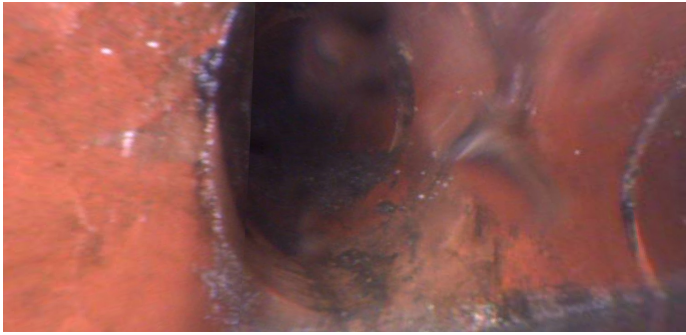
Code: **TFA**
Description: **Tap Factory Active**

Distance (ft): **99.8**
Structural Grade: **0**
O&M Grade: **0**
Clock Start/From: **3**
Clock To:
1st Value: **4.000**
2nd Value:
Value Percent:
Continuous Index:
Within 8" of Joint:
Remarks:

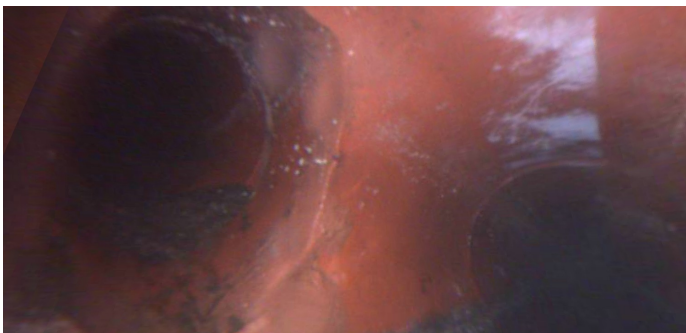
Code: **TF**
Description: **Tap Factory**

Distance (ft): **101.4**
Structural Grade: **0**
O&M Grade: **0**
Clock Start/From: **9**
Clock To:
1st Value: **4.000**
2nd Value:
Value Percent:
Continuous Index:
Within 8" of Joint:
Remarks:

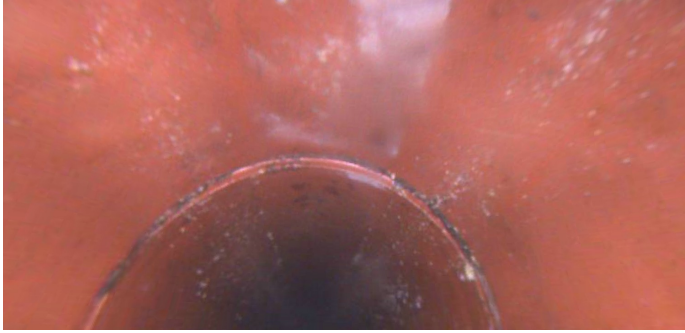
Code: **CL**
Description: **Crack Longitudinal**

Distance (ft): **102.3**
Structural Grade: **2**
O&M Grade: **0**
Clock Start/From: **12**
Clock To:
1st Value:
2nd Value:
Value Percent:
Continuous Index:
Within 8" of Joint: **YES**
Remarks:

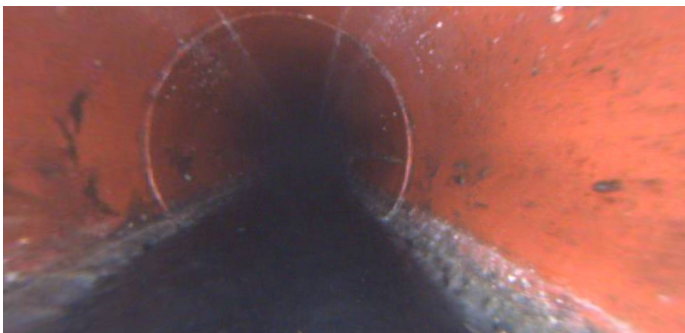
Code: **DAGS**
Description: **Deposits Attached Grease**

Distance (ft): **107.1**
Structural Grade: **0**
O&M Grade: **2**
Clock Start/From: **8**
Clock To: **4**
1st Value:
2nd Value:
Value Percent: **5.000**
Continuous Index: **S01**
Within 8" of Joint: **NO**
Remarks:

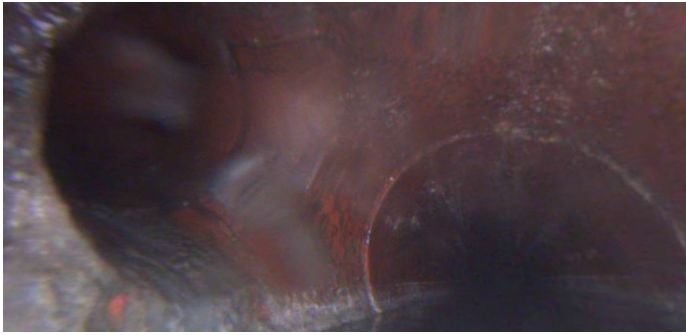
Code: **TF**
Description: **Tap Factory**

Distance (ft): **174.2**
Structural Grade: **0**
O&M Grade: **0**
Clock Start/From: **3**
Clock To:
1st Value: **4.000**
2nd Value:
Value Percent:
Continuous Index:
Within 8" of Joint:
Remarks:

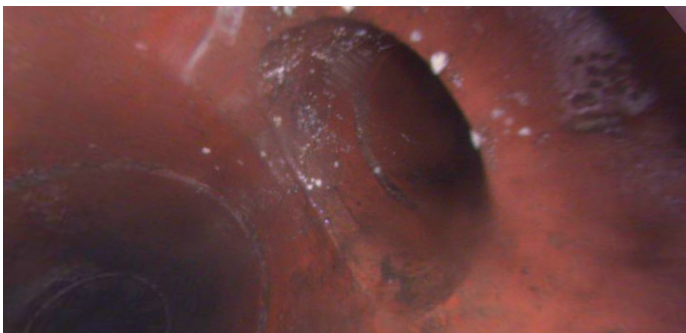
Code: **TF**
Description: **Tap Factory**

Distance (ft): **176.2**
Structural Grade: **0**
O&M Grade: **0**
Clock Start/From: **10**
Clock To:
1st Value: **4.000**
2nd Value:
Value Percent:
Continuous Index:
Within 8" of Joint:
Remarks:

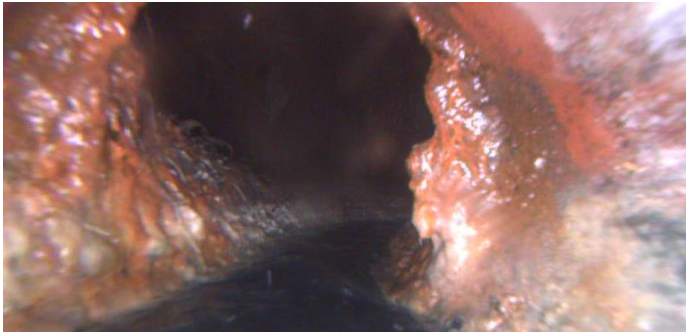
Code: **DAGS**
Description: **Deposits Attached Grease**

Distance (ft): **221.6**
Structural Grade: **0**
O&M Grade: **2**
Clock Start/From: **8**
Clock To: **4**
1st Value:
2nd Value:
Value Percent: **5.000**
Continuous Index: **F01**
Within 8" of Joint: **NO**
Remarks:
