Profile/Photo Observation Report

| Street: | ALLEY BETWEEN W 37TH AVE & W 3 | Flow Control: | Not Controlled |

| US MH: | M-303-050 | DS MH: | M-303-049 |

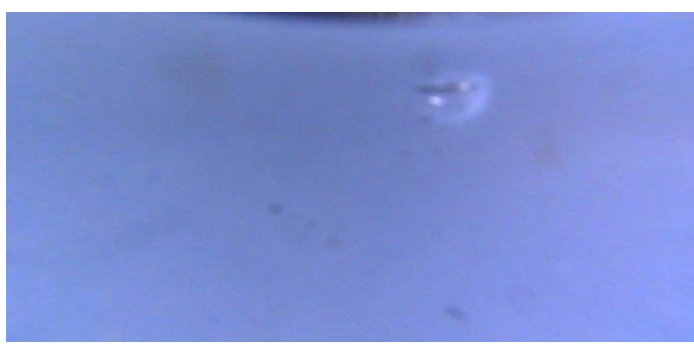
Code: **AMH**
Description: **Manhole**

Distance (ft): **.0**
Structural Grade: **0**
O&M Grade: **0**
Clock Start/From:
Clock To:
1st Value:
2nd Value:
Value Percent:
Continuous Index:
Within 8" of Joint: **NO**
Remarks: **M-303-049**

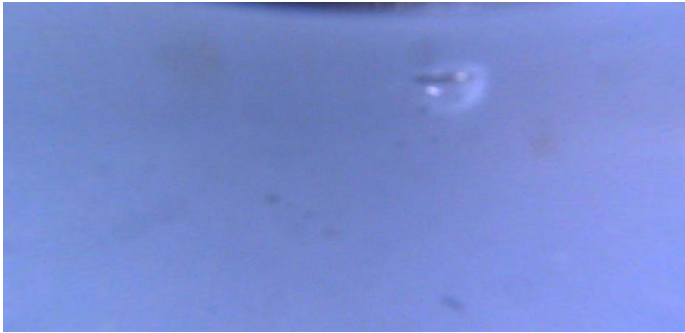
| Code: | MWL |
| Description: | Water Level |

| Value Percent: | 5.000 |

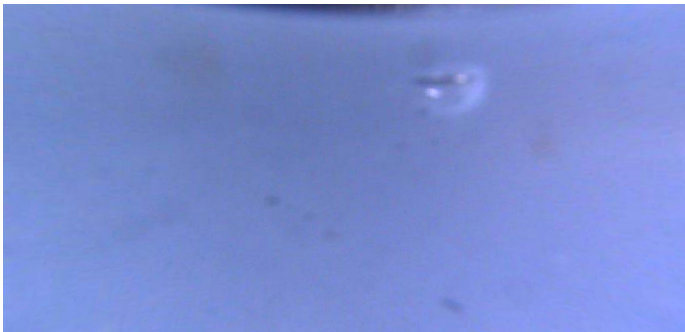
| Code: | MWLS |
| Description: | Water Level Sag |

| Structural Grade: | 2 |
| O&M Grade: | 3 |
| Value Percent: | 10.000 |

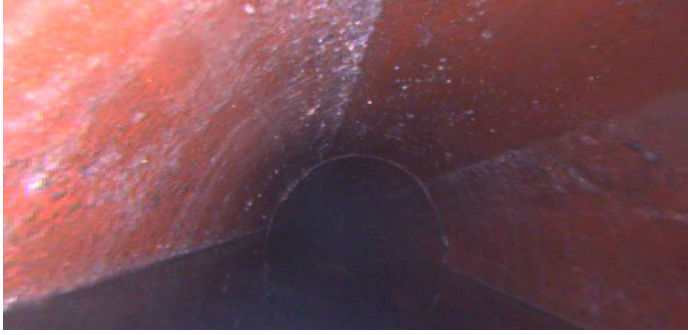
| Code: | MSA |
| Description: | Abandoned Survey |
| Distance (ft): | 8.5 |
| Remarks: | camera stopped |
