## Profile/Photo Observation Report

Street:	<b>W 37TH AVE</b>	Flow Control:	<b>Not Controlled</b>
City:	<b>Hobart, IN</b>	Year Renewed:	
Location:	<b>Other</b>	Tape/Media #:	
Purpose:	<b>Not Known</b>	Dia/Height:	<b>10"</b>
Use:	<b>Sanitary</b>	Material:	<b>VCP</b>
Drain Area:	<b>NA</b>	Lining:	
Category:	<b>NA</b>		
Comment:

Location Details:		Direction of Survey:	<b>Upstream</b>
US MH:	<b>M-303-050</b>	DS MH:	<b>M-303-049</b>
		Total Length Surveyed (ft):	<b>8.5</b>

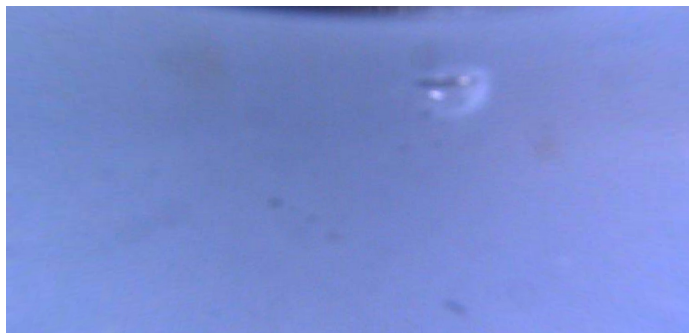
Code: **AMH**  
Description: **Manhole**

Distance (ft): **.0**  
Structural Grade: **0**  
O&M Grade: **0**  
Clock Start/From:  
Clock To:  
1st Value:  
2nd Value:  
Value Percent:  
Continuous Index:  
Within 8" of Joint: **NO**  
Remarks: **M-303-049**

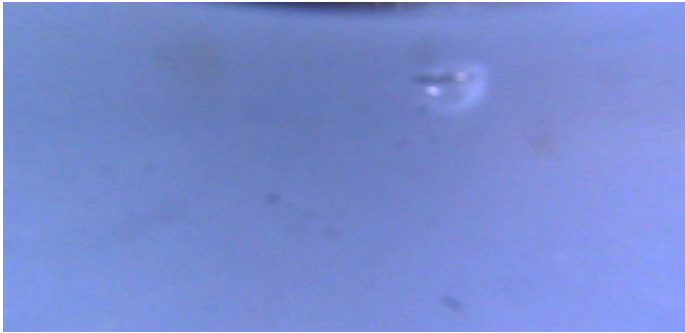
Code:	<b>MWL</b>
Description:	<b>Water Level</b>

Distance (ft):	<b>.0</b>
Structural Grade:	<b>0</b>
O&M Grade:	<b>0</b>
Clock Start/From:	
Clock To:	
1st Value:	
2nd Value:	
Value Percent:	<b>5.000</b>
Continuous Index:	
Within 8" of Joint:	<b>NO</b>
Remarks:

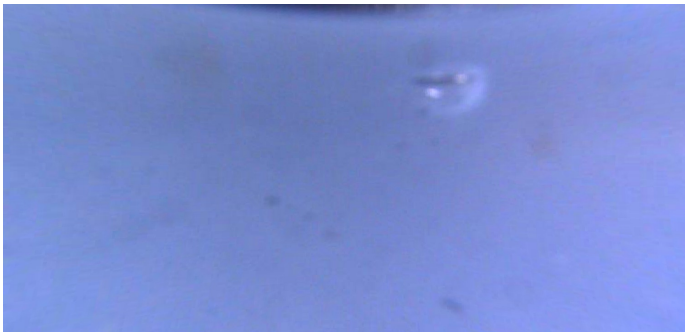
Code:	<b>MWLS</b>
Description:	<b>Water Level Sag</b>

Distance (ft):	<b>.0</b>
Structural Grade:	<b>2</b>
O&M Grade:	<b>3</b>
Clock Start/From:	
Clock To:	
1st Value:	
2nd Value:	
Value Percent:	<b>10.000</b>
Continuous Index:	
Within 8" of Joint:	<b>NO</b>
Remarks:

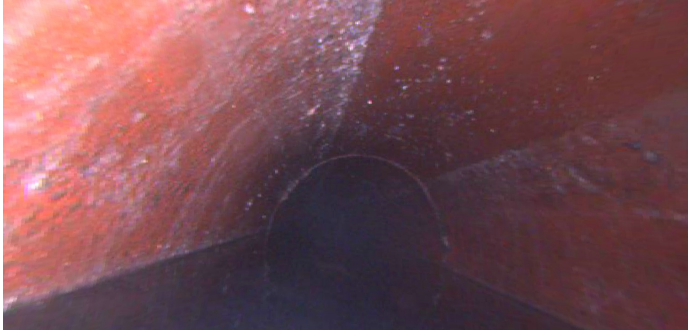
Code:	<b>MSA</b>
Description:	<b>Abandoned Survey</b>
Distance (ft):	<b>8.5</b>
Structural Grade:	<b>0</b>
O&M Grade:	<b>0</b>
Clock Start/From:	
Clock To:	
1st Value:	
2nd Value:	
Value Percent:	
Continuous Index:	
Within 8" of Joint:	<b>NO</b>
Remarks:	<b>camera stopped</b>
