Profile/Photo Observation Report

| Street: | Ridge Rd. | Flow Control: | Not Controlled |
| City: | Hobart, IN | Year Renewed: | |

| US MH: | M-303-050 | DS MH: | M-303-049 |

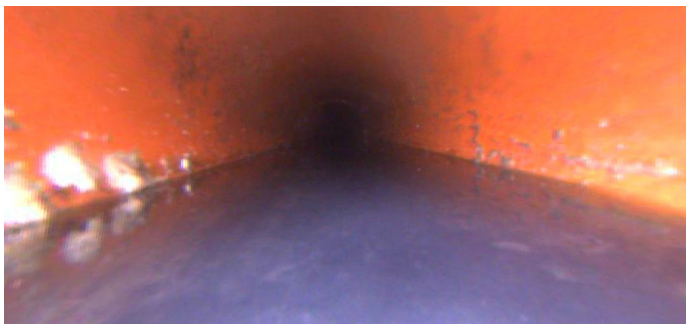
Code: **AMH**
Description: **Manhole**

Distance (ft): **.0**
Structural Grade: **0**
O&M Grade: **0**
Clock Start/From:
Clock To:
1st Value:
2nd Value:
Value Percent:
Continuous Index:
Within 8" of Joint: **NO**
Remarks: **M-303-049**

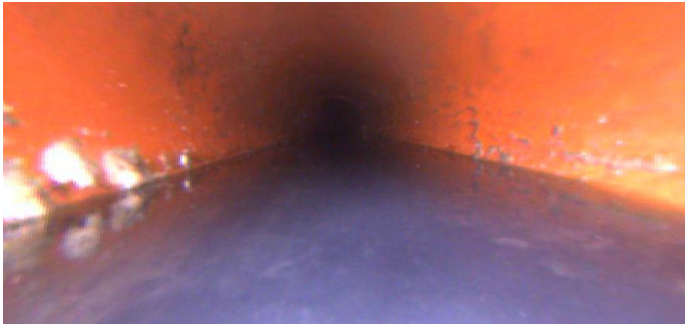
| Code: | MWL |
| Description: | Water Level |

| Value Percent: | 5.000 |

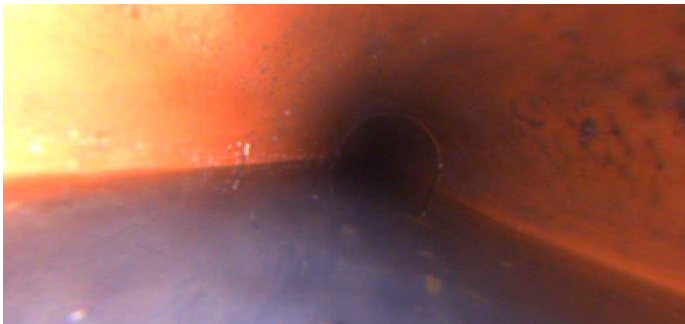
| Code: | MSA |
| Description: | Abandoned Survey |

| Distance (ft): | 7.5 |
| Remarks: | cAMERA STOPPPED |
