Profile/Photo Observation Report

Street:	N LIVERPOOL RD	Flow Control:	Not Controlled
City:	Hobart, IN	Year Renewed:	
Location:	Other	Tape/Media #:	
Purpose:	Not Known	Dia/Height:	10"
Use:	Sanitary	Material:	VCP
Drain Area:	NA	Lining:	
Category:	NA		
Comment:

Location Details:		Direction of Survey:	Downstream
US MH:	M-303-052	DS MH:	M-303-051
		Total Length Surveyed (ft):	11.9

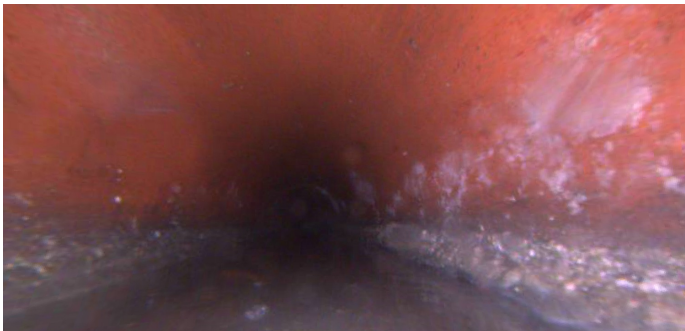
Code: **AMH**
Description: **Manhole**

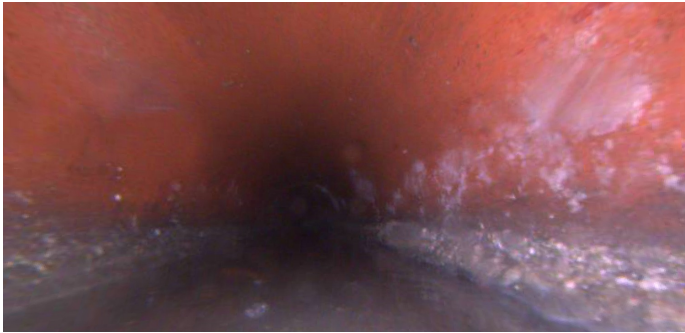
Code:	MWL
Description:	Water Level

Distance (ft):	.0
Structural Grade:	0
O&M Grade:	0
Clock Start/From:	
Clock To:	
1st Value:	
2nd Value:	
Value Percent:	20.000
Continuous Index:	
Within 8" of Joint:	NO
Remarks:

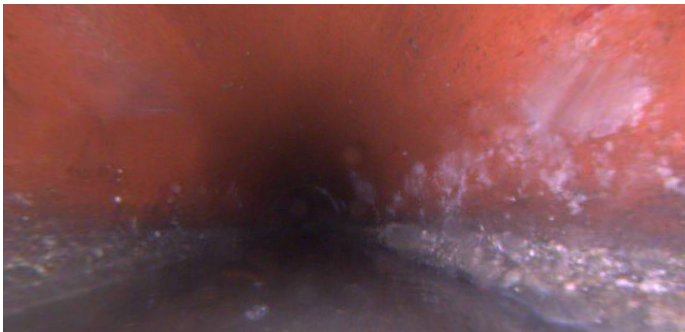
Code:	DAGS
Description:	Deposits Attached Grease

Distance (ft):	.0
Structural Grade:	0
O&M Grade:	2
Clock Start/From:	8
Clock To:	4
1st Value:	
2nd Value:	
Value Percent:	5.000
Continuous Index:	S01
Within 8" of Joint:	NO
Remarks:

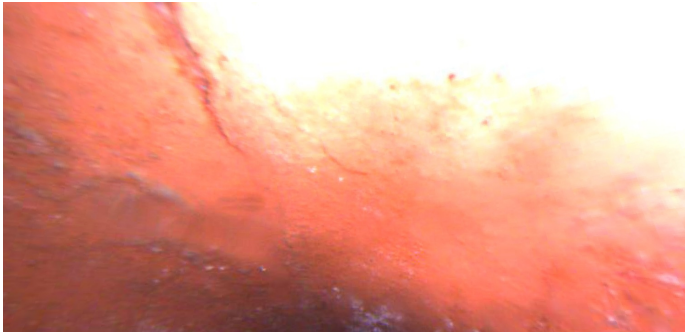
Code: **FM**
Description: **Fracture Multiple**

Distance (ft): **11.9**
Structural Grade: **4**
O&M Grade: **0**
Clock Start/From: **12**
Clock To: **1**
1st Value:
2nd Value:
Value Percent:
Continuous Index:
Within 8" of Joint:
Remarks:

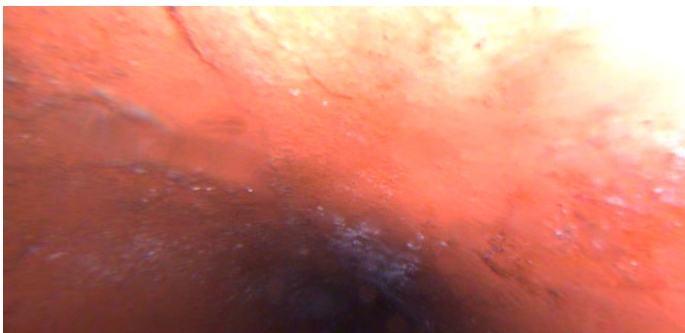
Code: **DAGS**
Description: **Deposits Attached Grease**

Distance (ft): **11.9**
Structural Grade: **0**
O&M Grade: **2**
Clock Start/From: **8**
Clock To: **4**
1st Value:
2nd Value:
Value Percent: **5.000**
Continuous Index: **F01**
Within 8" of Joint: **NO**
Remarks:

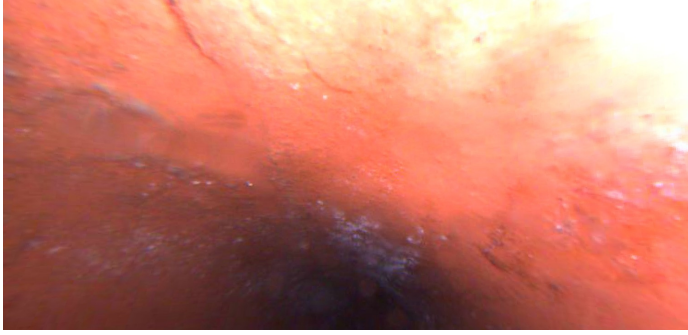
Code:	MSA
Description:	Abandoned Survey
Distance (ft):	11.9
Structural Grade:	0
O&M Grade:	0
Clock Start/From:	
Clock To:	
1st Value:	
2nd Value:	
Value Percent:	
Continuous Index:	
Within 8" of Joint:	NO
Remarks:	DEBRIS UNDER WATER
