## Profile/Photo Observation Report

Street:	<b>MAXWELL ST</b>	Flow Control:	<b>Not Controlled</b>
City:	<b>Hobart, IN</b>	Year Renewed:	
Location:	<b>Other</b>	Tape/Media #:	
Purpose:	<b>Not Known</b>	Dia/Height:	<b>10"</b>
Use:	<b>Sanitary</b>	Material:	<b>VCP</b>
Drain Area:	<b>NA</b>	Lining:	
Category:	<b>NA</b>		
Comment:

Location Details:		Direction of Survey:	<b>Downstream</b>
US MH:	<b>M-303-052</b>	DS MH:	<b>M-303-051</b>
		Total Length Surveyed (ft):	<b>11.9</b>

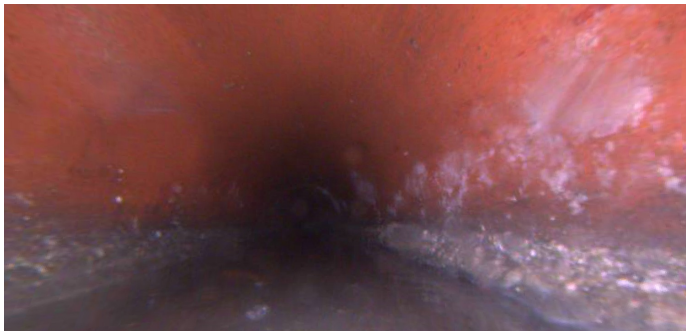
Code: **AMH**  
Description: **Manhole**

Distance (ft): **.0**  
Structural Grade: **0**  
O&M Grade: **0**  
Clock Start/From:  
Clock To:  
1st Value:  
2nd Value:  
Value Percent:  
Continuous Index:  
Within 8" of Joint: **NO**  
Remarks: **M-303-052**

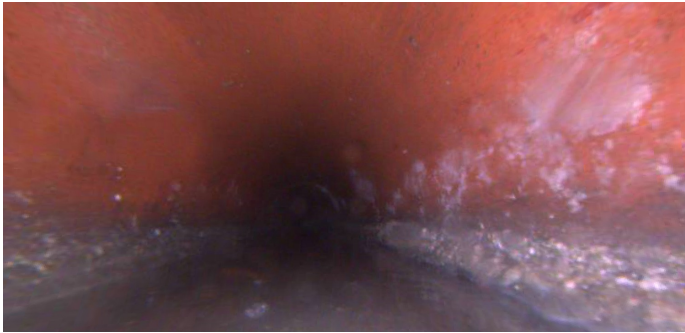
Code:	<b>MWL</b>
Description:	<b>Water Level</b>

Distance (ft):	<b>.0</b>
Structural Grade:	<b>0</b>
O&M Grade:	<b>0</b>
Clock Start/From:	
Clock To:	
1st Value:	
2nd Value:	
Value Percent:	<b>20.000</b>
Continuous Index:	
Within 8" of Joint:	<b>NO</b>
Remarks:

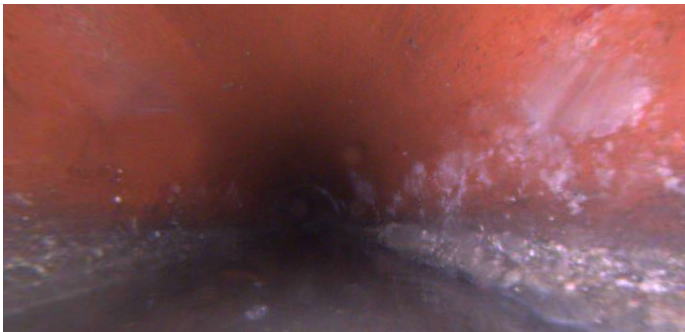
Code:	<b>DAGS</b>
Description:	<b>Deposits Attached Grease</b>

Distance (ft):	<b>.0</b>
Structural Grade:	<b>0</b>
O&M Grade:	<b>2</b>
Clock Start/From:	<b>8</b>
Clock To:	<b>4</b>
1st Value:	
2nd Value:	
Value Percent:	<b>5.000</b>
Continuous Index:	<b>S01</b>
Within 8" of Joint:	<b>NO</b>
Remarks:

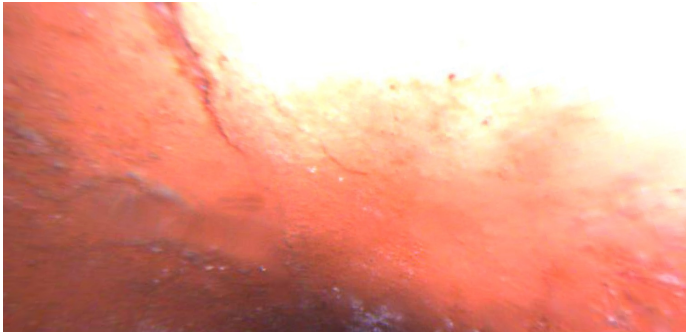
Code: **FM**  
Description: **Fracture Multiple**

Distance (ft): **11.9**  
Structural Grade: **4**  
O&M Grade: **0**  
Clock Start/From: **12**  
Clock To: **1**  
1st Value:  
2nd Value:  
Value Percent:  
Continuous Index:  
Within 8" of Joint:  
Remarks:

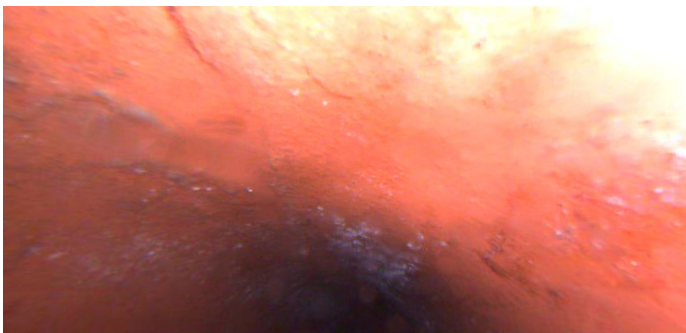
Code: **DAGS**  
Description: **Deposits Attached Grease**

Distance (ft): **11.9**  
Structural Grade: **0**  
O&M Grade: **2**  
Clock Start/From: **8**  
Clock To: **4**  
1st Value:  
2nd Value:  
Value Percent: **5.000**  
Continuous Index: **F01**  
Within 8" of Joint: **NO**  
Remarks:

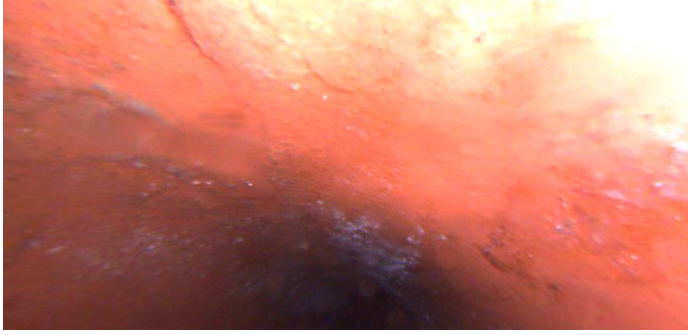
Code:	<b>MSA</b>
Description:	<b>Abandoned Survey</b>
Distance (ft):	<b>11.9</b>
Structural Grade:	<b>0</b>
O&M Grade:	<b>0</b>
Clock Start/From:	
Clock To:	
1st Value:	
2nd Value:	
Value Percent:	
Continuous Index:	
Within 8" of Joint:	<b>NO</b>
Remarks:	<b>DEBRIS UNDER WATER</b>
